Integrity Inspection of a Steam Turbine Rotor in a Geothermal Power Plant

Abstract—A 55 MW steam turbine in geothermal generation power plant has been in service for 26 years. This turbine stopped working in 2013 due to the failure of a first stage blade. By considering the damage and maintenance works are important for geothermal turbine to maintain the reliable operation before it will be back in use, the integrity inspection must be conducted. The methodology for integrity inspection was nondestructive tests e.g.; visual inspection, dye penetrant, UT phased array, eddy current, hardness, chemical composition test and microstructure analysis using replica technique. Chemical composition analysis, hardness data and microstructure analysis gave evidence that the material rotor met the standard of ASTM A470 class 8. Visual inspection and dye penetrant found that there were some surface defects and microstructure analysis on replica showed that pitting was observed. However, UT phased array and radiograph results revealed that no internal defects were found, which indicated that the surface defects only occurred on the surface and pitting did not propagate. Results of eddy current i

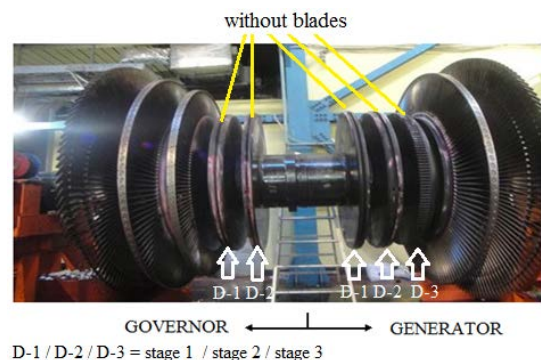
FIGURE 1. INSPECTED STEAM TURBINE ROTOR.

Figure 1 shows the typical rotor shaft of geothermal steam turbine to be inspected. The turbine contains 5 stages on generator and governor sides, respectively and operates at 161.9 oC and 6.82 bar.

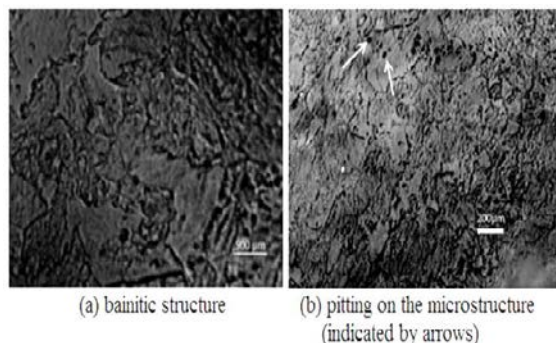
FIGURE II. MICROSTRUCTURE OF ROTOR MATERIAL (A) AND PITTING WAS OBSERVED (B).

Microstructure of the rotor material using replica technique shows that the material rotor has a bainitic structure (Figure.2a) and there is no indication that the material had experienced phase changes and exposed to high temperature. The bainitic structure supported the evidence that the type of material rotor is CrMoV steel alloy. Based on chemical composition, hardness data and microstructure analysis, it can be concluded that the material rotor satisfied with the ASTM A470 class 8. Microstructure analysis shows that pitting had occurred (Figure. 2b). The depth of pitting would be clarified using UT phased array. Visual inspection and dye penetrant method found some defects, as can be seen in Figures. 3 and 4.

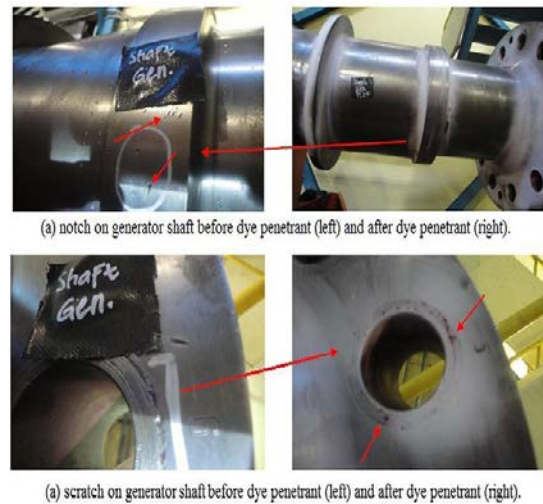
FIGURE III. NOTCH AND SCRATCH (INDICATED BY ARROWS) ON GENERATOR SHAFT.

Figures.3 and 4 show some surface defects (notch and scratch) that were found from visual inspection and dye penetrant. Notch that was observed near to pin lock on governor side (Figure.4a) seems due to mechanical collision when the blade was released. UT phased array and eddy current were conducted on all areas, and special attention was given to the area with surface defect sand pitting. The results of eddy current inspection in all areas indicated that no fine cracks either in surface or sub surface were detected and the results of UT phased array show that there were no internal defects. Therefore, it can be concluded that the notch, scratch and pitting occurred only on the surface and no evidence that pitting had propagated. The result of UT phased array on one of surface defect area (Figure. 4b) can be seen in Figure. 5.

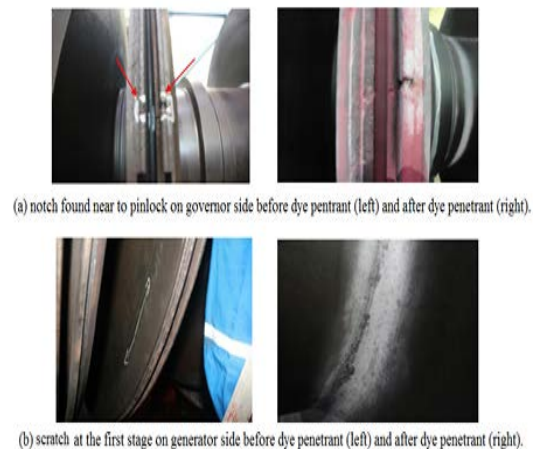
FIGURE IV. DEFECTS ON GOVERNOR AND GENERATOR SIDES (INDICATED BY ARROWS).

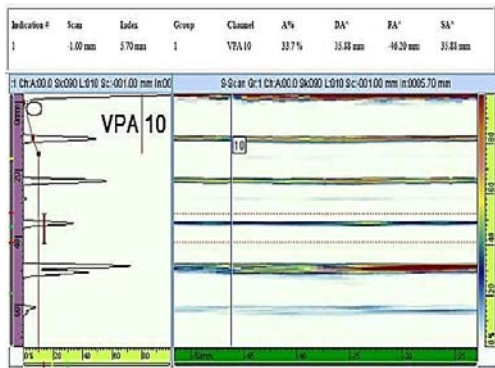
FIGURE V. UT PHASED ARRAY RESULT SHOWS NO DEFECT'S REFLECTOR ON SCANNED AREA.

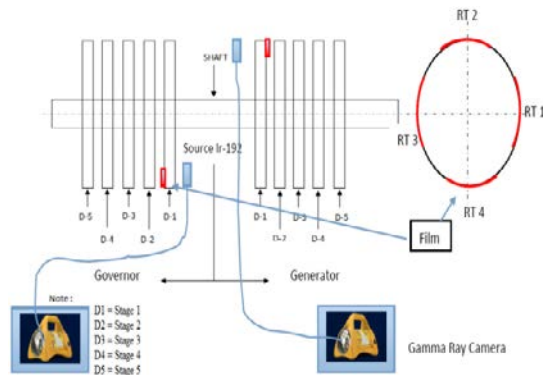
FIGURE VI. INSPECTED AREA AND FILM LOCATION IN RADIOGRAPH INSPECTION.

The RT 1 was the most critical area for blade attachment namely at pin lock of stage 1 looked at from governor side. The film was located in three different areas namely RT2, RT 3 and RT4 with counter clock wise direction (see Figure. 6). The results of radiograph inspection show that there were no internal defects.
