# *Effect of Technological Defects on Reliability of Engineering Products*

**Abstract**—The nature and reasons of two cases of premature failure of engineering products are investigated (metal-composite cylinder for moto fuel and metal rod of bulldozer's hydraulic cylinder). By methods of metallography and fractography with using the basic provisions of metallurgy, physics of metals, physics of strength and fracture we have identified the localization of initial cracks, the micromechanisms of their formation and subsequent development, and described the general picture of failure. It is shown that the main physical and mechanical causes of cylinder's failure are connected with coarsening and heterogeneity of intermetallic phase distribution in an alloy and the increased roughness of internal surface processing on the metal liner. It is established that the reason of the rod failure was unsatisfactory quality of metal caused by errors of heat treatment before chrome plating. As a result, there are structural inhomogeneities (ferritic banding, non-metallic inclusions) in the hardened layer and in the transitional zone to the core area which initiated the fatigue cracks. The main mec

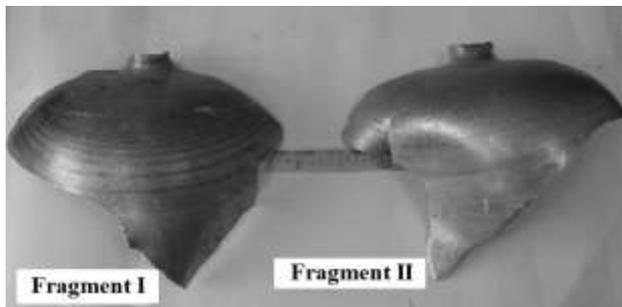
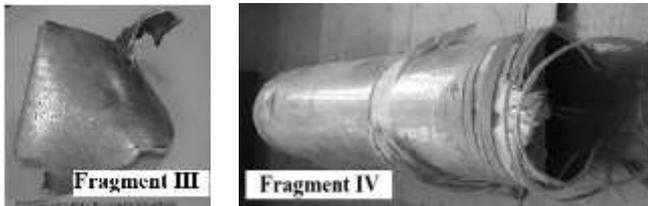
The emergency fragmental rupture of gas fuel cylinder had occurred in summer in the garage box shortly after fillings. The cylinder was torn apart with the separation of the bottom of inner metal shell (liner) from the side of a plug, dividing the bottom into several parts and removing of the outer composite shell (Fig. 1). Fragments of the emergency cylinder liner were heavily deformed. On the liner inner surface the visible corrosion defects such as pits and blowholes were not revealed.

Fig. 1. General view of the emergency liner fragments: a, b - fragments of the lower part; c - upper part on the side of valve with preserved composite shell

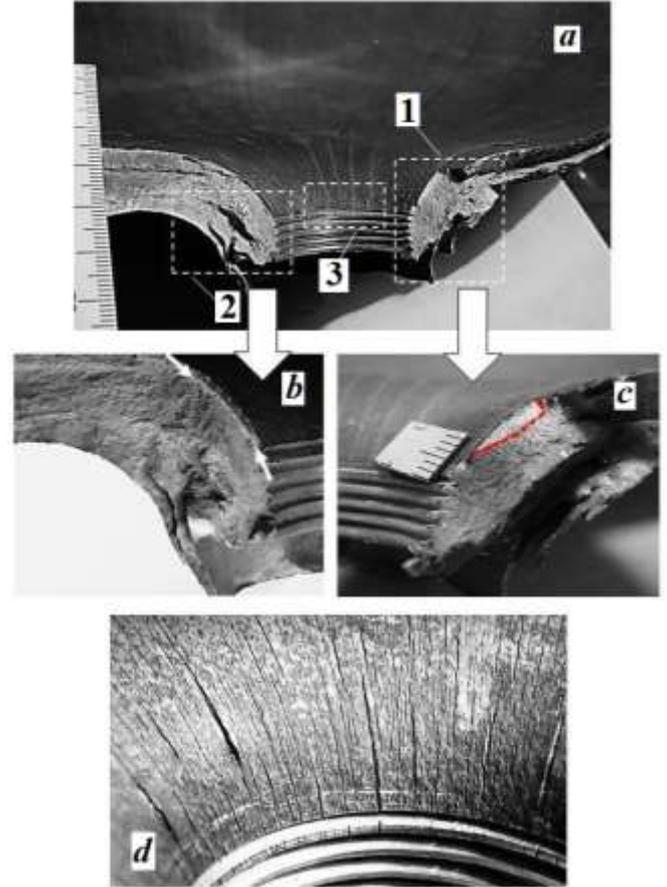
Macrofractographic features of fracture allowed determining that the cylinder destruction had begun from its inner surface on the side of a plug (Fig. 2, a). In zone 1 the

shiny surface of focal fatigue crack is clearly visible (Fig. 2, c). In zone 2 the focal crack is a narrow and also lapped areas (Fig. 2, b). The important feature of inner surface of the liner fragments I and II is the cracking of different length (up to 19 mm) and different degree of disclosures (up to 0.47 mm), which are mostly near the neck thread (Fig. 2, d). The maximum depth of their penetration into metal is  $\approx 1.1$  mm.

Fig. 2. General view of the failed filler neck (a) and the enlarged images of fracture zones 2 (b), 1 (c) and section 3 (d); light strip between arrows (b) and light area bounded by a dotted line (c) – surface of focal fatigue cracks.

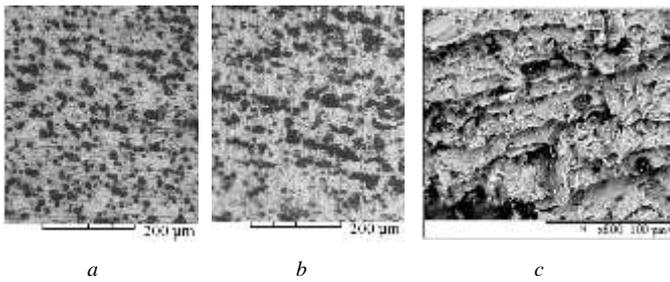
The alloy from which the failed cylinder had been made is characterized by heterogeneous structure with enlarged particles of the reinforcing intermetallic phase. These shortcomings of structure are more defined in the decayed bottom (Fig. 3, *b*). The particle coarsening led to the decrease in their number, increased the distance between them and contributed to the decrease in hardness. The brittleness of intermetallic compounds worsened the resistance of material to nucleation and propagation of fracture.

The cracks initiation had occurred on cracking of inner surface of the bottom. The surface of focal fatigue cracks has a typical cascade structure and contains a set of intermetallic compounds particles (Fig. 3, *c*).

Fig. 3. Metal microstructure of the decayed cylinder in the undamaged cylindrical part (*a*), in the zone of destruction (*b*) and microstructure of focal fatigue cracks in zone 1 (see Fig. 2, *a*)

According to the results of the studies, the main physical and mechanical cause of the cylinder liner destruction long before the wearing of designed life is the unsatisfactory structure of a material. Isolation of the hardening phase in the form of conglomerates of enlarged brittle particles of intermetallic compounds, their uneven distribution with weakly expressed linearity reduced the hardness value. The reduced hardness of a material caused the increased roughness of the liner inner surface. This led to the creation of a system of surface stress microconcentrators. In the zone of lower bottom neck on the stress microconcentrators under the action of operational loads arose the primary shatterings of the metal which had been already weakened by the relatively large allocations of fragile intermetallic phases.

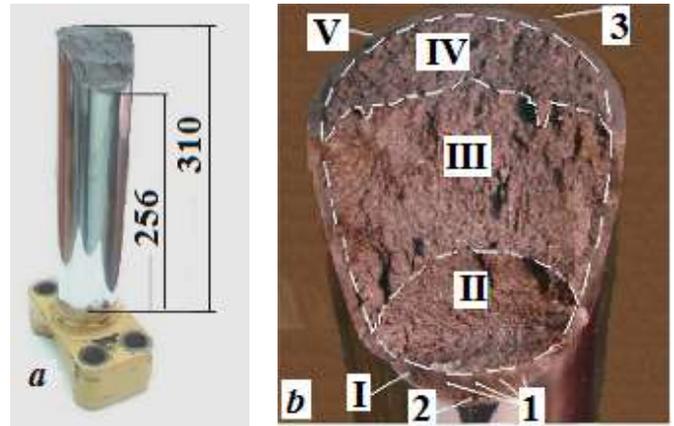
The emergency failure of the left rod of a bulldozer hydraulic cylinder happened after a minor operating time during 550 motor hours while performing the works (pushing of open peats). Ambient temperature at the moment of breakage was  $-25\text{ }^{\circ}\text{C}$ . The fracture occurred at distance of  $\approx 256\text{ mm}$  from the rod lower end (Fig. 4, *a*). The rod diameter is  $76.15\text{ mm}$ ; the original length is  $182.3\text{ mm}$ .

Fig. 4. General view (*a*) and fracture surface of a rod short fragment (*b*). I, II, III and IV are fracture areas; 1 – the place of the destruction nucleation; 2 – lapped areas; 3 – cracking from the outer surfaces

A visual study of the fracture reveals several sites that different in appearance of macro-relief and roughness (Fig. 4, *b*). Fracture focuses are in the subsurface layer (Fig. 4, *b*, zone I, arrows 1). Zone I consists of smooth slightly convex areas and is located near the rod surface at a depth of  $\approx 3$  mm. In areas of focal cracks distribution there are scars arising from the merger of adjacent cracks; also in zone I, the bow-shaped lapping of a surface is clearly visible (arrow 2 in Fig. 4, *b*), formed at the friction of crack faces during the time interval from the moment of its formation to the final destruction of a part.

Reduction of the rod working section due to the appearance of cracks over time led to the appearance of the cracking from the outer surface on the opposite side of the rod

(arrow 3 in Fig. 4, *b*). The direction of the chevron marking of brittle fracture that framed the rod fracture (zone V, Fig. 4, *b*),

characteristic of features and a high level of relief allow defining zones II, III, IV as zones of final rupture.

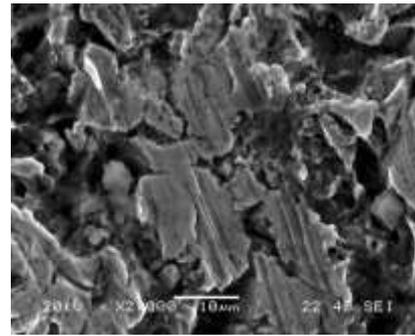
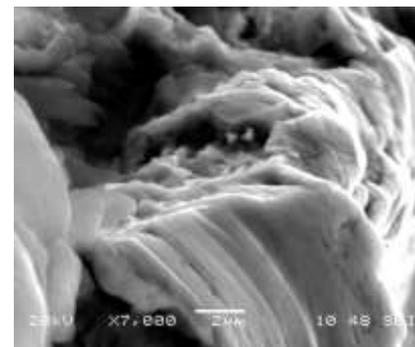
Fig. 5. The sites of fracture with fatigue striations

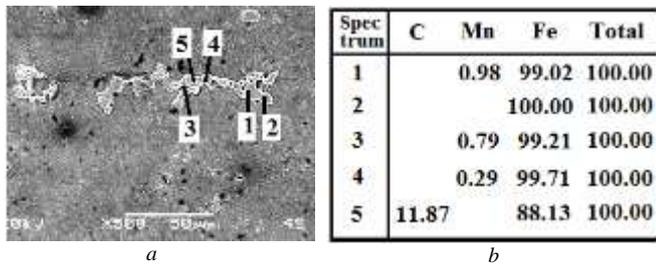
In the microstructure of the cross section of the rod, there are several zones: chrome coating, a zone hardened to a depth of 3 mm, intermediate zone and base metal. A great influence on the quality of chrome plating has such an operation of pre-preparation of rods as a heat treatment. As the chrome coatings are needed to be deposited on a sufficiently solid foundation, the investigated rod was subjected to quenching with the use of high frequency currents before chroming. The detail study revealed the presence of structural defects in the quenching zone and the transition zone from the hardened layer to the core. These are the single and banded structure formations which are the selection of ferrite interspersed with carbide particles (Fig. 6, *a*, *b*). The presence of such "soft" decarburized zones with reduced strength is particularly dangerous in the transition zone which is confirmed by the origin of fatigue cracks in this area.

Fig. 6. The microstructure of a rod metal: *a* – banded ferrite formations; *b* – micro-distribution of chemical elements in ferrite formations.

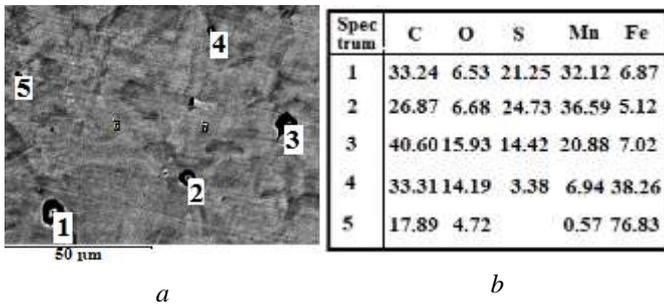
One of the causes of ferrite banding is the presence of plastic sulfide inclusions in the steel structure. The microstructure analysis of a transition layer and a core revealed a significant number of non-metallic inclusions with various size and origin (Fig. 7, *a*). According to data of the electron microprobe it has been identified that non-metallic inclusions really have mainly sulfide and also oxygen origin (manganese sulfides, simple oxides, oxysulfides), and also silicates (Fig. 7, *b*).

Fig. 7. Non-metallic inclusions in the transition zone (*a*) and the chemical composition of non-metallic inclusions (*b*)
