Failure Analysis of Condenser Tube in Unit 1 of the Tenayan Steam Power Plant 2 X 110 MW

Abstract—This study conducted a failure analysis of the condenser tube in unit 1 of the Tenayan Steam Power Plant. It started from the inspection in the first year after the commercial off date (COD) where there is a leaky tube, so there is further suspicion. Various tests and analysis are carried out such as tube vacuum testing, Eddy current testing, condenser tube material analysis, condenser water quality analysis, effectiveness and heat transfer on a condenser to the determination of root cause failure analysis to ensure condenser performance. From the results obtained, the cause of the failure of the condenser tube in unit 1 is the thinning of the condenser tube wall. The failure mechanism is erosion corrosion caused by the use of water in condensers that contain high turbidity.

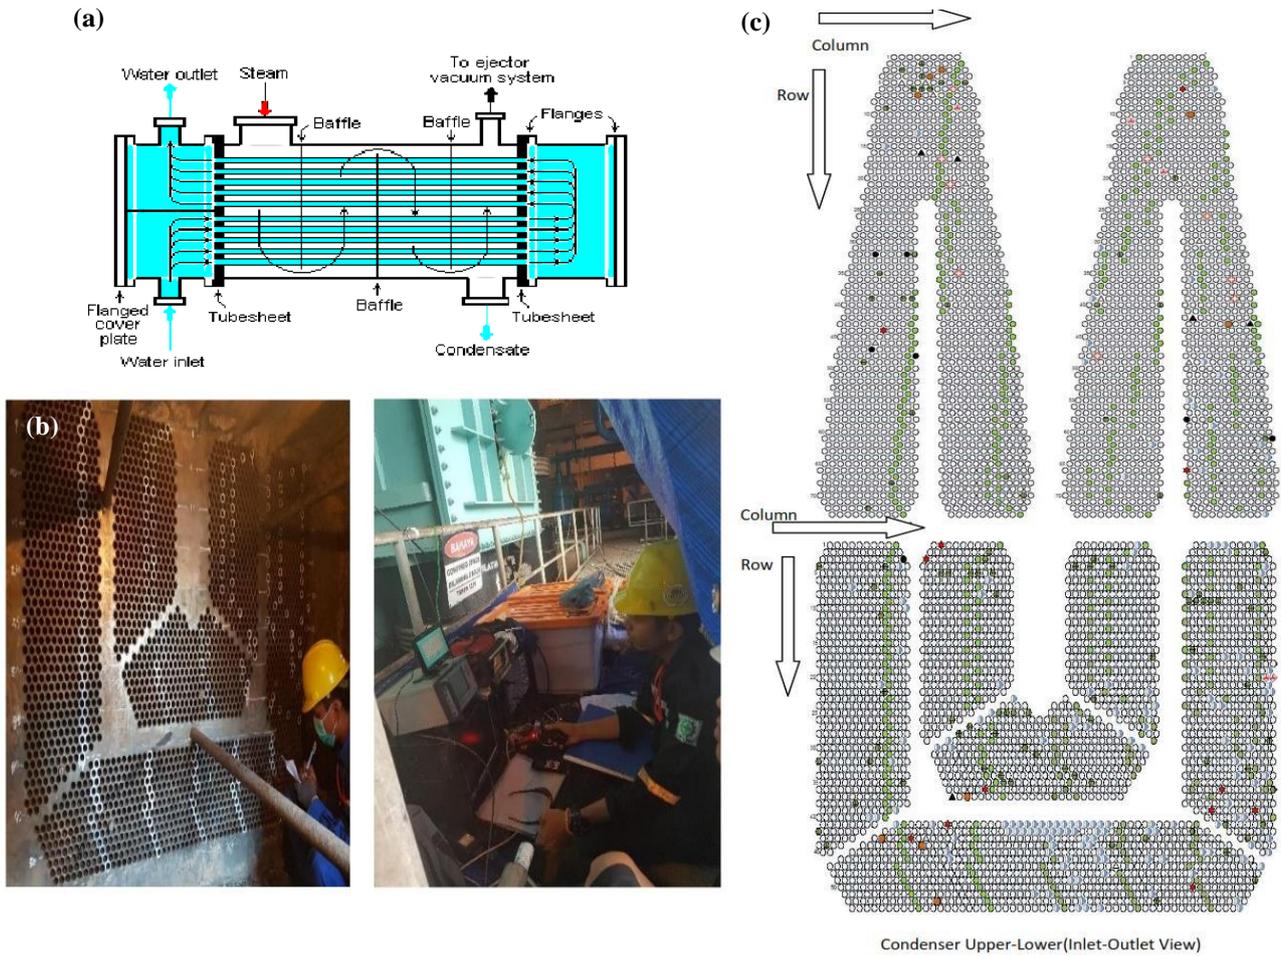
The condenser is a component that works to convert steam into water and be reused [5]. The change process is carried out by flowing current into the room that contains the pipe. Steam flows outside the pipe while water as coolant flows through the inside of the pipe as the scheme shown in Figure 1 (a). Water requirements for cooling in the condenser are very large, so planning is usually taken into account. Cooling water is taken from sources that have enough water, such as lakes or the sea.

coordinates, Row number and Tube number following the tube sheet configuration. Furthermore, plotting the X-Y coordinates is adjusted to the segmentation as shown in Figure 1 (c).

Fig. 1. (a) condenser scheme, (b) arrangement of condenser tubes, (c) plotting and marking condenser tubes

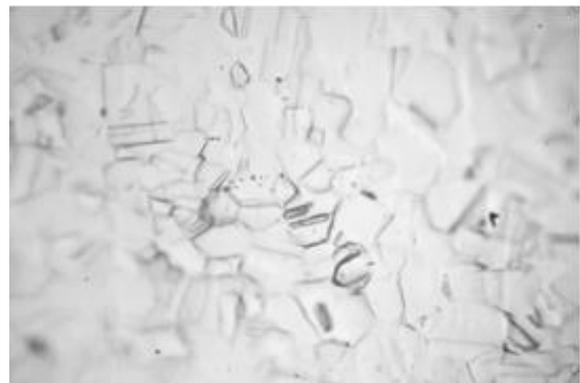
Test results of the chemical composition of the tube material are shown in Table II. When viewed from the composition test results based on the alloy elements contained in the material is almost the same as the SS304 material [13]. The microstructure analysis of the tube material was then performed as shown in Figure 2. The microstructure image of the tube material is matched with the microstructure of the SS304 material using ASM Handbook Metallography and Microstructures [13]. The microstructure image obtained is a condenser tube material that has been used for 3 years with a maximum working temperature of 80 °C.

Fig. 2. The microstructure results from the condenser tube, 400X magnification.

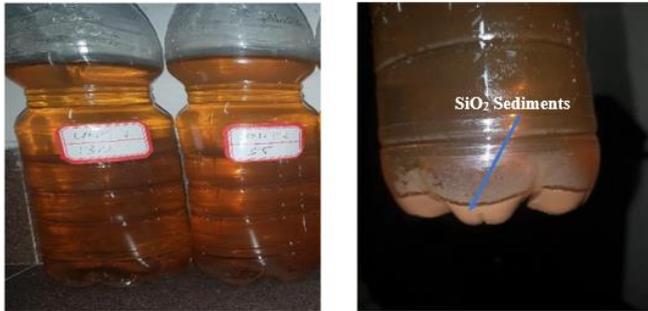
NTU, where this value exceeds the standard that is <15 NTU. Tests were also carried out on cooling water and turbidity values obtained 227.86 NTU and Total Suspended Solid (TSS) 236 mg/L. The application of chemicals in the water treatment system has not been maximized and solid particles from the Siak river water are still carried away, which can be seen in Figure 3.

Fig. 3. Condition of Air Cooling Tower

It is recommended to use water for condensers using a closed cycle where the water used comes from the water treatment system and not from the river anymore.

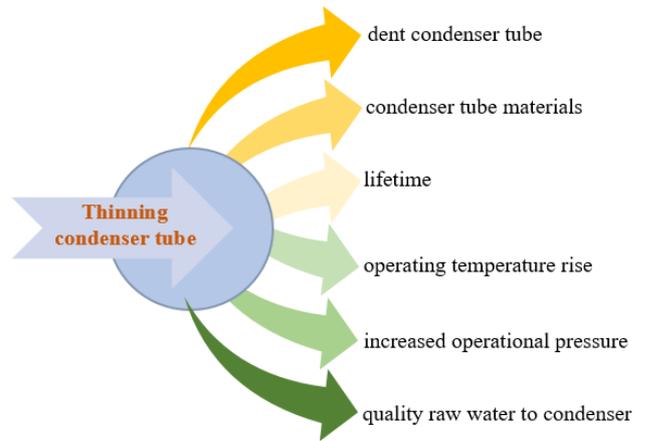
Fig. 4. Fish Bone Diagram

From the above data, several causes of condensing tube depletion in unit 1 can be taken which is poured into the fishbone diagram shown in Figure 4. The results of this discussion will be the basis for determining the root cause of the problem so that failure defense tasks can be obtained to minimize condenser tube failures.

From some of the causes above, there are 2 causes of problems that can be a way for condensation depletion, namely: Condenser dent tube and Condenser raw water exceeds quality standards.

The thinning of the Unit 1 condenser tube begins with the amount of dent and high turbidity in the condenser cooling water. When ECT was done, there was a lot of damage in the form of a dent in the tube and there were several tubes that had been plugged. Therefore, it can be concluded that the dent occurred due to fabrication at the time of installation so that the cooling water flow in the condenser tube experienced turbulent flow. Such conditions are exacerbated by the high content of sludge and TSS in cooling water. These two things that cause erosion corrosion to occur and cause thinning of the condenser tube.
