Dampness, Mold, and Health Conditions of Residents in Kampongs: A Case Study of Bandung, Indonesia

Abstract—The ultimate purpose of this study is to develop a new Kampong Improvement Program (KIP) in collaboration with the residents to improve their indoor environmental conditions, focusing especially on their indoor air quality (IAQ) and health of occupants. According to the WHO's report in 2013, acute respiratory infection (16%) is the second top cause of death among infants under 5 years old after prematurity (19%) in Indonesia [1]. The prevalence of respiratory diseases is suspected to be related to IAQ conditions in their houses. This paper presents the results of field investigations of dampness, mold and health conditions of residents in a typical Kampong area located in the city of Bandung, Indonesia. The result is later to be used as an example of how building physics and occupant's behavior may affect occupant's respiratory health.

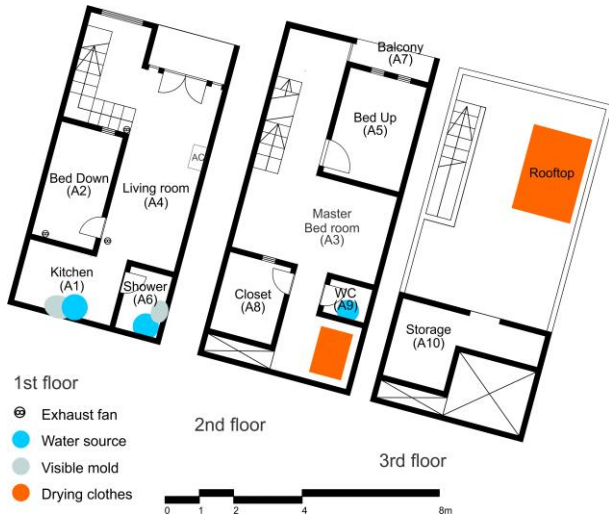
Fig. 2. Floor Plan of Unit 1

Some walls/floors are equipped with waterproof paint especially on the first floor to prevent water from permeating from the next house's bathroom. As shown in Fig. 2, AC is installed in the living room, whereas 3 exhaust fans are used to regulate air temperature and relative humidity. In addition, there are also 2 air purifiers that are moveable but usually placed near the kitchen and master bedroom.

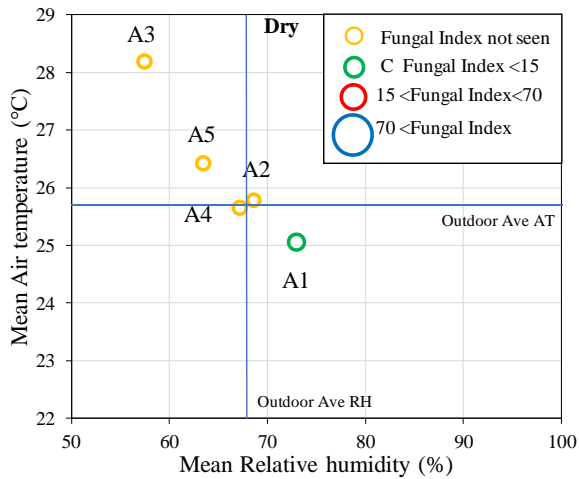
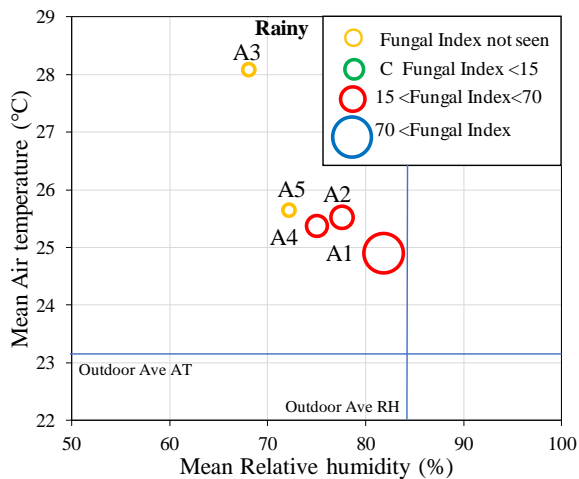
Fig. 3. Mold Results Related to AT & RH in Unit 1 (The dry season)

Fig. 4. Mold Results Related to AT & RH in Unit 1 (Rainy Season)

Figs. 3-4 show the measured fungal indexes in relation with AT & RH during dry and rainy season respectively. All AT & RH were measured in each unit for 7 days in the dry season and 6 days in the rainy season. In each room of unit 1, there are noticeable differences in average AT (higher in the dry season), and RH (higher in the rainy season) between the two seasons. Furthermore, temporal variations of AT & RH differ depending on the floor levels. For example, higher AT and lower RH can be seen in the rooms on the 2nd floor with a larger difference. This might be an indication that both rooms are influenced more by outdoor AT & RH compared to the first floor. There are more openings both for airflow and sunlight on the 2nd floor. In contrast, there is an AC on the 1st floor, and therefore windows tend to be closed more.

As shown in Fig. 4, fungal index (FI) is increased up to 60.7 (A1), showing a high possibility of propagation. High FI results can be seen especially when the RH is higher than 70% in both seasons (Figs. 3-4). According to the observation, visible mold was only found at the kitchen and shower downstairs, with higher levels of FI at the kitchen (A1), especially in the rainy season. This leads to the implication that mold was caused mostly by internal sources of vapor and humidity by cooking and showering, not by damages in the building materials (i.e. floor, roof) or water leaks. It should be observed that, although the FI is also high in the living room (19.4) and bedroom (21.2) on the first floor during the rainy season, there is no visible mold. This could be due to the fact that the first floor is equipped with an AC, which helps keeping humidity level low and three exhaust fans which can help to keep the room ventilated.

Besides the kitchen, the other two measured rooms on the ground floor (A2 and A4) recorded the highest RH during the rainy season (Fig. 4). Although the RH was almost as high as at the kitchen (70 - 80%), the FI value for these rooms was not as high as that of the kitchen. This can be related to the fact that the kitchen has poorer ventilation compared to the other rooms on the first floor, in addition to the moisture generation as discussed before.

Since no windows can be open at the backside of the building due to the existence of chicken coop, the best ventilation option would be to substitute the glass roof by a skylight window that could be opened a few hours a day, especially at times when someone is cooking or taking a shower. In addition, it would be recommended to install a fan at the shower and the kitchen to stimulate the airflow whenever the weather doesn't permit the opening of windows and turn them on any time there is the possibility of moisture collection.

Additionally, these environments where mold is already visible should be cleaned and painted with anti-mold paint, which protects walls and ceilings in humid environments.

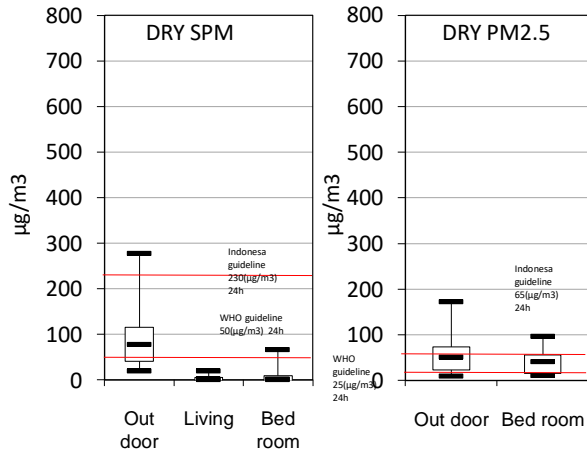
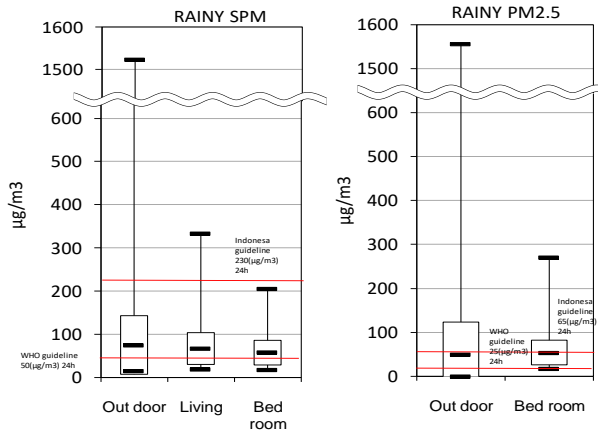
Indoor dust levels are comparably lower than the outdoors, indicating that dust source is likely dominated by outdoor sources (Figs. 5-6). The outdoor SPM values range from 19-277 $\mu\text{g}/\text{m}^3$, while the corresponding indoor values are 0-66 $\mu\text{g}/\text{m}^3$ during the dry season. Meanwhile, the outdoor PM_{2.5} values range from 9-172 $\mu\text{g}/\text{m}^3$, while the corresponding indoor values are 10-96 $\mu\text{g}/\text{m}^3$ during the dry season. The indoor dust levels are increased during the rainy season, ranging from 18-333 $\mu\text{g}/\text{m}^3$ in SPM and 0-1556 $\mu\text{g}/\text{m}^3$ in PM_{2.5}, respectively. Red lines in the graphs indicate the acceptable levels of dust particles by the WHO [3] and the Indonesian government [4].

Fig. 5. Unit 1 Dust Measurement Results (Dry Season)

Fig. 6. Unit 1 Dust Measurement Results (Rainy Season)

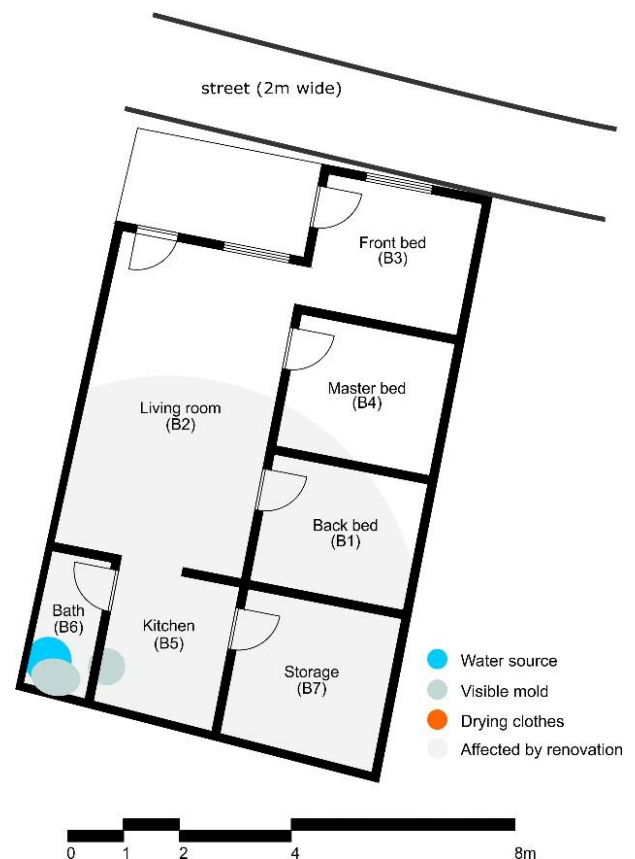
Fig. 7. Floor Plan of Unit 2

kitchen (B5), but the occupants sealed it off to avoid the smell from the chicken coop just behind the building. The living room (B2) has windows that never be opened, while the front bedroom (B3) has windows which are opened during the day. No air conditioning or fans exist. There is an instance of water permeating in the wall between the bathroom and kitchen (Fig. 7). This rendered the house to be quite damp and humid. The surveyor's first impression of the house is that it rather lacks maintenance, slightly low in temperature, high humidity and dampness, and lack of natural lighting. This house received a subsidy from local government in late November 2018 and has been improved especially around the kitchen and storage room (Fig. 7).

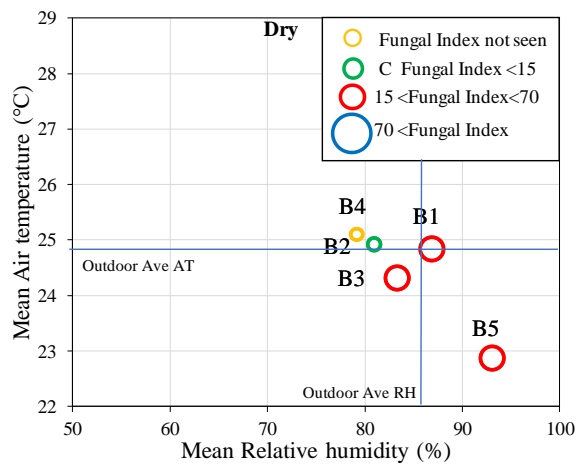
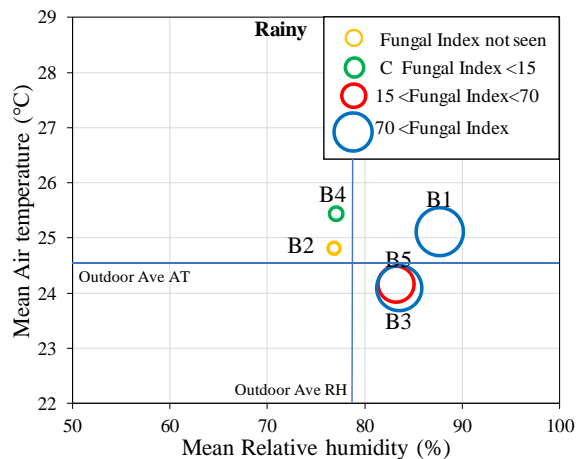
A brief renovation was conducted between dry and rainy season measurement periods by using a subsidy from the Bandung City government. The roof structure for the kitchen and storage area were replaced by new roofs with sunroof, new flooring, waterproofing of the wall, and significant clean-ups. This caused a dramatic change in the back rooms and its adjacent rooms of the building. The walls are no longer permeated by water and more sunlight enters the rooms. Due to the renovation, humidity conditions in the kitchen (B5) was slightly improved as shown in Fig. 9.

Fig. 8. Mold Results Related to AT & RH in Unit 2 (Dry Season)

Fig. 9. Mold Results Related to AT & RH in Unit 2 (Rainy Season)

According to the observation, visible mold was only found at the kitchen and shower, but the FI levels were very high for both dry and rainy season not only in the kitchen (B5) but also in the front bedroom (B3) and the back bedroom (B1). It should be noted that, during the rainy season, the FI in the front and back bedrooms was even higher than that in

the kitchen (Fig. 9). This leads to the implication that mold was caused by internal sources of vapor and humidity not only by cooking and showering, just like in Unit 1, but also by other sources that could include water leaks (from pipes, roofs or walls, taps or showers), darkness, poor ventilation and water at the house's foundation.

The main problem with Unit 2 is caused by water leaking and the lack of opening/ventilation. After removing the water leaking by the renovation, the humidity levels in some rooms such as the kitchen (B5) reduced despite the rainy season. This renovation can be applied to other rooms in the future. Other than that, it is obvious that Unit 2 needs more ventilation and increasing window opening behavior in the available rooms (B2). No windows can be open at the backside of the building due to the existing chicken coop, so the best ventilation option would be to change the roof, creating a higher more open design with skylight windows that could be opened a few hours a day, bringing outside air and sunlight in. In addition, it would be recommended to install a fan at least at the shower and the kitchen to stimulate the airflow and turn them on any time there is the possibility of moisture collection.

Additionally, these environments where mold is already visible should be cleaned and painted with anti-mold paint, which protects walls and ceilings in humid environments. The existing furniture should also be checked for the presence of mold.

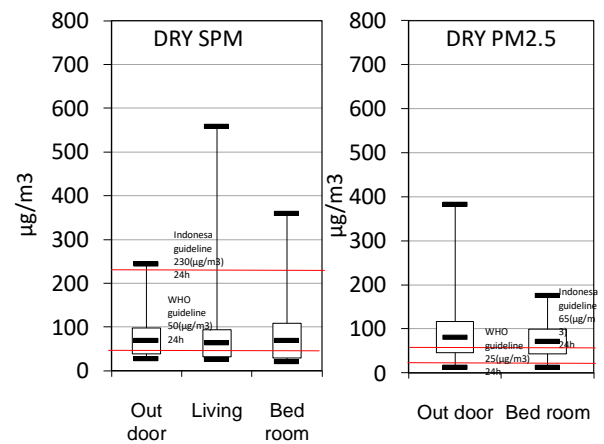
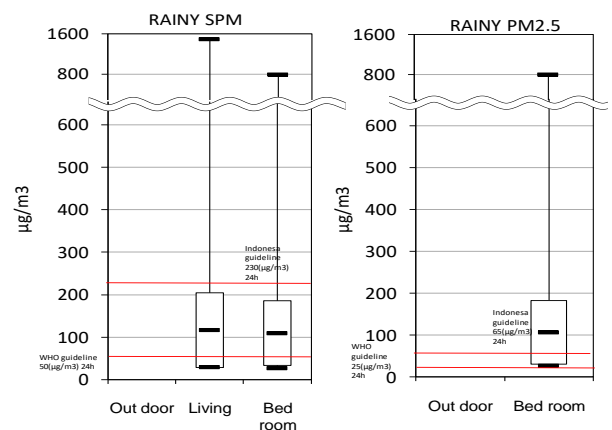
Fig. 10. Unit 2 Dust Measurement Results (Dry Season).

Fig. 11. Unit 2 Dust Measurement Results (Rainy Season).

As shown in Figs. 10-11, in Unit 2, indoor dust levels (both SPM and PM_{2.5}) are found to be equal or even higher than the outdoors. This is mainly because windows and openings are closed or absent in both rooms. Since Units 1 and 2 are close to each other, outdoor dust levels are noticeably similar. Hence, relatively high indoor dust levels in Unit 2 are mainly caused by indoor sources.

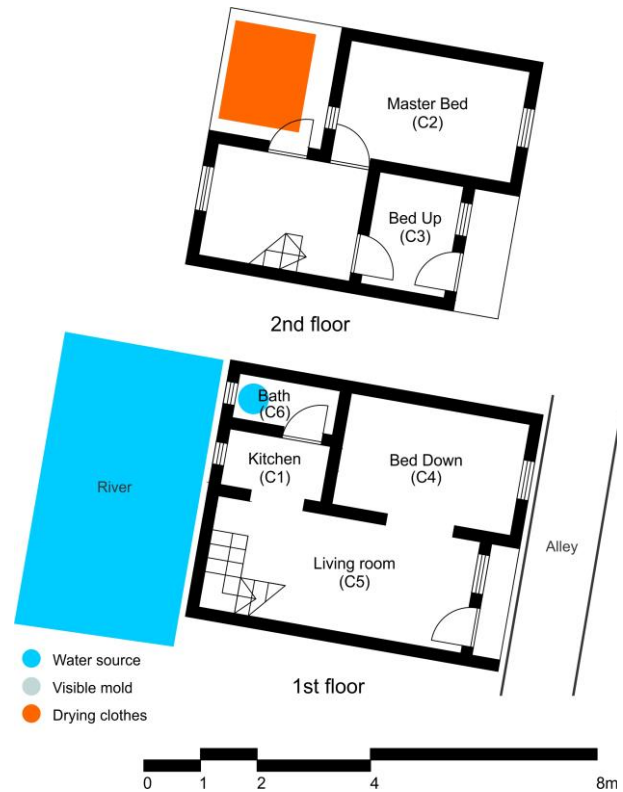
Fig. 12. Floor Plan of Unit 3

This house was constructed about 15 years ago (Table 2). It is located exactly by the river, about 2-3 m above the water level (Fig. 12). In general, most of the ventilation and daylighting come from the west side of the building (north and south are bordered with next houses, while the east side

is only separated by one-meter alley from the next house (Fig. 12). Motorbikes sometimes pass through this alley, rendering the cramped space to be quite polluted. Though the west/riverside is more aerated and lighted, this side is particularly humid, most likely due to river water and bathroom. Surveyor's impression on this house is that the air quality/thermal condition is averagely pleasant, rather humid but still satisfactory, and without much damp sensation compared to other units, especially on the 2nd floor.

Since cross-ventilation is existing on the second floor of Unit 3 (Fig. 12), the issue appears to be only on the first floor, as the FI values for the living room (32.2) and bedroom (38.7) are considerably high. Therefore, it is recommended to increase the ventilation on this floor, and this can be achieved by opening a window at the back (river) side of the living room, allowing better cross-ventilation.

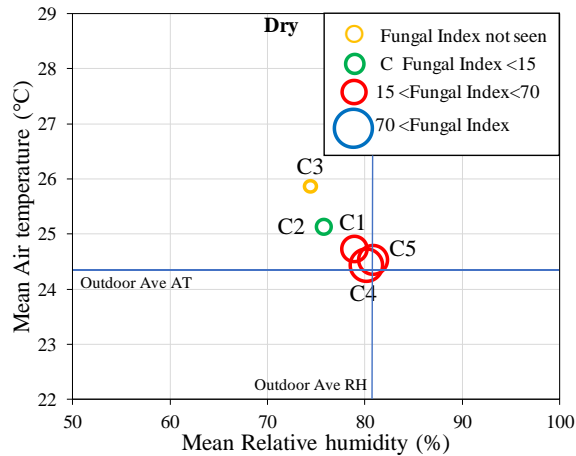
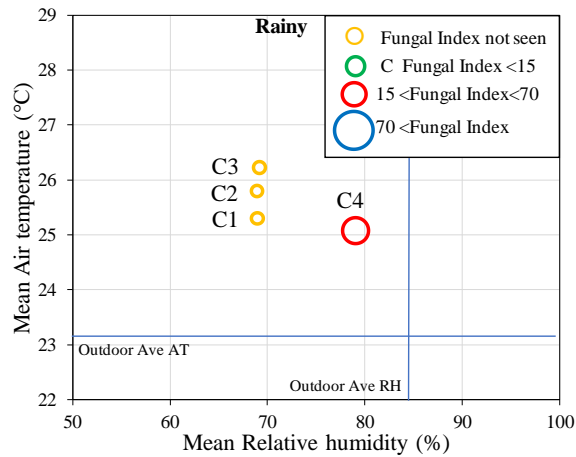
Fig. 13. Mold Results Related to AT & RH in Unit 3 (Dry Season)

Fig. 14. Mold Results Related to AT & RH in Unit 3 (Rainy Season)

Overall, the average AT in Unit 3 is relatively higher in the rainy season while higher RH is seen in the dry season (Figs. 13-14). Between the two measurements, there was no physical change in the building. Accordingly, FI shows higher values in the dry season than in the rainy season. This might be because of the behavioral change by the occupants.

According to the observation, visible mold was only found at the bathroom (only water source of the house) and, in addition, the levels of the FI were very high for both dry and rainy season at the bedroom (C4). FI values were high only on the first floor of the house. This can be related to the fact that there is a river running behind the building.

It is recommended to install exhaust fans on the westward side of the house especially on the first floor to create cross ventilation. Higher average SPM level in the living room at the rainy season may be caused by cooking activities as there is no pet nor active smokers in the house. To reduce the effect, opening windows or adding exhaust fans around the kitchen is also recommended especially during the cooking period.

The apparent mold at the bathroom probably has its source of the vapor from the shower and the presence of constant moisture in this room. Consequently, it would be advised to install an exhaust fan there. There doesn't seem to be any problem with the roof and the foundation of the house, but special attention should be paid to the existing river and how it can be related to the RH values of this house.

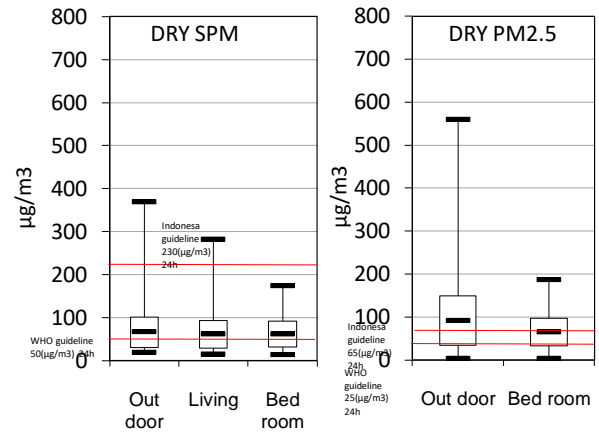
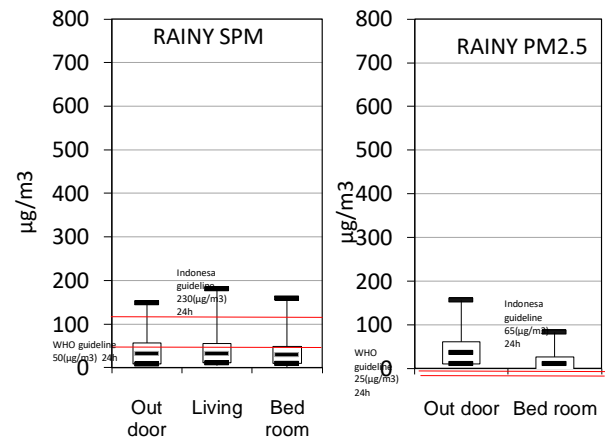
As shown in Figs. 15-16, outdoor dust levels in Unit 3, particularly PM_{2.5}, are mostly higher than those in indoor, indicating that dust particles mainly come from outside, though the outdoor levels are not as high as those near Units 1 and 2 (Figs. 15-16).

Fig. 15. Dust Measurement Results in Unit 3 (Dry Season)

Fig. 16. Dust Measurement Results in Unit 3 (Rainy Season)

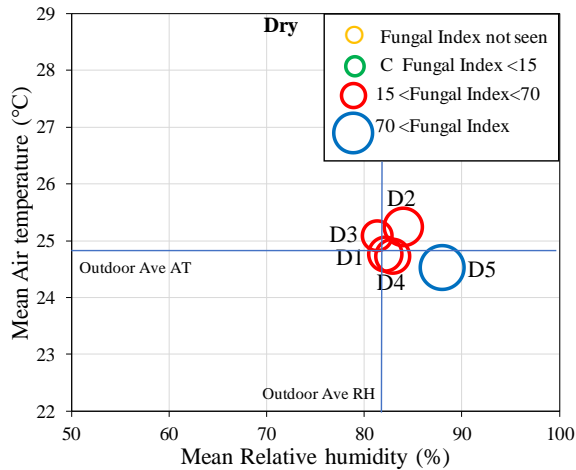
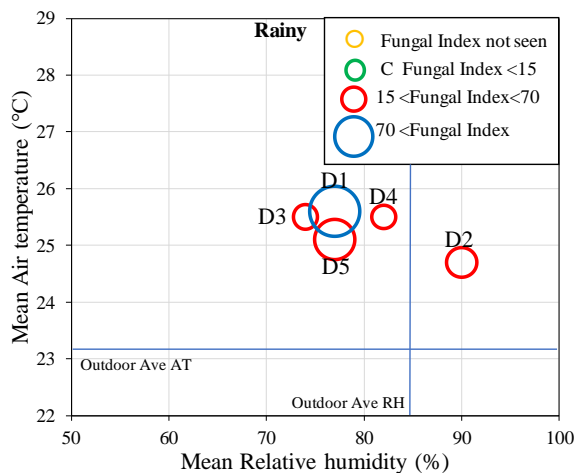
Unit 4 has few openings which rarely open according to the occupants. As a result, most of the rooms record relatively high average RH, rendering high FI values in both seasons (Figs. 18-19). This is partially due to the existence of pond and garden in front side of the house where all the openings are located, whereas window opening behavior and cleaning behavior may be some of the possible factors for the increased RH among others.

According to the available information, there was no visible mold in this unit. Nevertheless, the levels of the FI were considerably high for both dry and rainy season in all the measured rooms, especially at the living room (D5), right bedroom (D1) and master bedroom (D2). As only the east side of the house is not blocked, it is almost impossible to have cross-ventilation in this unit. This condition is further worsened by the fact that a part of the house is completely closed due to the presence of cats.

Fig. 18. Mold Results Related to AT & RH in Unit 4 (Dry Season)

Fig. 19. Mold Results Related to AT & RH in Unit 4 (Rainy Season)

It is recommended to increase the ventilation and the opening of the windows. A net can be installed at the windows of the rooms where cats roam freely, so that the window can be opened and the cats won't escape. The installation of extractor fans and vents in the walls could be also a helpful solution, especially the second as it is a cheap but effective solution.

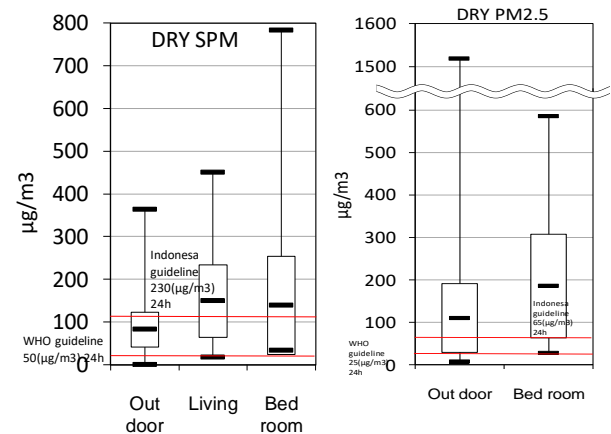
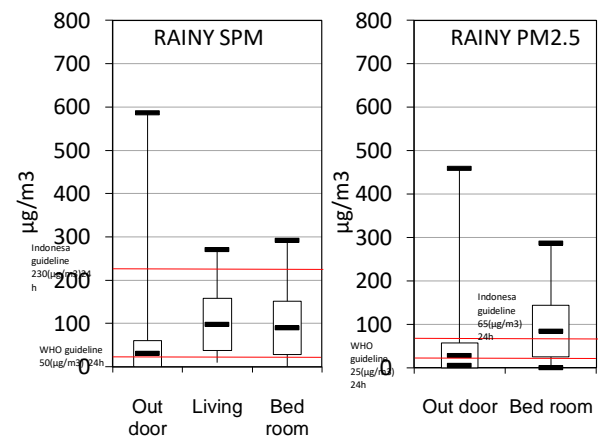
As shown in Figs. 20-21, both SPM and PM_{2.5} are significantly higher than the outdoors. For example, outdoor SPM ranged from 0-363 µg/m³, whereas the corresponding

indoor levels ranged from 33-783 µg/m³ during the dry season. The results indicate that the dust sources are most likely present inside, especially in the master bedroom (Fig. 20).

As mentioned before, most of the dust particles in Unit 4 originate from indoor activities. Smoking behavior, less frequent cleaning behavior, and the existence of pets might be the main cause of it.

Fig. 20. Dust Measurement Results in Unit 4 (Dry Season)

Fig. 21. Dust Measurement Results in Unit 4 (Rainy Season)

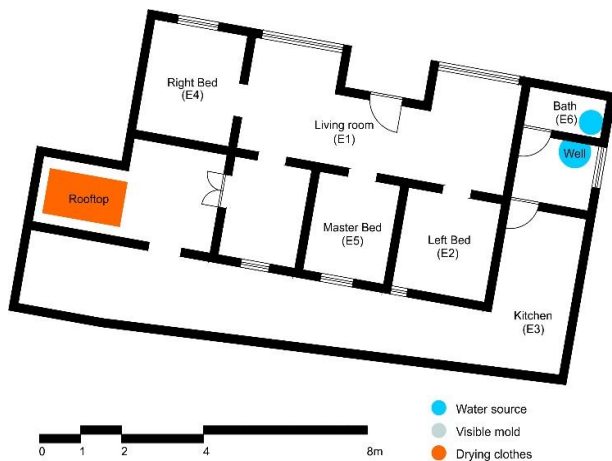
Fig. 22. Floor plan of Unit 5

laundry, this household dries the clothes on the rooftop, which can be accessed with a stair from a room bordering the front bed (Fig. 22). Around 4 pet cats also live in this house. This unit also has an indoor footwear policy, which means that indoor floors tend to be dusty. Surveyor's impression on this unit is that the air condition is quite damp, humid, pleasant air temperature, and slightly unmaintained conditions in most of the rooms.

Most rooms in this unit show averaged AT & RH conditions among the units surveyed (Figs. 23-24). According to the available information, mold was visible in the kitchen and the bathroom. The FI values are not extremely high for any of the rooms and the highest values were recorded at the kitchen (E3) and right bedroom (E4) (Fig. 23). There is not much ventilation at this unit, as the windows are only located at the front of the house and are kept closed most of the time (Fig. 22).

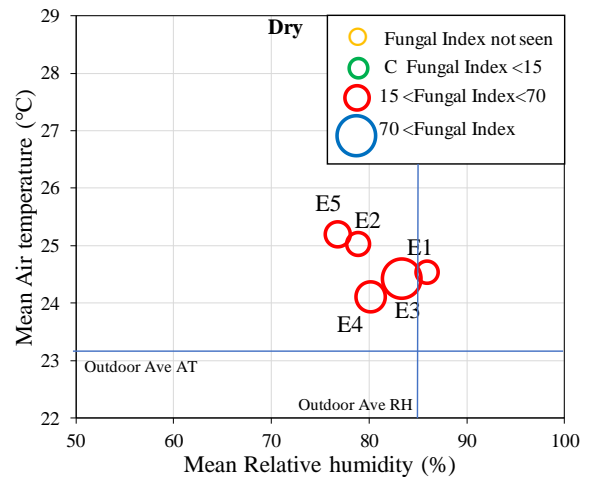
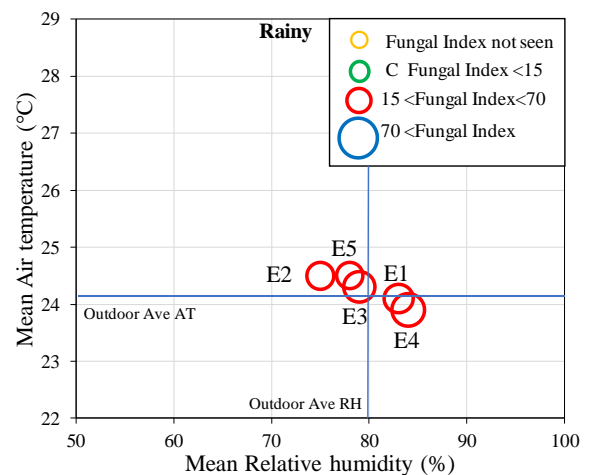
Fig. 23. Mold Results Related to AT & RH in Unit 5 (Dry Season)

Fig. 24. Mold Results Related to AT & RH in Unit 5 (Rainy Season)

The biggest problem with this unit is also the absence of cross-ventilation. The recommendations for this unit can be the same as the previous unit, which means it is recommended to increase the ventilation and the opening of the windows.

The installation of extractor fans and vents in the walls could be also a helpful solution, especially the second as it is a cheap but effective solution. As there is only one floor, it is also possible to install skylight windows that could be opened a few hours a day, bringing outside air and sunlight in. In addition, it would be recommended to install a fan at least at the shower and the kitchen to stimulate the airflow and turn them on any time there is the possibility of moisture collection.

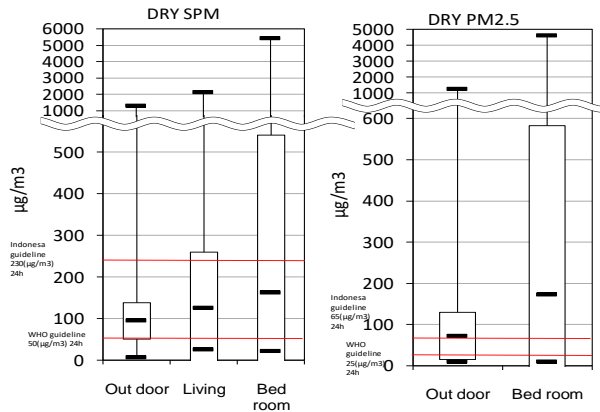
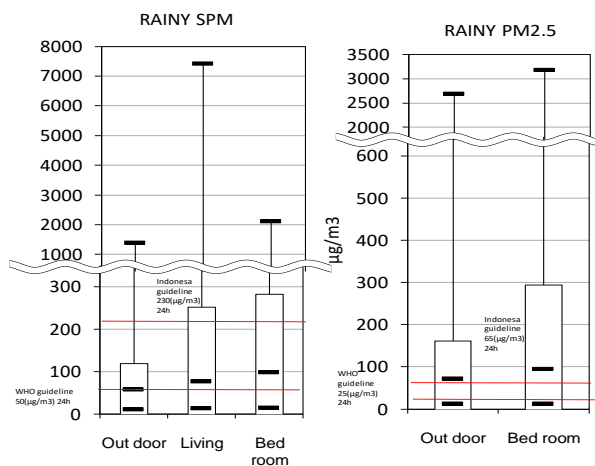
As shown in Figs. 25-26, dust level profiles in Unit 5 are similar to those of Unit 4. Although air change rates are better in this unit, more active smokers are present, and therefore indoor dust sources are prominently high. Furthermore, the outdoor dust levels are also severe in this unit mainly because

the house is situated next to the main road (Fig. 1). Most of the indoor dust levels are above the recommended guidelines, especially in the bedroom (Figs. 25-26).

Fig. 25. Dust Measurement Results in Unit 5 (Dry Season)

Fig. 26. Dust Measurement Results in Unit 5 (Rainy Season)
