Road Damage Conditions Analysis Of Tanjung Api-Api - Gasing District Road Based On Surface Distress Index (Sdi) Method

R. Marpen^{1,*} A. Hasan¹ AN. Sari¹ HWS. Putra¹ R. Pranoto¹

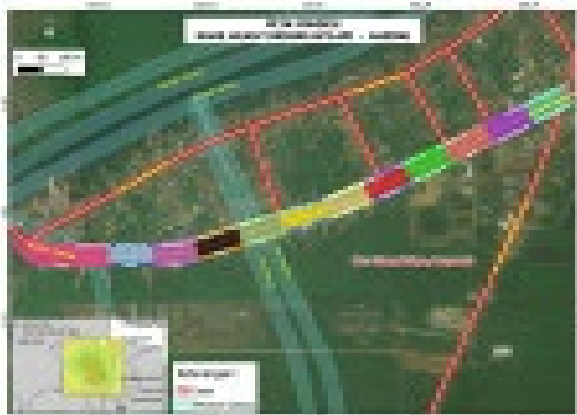
Figure 4 Roadmap of Road Damage

The results of the SDI analysis carried out can be concluded that there are 3 segments that are heavily damaged and 1 segment in moderate condition, while the other segments are still in good condition.

Based on the results of the discussion from the observations obtained input data which is then processed using the ArcGIS application to make Road Damage Geomapping. The results of data processing using ArcGIS to produce a road damage map can be seen in the image below.
