The Quality Assessment of Structure of Simple House in Gowa Sari Residential, Bantul Regency

Dwi Kurniati^{1,*}, Restu Faizah²

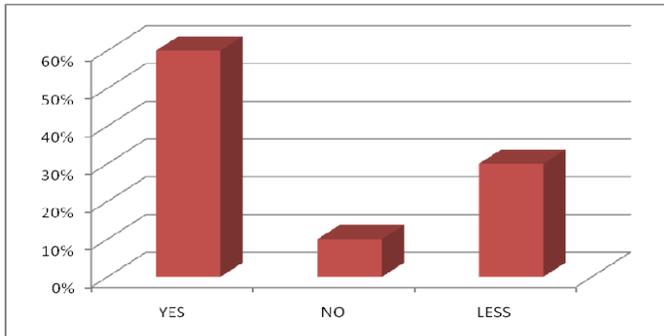
Figure 3. Number of Scoring Results

From the assessment, number of "Yes" from 24 items includes 1 point for picture, 2 points for floor plan, 4 points for foundation, 1 point for sloof, 2 points for column, 1 point for wall, 2 points for ring balk, 1 point for the connection, 5 points for the mountains and 5 points for the truss, up to 60%. The remaining 10% is other works in the field, and 30% is less neat work ranging from casting, Twisted bar installation or formist release the percentages "Yes", "No" or "less" can be seen in Figure 3 and Figure 4.

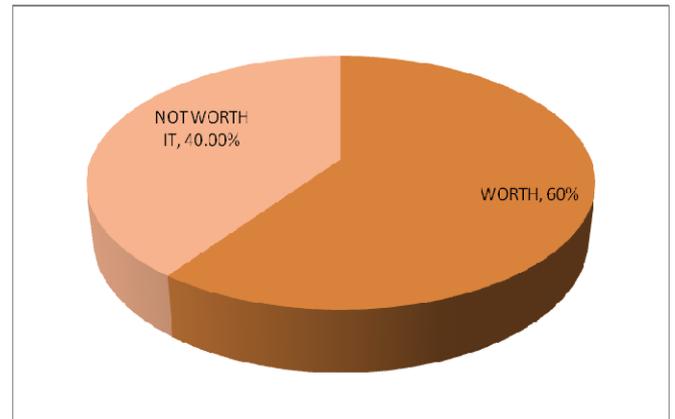
Figure 5. Recommendation of Feasibility

The percentage of untidiness of the implementation of residential structures in succession occurs in the element of the sloof structure 10%, the foundation 2.5%, the main column 12.5 %, the connection 2.5% and the truss 12.5%. 40% of elements was categorized not feasible, while 60% was feasible. This factor will trigger reinforcement bar loss in structural elements. These results can be seen on Figure 5.

Tidiness of structural and non-structural elements needs to be improved, to maintain quality of the reinforcement bars and concrete mixtures to avoid oxidation. The results of the assessment get a level of untidiness of sloof work 10%, foundation 2.5%, main column 12.5 %, connection 2.5% and truss 12.5%, with a construction feasibility rate of 60% so that it can be concluded that Gowa Sari housing has technically followed the applicable development rules and it is habitable.
