Wheelchair Facilities Recommendation at Gambir Station

ABSTRACT

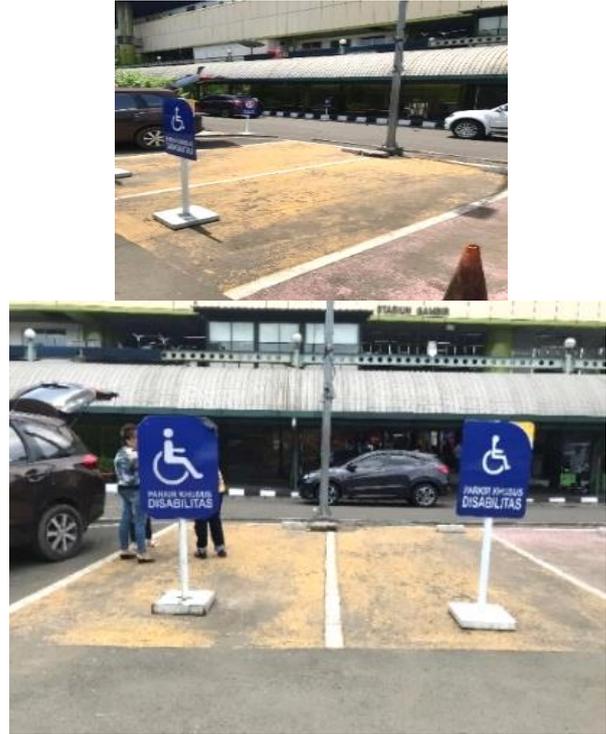
The parking area is located on the west side of the Gambir Station main building (see figure 1). Gambir Station has provided two disability parking lots that are marked with different symbols of disability and floor surface color. Nonetheless, this parking lot is only 230 x 450 cm, while the minimum standard for disability parking lots is 370 x 600 cm for single parking and 620 x 500 cm for double parking. This parking lot also does not yet have a circulation area for wheelchair users. The parking lot’s location is 11.7 m from the west entrance and is directly connected to the western corridor.

Figure 1. Existing photo of disability parking area [6]

Ideally, the disability parking lot has an appropriate area, which is 370 x 600 cm for single parking and 620 x 550 cm for double parking, which has a 120 cm wide circulation path. In the recommended parking area, the researchers designed a disability parking lot (priority parking) of three, assuming 2% of the total available parking lot. Researchers designed each parking lot of 230 x 600 cm with an additional 160 cm that serves as a circulation area for wheelchair users. The parking lot also has a marker on the floor colored blue with a disability symbol and a signboard that reads “PARKING PRIORITY.” The parking area has a higher elevation than the main road, so researchers provide a curb ramp with 5 degrees and a zebra crossing (Figure 2).

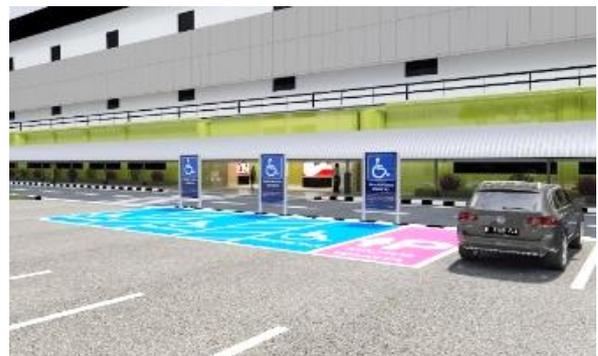
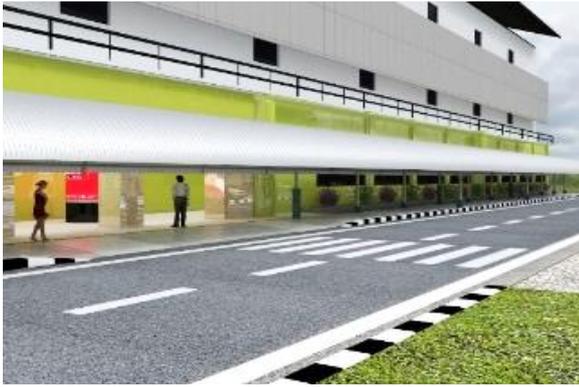
Figure 2. Illustration of parking area recommendation

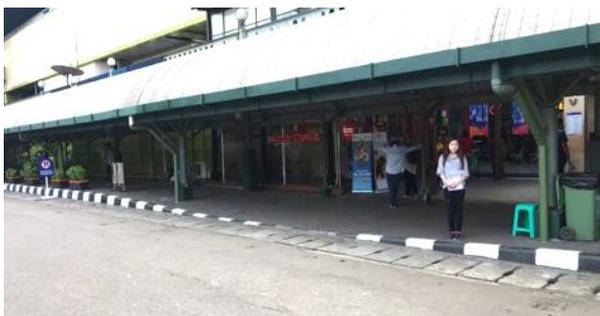
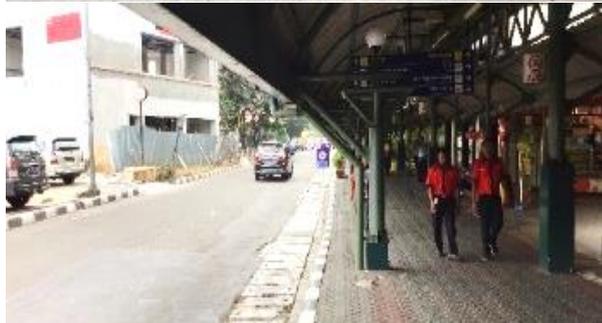
The western corridor has a width of 340 cm with a surface slope (width) of 3 degrees, where the maximum slope (width) of the ideal pedestrian path surface is 2 degrees. This western corridor uses a paving block as a flooring material (Figure 3). This material is not suitable for wheelchair users because it has a rough and uneven texture, making wheelchair users need more effort to access the corridors.

Figure 3. Existing photo of the western corridor [6]

The western corridor's recommendation is to replace the paving block with other material that has smoother but more durable and is not slippery when exposed to rain, i.e., using unpolished homogenous tiles. In the area that connects the road (zebra crossing) to the building (Figure 5), the researchers recommend a curb ramp with a width of 1400 cm and a slope of 5 degrees. In the edge area of the curb ramp, a yellow combination of black markings is given as a boundary marking of the curb ramp (Figure 4).

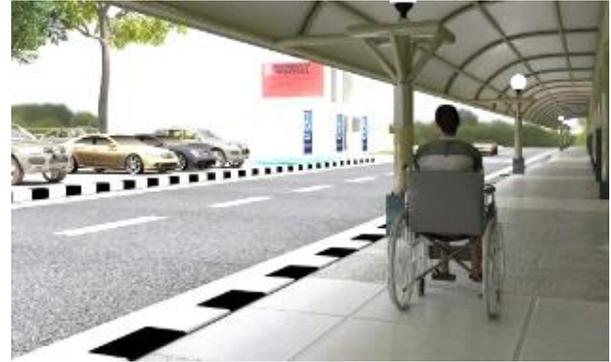
Figure 4. Illustration of western corridor recommendation

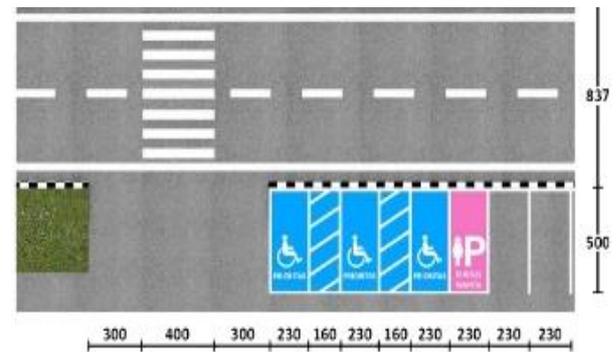
Figure 5. The zebra cross and dimension of the parking area and western corridor

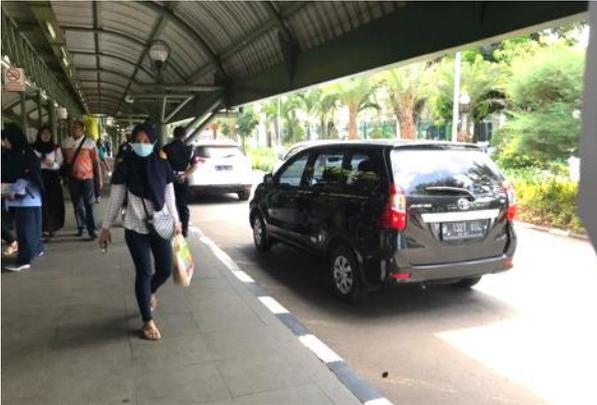
The loading zones Passenger Area (after this referred to as PLZ) is located on the east side of Gambir Station's main building. PLZ area has 250 cm x 790 cm, which should have a minimum area of PLZ is 360 x 600 cm. This area is directly related to the eastern corridor. The eastern corridor has a 295 cm width with a surface slope reaching 2 degrees that have met the standard. The floor in the eastern corridor uses the same paving block as the western corridor. The use of this material is not suitable for wheelchair users because it will make wheelchair users use more effort to be able to access the area. PLZ and the curb ramp connects the eastern corridor (Figure 6 and 7). This curb ramp has a width of 120 cm with a length of 120 cm and 12 degrees. Whereas ideally, the maximum slope of the curb ramp for the outside area is a maximum of 5 degrees.

Figure 6. Photo of the eastern corridor and PLZ [6]

Researchers recommend PLZ with a width of 360 cm and 1400 cm to be used by two cars concurrently. To access the eastern corridor and main building, the PLZ is connected with a curb ramp, 1400 cm wide, with a slope of 5 degrees. Reducing the curb ramp's slope will reduce the effort spent by wheelchair users. The use of paving blocks should be replaced with other materials that have smoother but more durable and is not slippery when exposed to rain, i.e., using unpolished homogenous tiles (Figure 8, 9, 10).

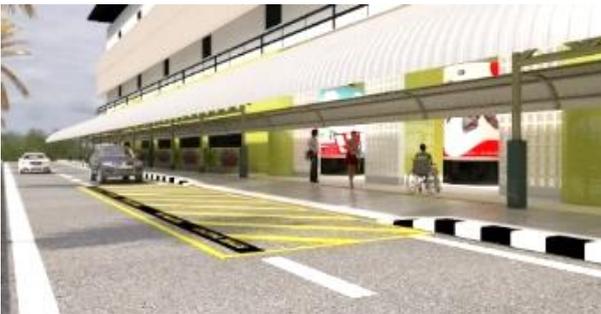
Figure 8. Illustration of PLZ

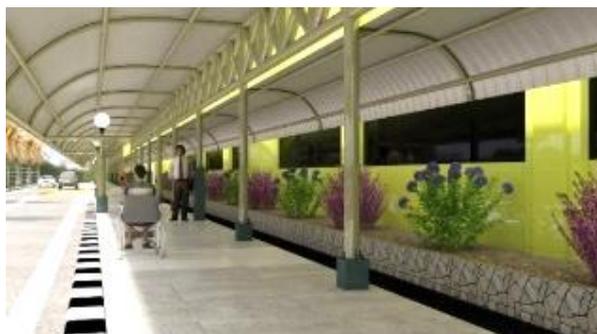
Figure 9. Illustration of the eastern corridor

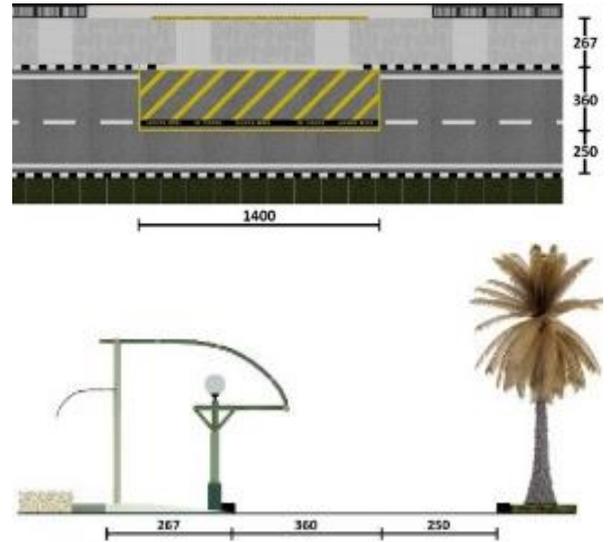
Figure 10. Illustration of PLZ dimensions and eastern corridors
