Disaster Mitigation Plan Based Flood Event Occurred on January 30th, 2021 in Kuta-Mandalika, Lombok, Indonesia

Atas Pracoyo, Ery Setiawan^(✉), Muh. Bagus Budianto, and Eko Pradjoko

Department of Civil Engineering, University of Mataram, Mataram, Indonesia
ery.setiawan@unram.ac.id

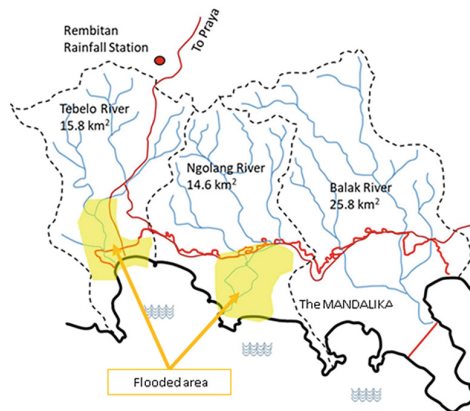
Kuta-Mandalika Basin consist are 3 cathments, i.e.: Tebelo, Ngolang and Balak cathment area. Figure 1 is describing DEM (digital elevation model) and map of study location in Kuta-Mandalika Basin, Lombok, Indonesia. There are three rivers flowing to this watershed, Tebelo River in the western part, Ngolang River in the middle part, and Balak River in the eastern part, whereas the flood was occurred only in Tebelo and Ngolang River (Fig. 2).

Fig. 2. Study location of the flooded area during the January flood.

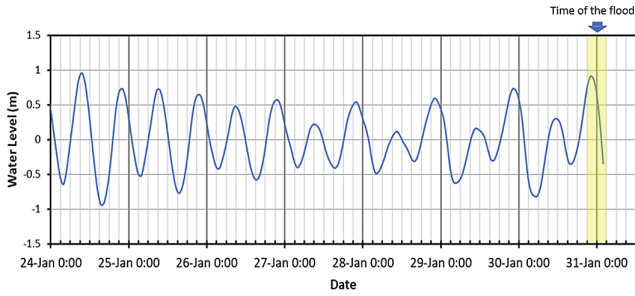
Fig. 3. Tide condition on January 2021 in Kuta-Mandalika, Lombok

Location of the flood is close to estuary where tide condition takes much effect on the flow condition in the river. According to the lunar calendar, the event of flood was occurred on the day of 16th when the tide was extreme (Fig. 3).

The time of flood was at the same time of high tide (Fig. 3). In the area close to the coastline, such as in the traditional market in Kuta, the flow velocity to the sea was reduced while incoming flood from the upstream was still continuing. There was an inundation in the traditional market and the surrounding areas. When the tide was changed to low tide, the inundation was reducing. In Fig. 5 hillslope and flow direction have a main influence on the contribution of flooding. Kuta Mandalika Basin is surrounded by hills in the West to part of the East. This causes a large slope gradient in this area, whereas flow direction can run to go to downstream area in southward and southwest because the lowest land system is in this section [3]. In Fig. 6, mainly Kuta-Mandalika Basin have texture of soil are clay. This one is easy for soil moisture exceeded (saturated), especially in the rainy season. So that, there is rainfall with intensity and antecedents falls on the surface, it will be a surface runoff thoroughly until the capacity of the field is refillable water again [2].

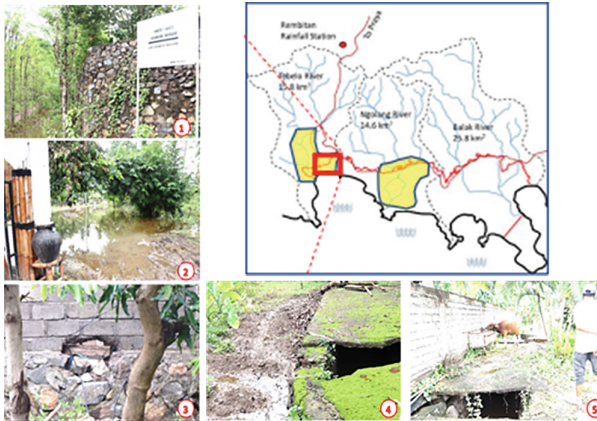
Fig. 6. Condition of river, drainage and inundated area in Tebelo cathments area.

In Fig. 6, in this location is frequently inundated by flood (1). Runoff water entering to the natural drainage canal is blocked by masonry fences and buildings (2,3). The drainage canal is utilized by the land owner by constructing any structure that block the runoff water to enter the canal (3,4). Water was blocked by the surrounding structures to enter to the river. There was a big difference between water head inside and outside of the wall, made the wall collapse. Inundation of runoff can be collapse some structures due to flood in Tebelo River.

In some locations in Tebelo catchments area, especially for older buildings, elevation of the road is higher than the building, therefore the water was come and inundated. There is no way for water to return to the river, it was blocked by the surrounding buildings, fences/wall (Fig. 6). In some cases, the owner of the wall made holes in order to release the inundated water. In other cases, the inundated water was accumulated, getting higher and it made a big difference of water head between the inside and the outside of the wall, then the wall collapsed. In Ngolang River, where the drainage system is still under construction, mostly the flood was caused by connection between each of all canal reaches has not been connected yet. One thing that need more intention is when the canal cross a road. In many cases, the structure used is like a box rather than a bridge. The box has the width smaller than the height (Fig. 7). For sure it was designed that flow capacity of the boxes is sufficiently enough transferring flood design flow, however the presence of floating objects can reduce the capacity of the boxes because they trapped in the front of the box that functioning as a screen bar (Fig. 9).

- a. Constructing drainage system therefore all drainage water in the service area able to flow to the main drainage system (the sea or the river).
- b. Considering the floating objects, construction of the crossing structure between road and drainage system (river or canal) must be ensure that the floating object will not trap in the structure therefore reduce the capacity of the structure flowing the flood

- c. Flood plain of the river must be maintained therefore not be occupied by the personal ownership.
- d. When the east part of The Mandalika is developed, it must be aware that the land use in Balak catchments area will change drastically. In term of flood, runoff coefficient will increase rapidly.

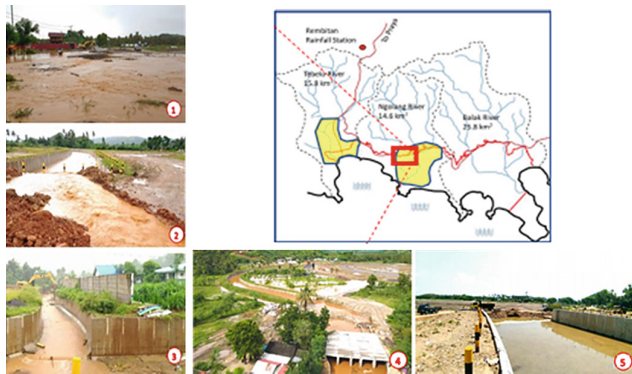
There is flood canal system but not integrated yet. Some areas were not covered by the system. Some parts of the system are under construction. It was not serve the catchments area properly condition of drainage system that was not connected yet, under construction. The drainage system is not connected yet, the existing bridge is small, there is possibility of being blocked by floating object during flood (Fig. 7).

Fig. 7. Flood in Ngolang River and condition of drainage system in Mandalika Street Circuit.

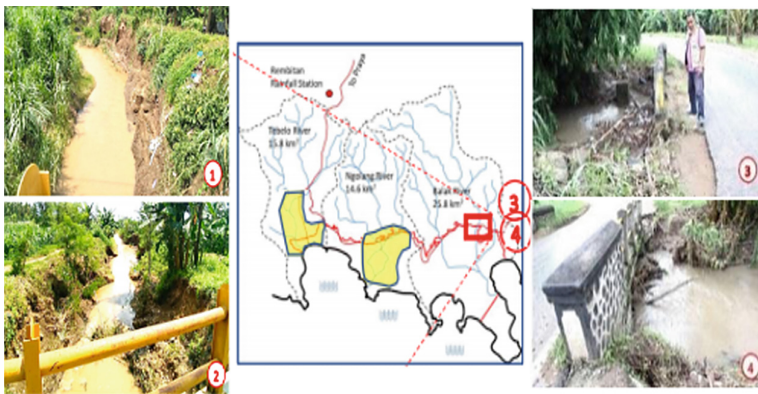
There was no flood occurred in Balak River, but there was an interesting evident in other river out of Kuta-Mandalika Basin area (Fig. 8).

Fig. 8. Condition of Balak and other river outside of The Mandalika area.

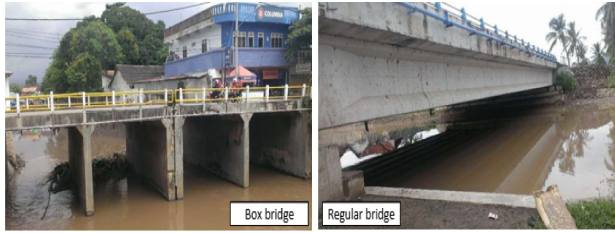
There was an evident comparing phenomenon of floating objects. In Fig. 9, there was a small bridge that full of floating object trapped beneath the bridge. It was found that overflow occurred. In contrast, showing a bridge in Balak River which flood didn't occur. It is believed that there was no blockade in Balak Bridge, capacity of transferring flood flow was not reduced, overflow was not occurred. As a verification, according to common historical information, there has no flood been occurred in Balak River [4].

Fig. 9. Comparison of box bridge and regular bridge; a bridge consist of boxes, their capacity transferring flow during flood will be reduced by the trapped floating objects.
