Analysis of Building Damage to the Housing Sector Based on Post-North Lombok Earthquake 2018 Investigations

Abstract. A major earthquake with a magnitude of 7.0 on the Richter Scale occurred in the Province of West Nusa Tenggara in 2018. Along with the deaths caused by the earthquake, public infrastructural facilities also sustained significant damage. One of the many losses experienced by the people of West Nusa Tenggara, especially those on the island of Lombok, was the destruction of the housing sector. The main impact of the strong earthquake, which had a magnitude of 7.0 on the Richter Scale, was felt on the island of Lombok, namely in the North Lombok Regency. The investigation was carried out based on information gathered during site visits and photographs. It was clearly found that non-engineered construction made up the majority of the demolished homes, with the sloof and foundation taking the most damage. Meanwhile, the walls, columns, and beams were not built according to engineering standards, and the materials used were of very poor quality, making them unfit to endure seismic stresses and other natural forces. Additionally, during an earthquake, the roof structure is

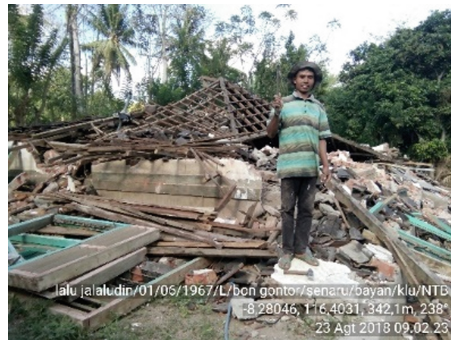
Fig. 4. Photo of House Damage due to Lombok Earthquake 2018

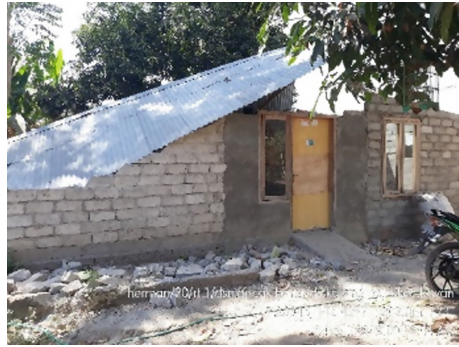
The majority of damage to houses in the heavy category, namely buildings that are dangerous to live in during the 2018 Lombok Earthquake, was caused by the absence of

Fig. 5. No foundation and sloof structure in the building

all or one of the lower structures of the house, namely the foundation and sloof, and the materials used were not up to standard (Fig. 5).

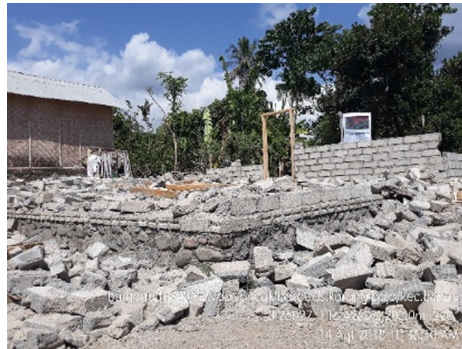
Fig. 6. Sloof Structure is not present in Building

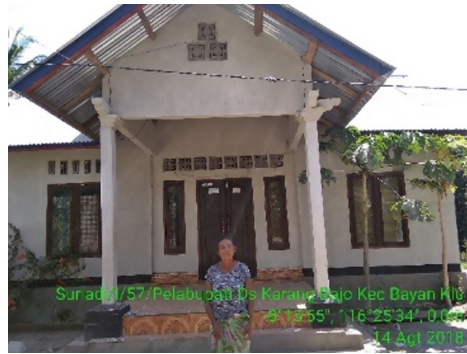
Fig. 7. Typical Damage to buildings with sloof and foundation structures

Typical damage to buildings that have sloof and foundation structures. Typical damage to houses that have sloof and foundation structures tends to experience light damage (Fig. 7), where the damage occurs in the form of hair cracks on the upper structure, but the condition of the building is still very low. Worthy to be occupied.

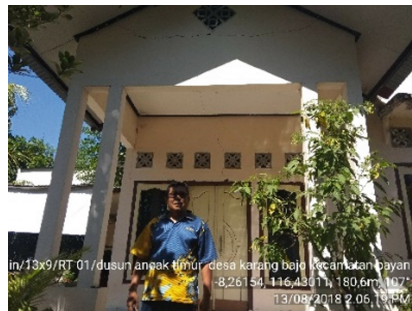
Fig. 8. Damage to the wall in the category of light damage

Wall damage with the category of light damage (Fig. 8) tends to have damage in the form of fine cracks in the plaster, as well as falling stucco flakes covering a limited area, these fine cracks have gaps smaller than 0.075 cm, with wall damage in this category, house buildings only need to be damaged. Only architectural improvements. House buildings with wall damage categorized as lightly damaged by the 2018 earthquake,

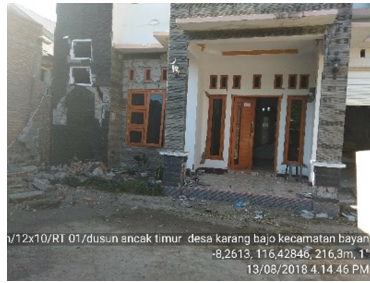
Fig. 9. Damage to the wall in the category of moderate damage

The condition of the house building after the 2018 Lombok earthquake is categorized as moderately damaged, for the walls of the building, there are large cracks scattered in many places including load-bearing walls (Fig. 9), while cracks in the walls are larger than 0.5 cm. Based on the results of observations, it was found that the damaged walls in the moderately damaged category had structural components, but the existing structural components (foundations, sloof, columns, beams) were incomplete, resulting in increased earthquake damage.

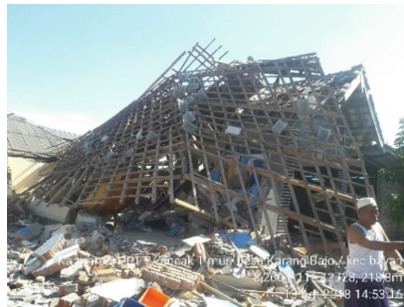
Fig. 10. Wall Damage Category Heavy Damage

For the condition of the wall structure in a typical damaged house with the category of heavy damage, the entire wall collapsed so that the building became very dangerous to live in (Fig. 10). Most of this type of damage is caused by the absence of structural components, in which there is no binding component in the house building.

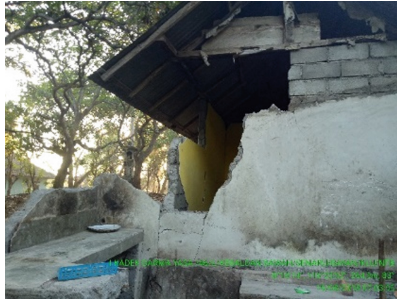
Fig. 11. Building Houses without Reinforcement of Columns and Beams

In observing the damage to houses in the 2018 Lombok earthquake, significant damage occurred due to houses built with the Unconfined Unreinforced Masonry building structure system, namely a building system consisting of only brick/stone walls, without strong and rigid binding elements, so that in holding Earthquake and gravity forces practically rest on the wall system. As a result, if there is an earthquake forces on the house building, the damage that occurs is included in the category of severe damage (Fig. 11), with a physical average of more than 70%, so that damage in this category access to the house building must be limited.

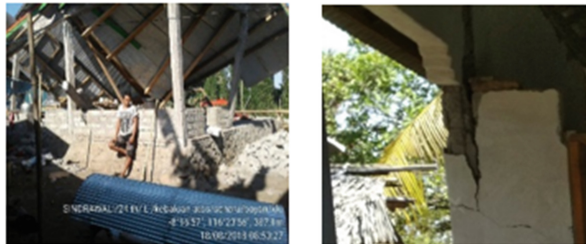
Fig. 12. Damage to Columns and Column-Beam Connections in House Buildings

In houses affected by the 2018 Lombok earthquake, although the building structure is complete (columns and beams) and the construction system uses a Confined Masonry structural system, namely a building system consisting of brick walls that are given binding elements in the form of frame elements on all four sides of the wall, frame elements and boundaries. Together to withstand gravity and earthquake forces in this system, but the quality of natural and non-natural materials used is very poor (Fig. 12), most of the existing concrete materials are porous and appear to lack cement, wide ring reinforcement spacing, and elongated reinforcement, this causes the Columns and Beams to not be strong enough to withstand the earthquake shaking.

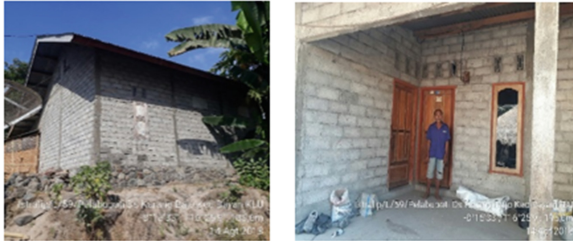
Fig. 13. Condition of House Building with adequate quality concrete material

forces, it can be seen that this typical house building does not cause significant damage to both structural elements and non-structural (Fig. 13).

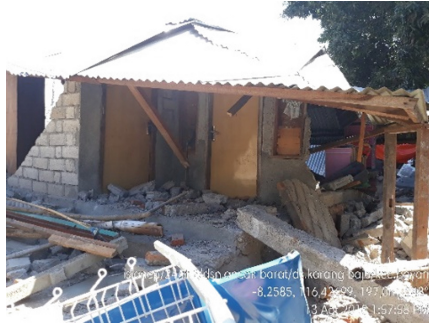
The term roof structure is defined as the part of the building that holds/flows the roof load. The roof structure is divided into two, namely the roof truss and roof truss support, the roofing structure materials used by the people of North Lombok Regency are dominated by wood and steel materials. As for the roof covering material, most of them use spandex and clay tile materials. Roof damage due to the 2018 North Lombok earthquake, caused by the supporting wall as a support for the roof structure collapsed, due to the collapse of the walls or beams of the house building, causing the support of the roof structure to not exist (Fig. 15).

Fig. 15. Roof damage due to collapsing supporting walls

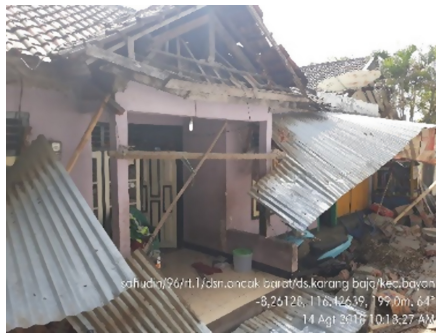
The roof structure is not solid between the connections, and there is no reinforcement/stiffening between the roof structure and beams or walls so that the earthquake forces that work cause the roof to be damaged, even though the supporting structure of the house building still survives (Beams, Walls) (Fig. 16).

Fig. 16. Roof damage due to the absence of reinforcement/stiffening between the walls or beams with the roof
