Current Condition in Lowland Irrigation Area Tahai: Challenges and Solutions

Zachlul Zelvi¹ Istiarto^{2,*} Lestari Rahayu Waluyati³

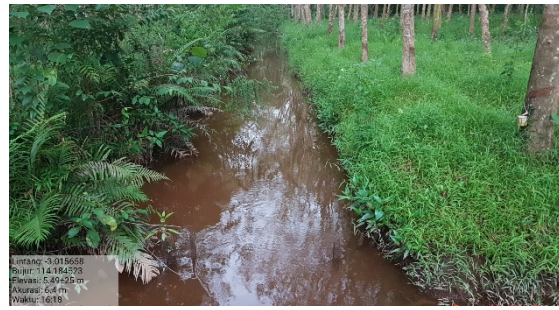
In the area, observation of the left secondary channel 8 has been carried out to see the function of the land. In Figure 2, the land at the observation point functions as a rubber plantation.

Figure 2 Typical condition of left secondary channel 8.

In terms of tidal overflow, the channel observations were carried out again in the spring tide period. At 16:20 on 15 March 2022, the water level reached 0.76 m. However, the water level in this channel has not yet reached the land. One hour later, the water level peaked at 0.9 m, probably only close to the land surface elevation, as shown in Figure 2.

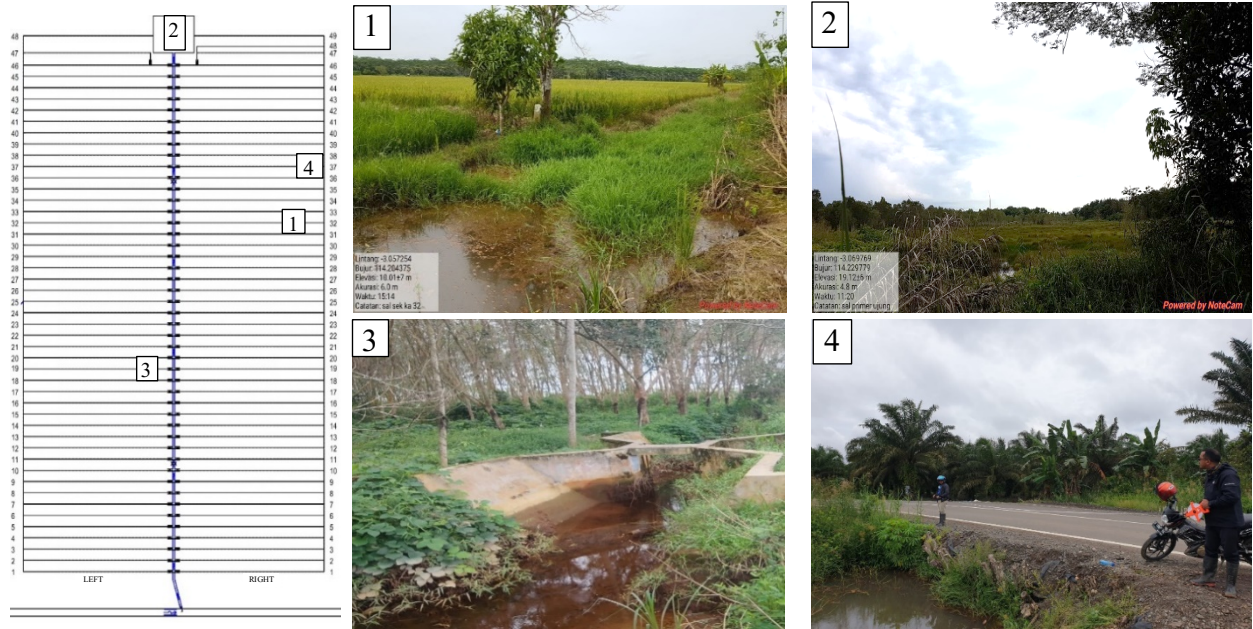
The primary channel was dredged for approximately 7 km from the end to the center of the channel in 2020. However, the secondary channel is still silting and overgrown with plants (Figure 3 (1)). This will reduce the volume of water in the channel and the land at high tide.

In addition, the pond was full of sediment and vegetation (Figure 3 (2)). The dimension of the pond is 400 x 500 m whose depth is 2 m – 3 m. The sediment volume is around 400,000 m³. Sediment and toxicity have accumulated for years in pond and will be a new problem if an excavation is done. The problem is that these substances will diffuse and contaminate the primary channel. If the sediment still shows high acidity,

Figure 3 The condition of the water system network and location in scheme. (1) Sediment and vegetation in secondary channel. (2) The pond was covered by sediment and vegetation. (3) The gate was damaged. (4) Road over the channel without a culvert.

The sluice gates in the secondary channel were damaged due to a lack of maintenance (Figure 3 (3)). The operation has not been carried out following the established standards. The sluice gates play a significant role in regulating water circulation.

The collector channel is just like a belt surrounding the DIR (*Daerah Irigasi Rawa*) Tahai. Many secondary channels are not connected to the collector channel. Road construction has also resulted in the right collector channel being cut off due to road embankment. The road embankment location is near the right secondary channel 37 (Figure 3 (4)).

Currently, normalization still needs to be continued, especially for secondary and collector channels. This approach is essential to restore the channel's ability to drain water. After the normalization of the primary channel, the problem of low water quality remains unresolved. During the two-way flow system, the problem of water acidity will still occur. A one-way water system is recommended to avoid retaining of acid water at the end of the channel [12].

Another important thing is the construction of a culvert under the road will reconnect the right collector channel. Secondary channels that have been cut off due to hoarding also need to be reconnected with collector channels.
