# The Link Between Historical Research and Structural Rehabilitation in the Case of Palace Building from Craiova

**Abstract.** The structural rehabilitation of buildings with cultural value represents a complex field for practice. We had the opportunity to participate in the project of rehabilitation of Palace Hotel, one of Craiova's most iconic buildings. The Palace Hotel is a historical monument and it was built with the original function of hotel, bank and commercial spaces.

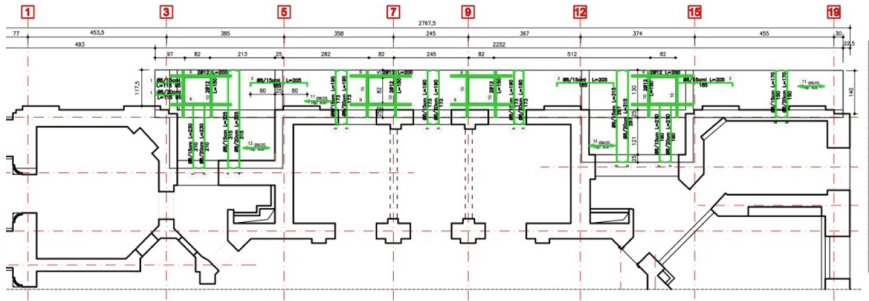
At the ground floor and upper levels, the consolidation interventions focused on treating the cracks that endangered the stability. The wall clutters, pilasters and cracked brick bolts, will be strengthened by injection using mortars based on hydraulic lime according to EN 459–1 norms, suitable for structural consolidation, resistant to water and to salts. For this purpose, the cracks will be thoroughly cleaned of dust with a jet of compressed air, they will be washed with water, after which the grooves through which the injection is to be made are placed on the depths of 5 cm. This method is minimally invasive, ensuring maximum stability without affecting the original substance (Fig. 5).

**Fig. 5.** Palace building wall consolidations, project by Arhing for GETRIX S.A.

In accordance with the norms and design requirements, the injection routes are mounted at distances of 1 to 1.5 m along the crack and are fixed with mortar. The injection pressure should not exceed three atmospheres. The injection is done initially through the pipe located at the base of the fissure. After the mortar has begun to drain

out through the following pipe, the first shot is stopped with a special device and the injection is continued through the next shaft.

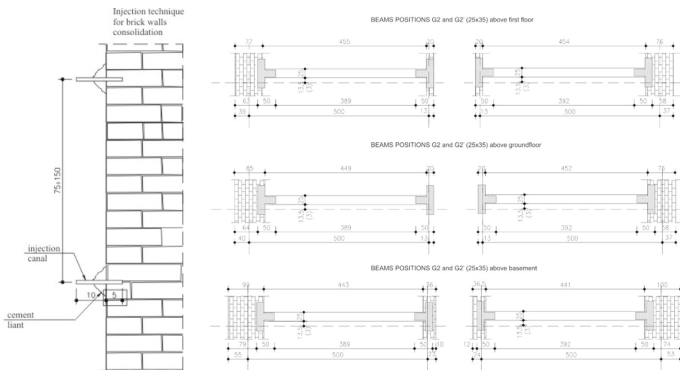
In addition, all the wooden elements will be treated antiseptic, water-repellent, anti-fungal and fireproof. Unfortunately, the existing framing had major degradations, with rotting components, affected by cavities, fungi and infiltrations of meteoric waters. Thus, not being an element of high value, many original elements being replaced by previous repair works, we imposed its total replacement with a new structure. Also, the metal structure of the two skylights requires local consolidation, at the level of the perimeter leaning, by introducing complementary elements, as well as by consolidating the existing ones. The proposed consolidation solution does not affect the initial structural concept and the way of cooperation of the skylights with the main structure. The entire

**Fig. 6.** Palace building wall consolidations, project by Arhing for GETRIX S.A.

metal structure, compulsorily rehabilitated, will be cleaned and anticorrosive treatment, fireproof and painted (Fig. 6).
