Strategy for Facade Restoration in Case of Craiova's City Hall Building

Andreea Gabriela Trif¹ (✉) and Cristian Oliviu Burada²

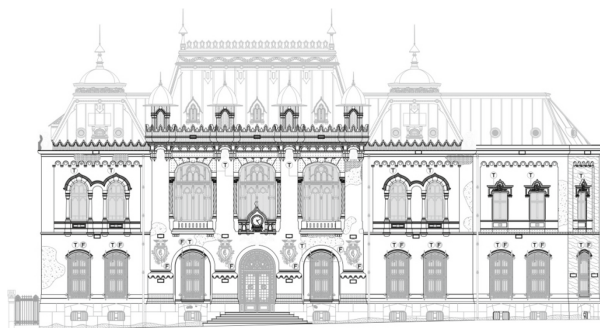
Fig. 2. The entrance main façade of Craiova's city hall – degradations investigation. Project by Getrix S.A., Craiova

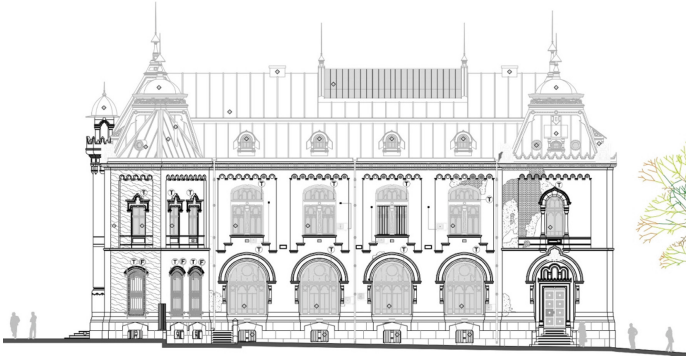
Fig. 3. The lateral facade of Craiova's city hall – degradations investigation Project by Getrix S.A., Craiova

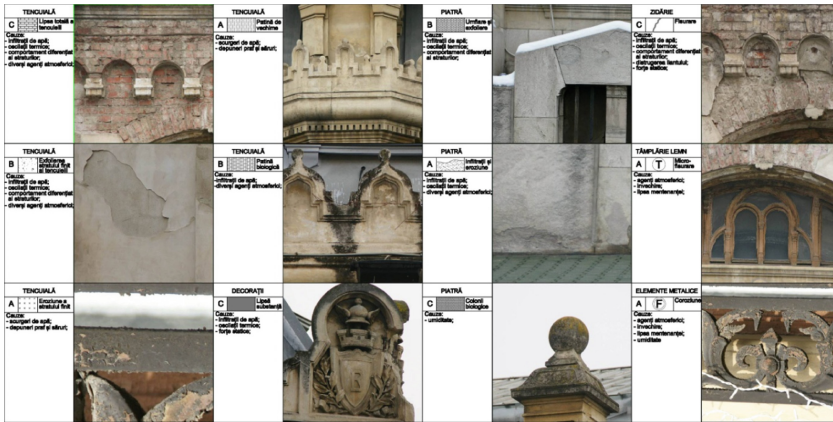
The main causes of the degradation of the building were determined by the water infiltrations, the phenomena of dilation and contraction generated by the warm-cold fluctuations, the aging of the finishes, the deposition of biological compounds or salts. The pollution covered the facades of the edifice with tar deposits and adherent atmospheric

Fig. 5. The facades degradations investigation. Project by Getrix S.A., Craiova

dusts and determined most of the stain type degradations. The presence of vegetation favored the development of biological attack, especially on the southern side of the building. The infiltrations were caused due to the degradation of the downpipes and the rainwater leaks on the surface of the walls.

The façade analysis revealed manageable degradations, without serious losses, difficult to reconstruct. From the point of view of material damage, the most degraded façade is the western one, the plaster layer being 25% lost. The rest of the facades had the integrity of the elements, with small exfoliations or fragmentations. Still, large areas of plaster showed micro-cracks, which is indicative of the imminent aggravation. The coating with successive layers of plasters made with inappropriate mortars represents both a harmful intervention and a cause of degradation.

The objects made of stone massifs that form the access steps on the three sides of the edifice as well as the decorative elements made of similar-stone (columns, frames, portals, consoles) present numerous cracks of different sizes. These led to loss of original matter.

Regarding the harmful interventions, there were identified replacements of the original metal grids, the placement of conditioned air appliances and lighting fixtures with inadequate shapes and style. However, fortunately, much of the original elements were maintained.

In order to control the negative effects brought by the biological deposits on the eastern façade, a biocidal layer proved necessary. The biocidal operation is performed with a base of quaternary ammonium salts brushed and sprayed. It is emphasized that the biocide must be general and applied both for curative and preventive purposes.

For the control of superficial deposits of dust, guano, tars, which were found especially in the upper part of the profiles in the cornice area but were also met in the lower areas and even on the vertical fields, works have been proposed to overcome the adherent deposits.

After a preliminary analysis, dust removal was necessary. The dust was treated with air jet and soft brushes, cleaned with a water jet at low pressure and the application of compresses made of cellulosic powder and PH neutral water in order to eliminate the of existing astrals.

The appearance of saline veils has been identified in areas with infiltrations or in areas with capillary moisture. The removal of the soluble salts from the areas with saline efflorescences visible on the surface is achieved by dry brushing, in a first phase, after which are applied series of successive compresses with cellulosic powder and water.
