2013 Landslide Failure Mechanism and Back Analysis of Tijuana-Ensenada Scenic Highway

Abstract. The Tijuana-Ensenada highway crosses the “Salsipuedes Bay”. This zone has been subject to numerous landslides due mainly to geological conditions. The last great landslide occurred on 28 December 2013. The principal causes that triggered the landslide were: the shale weathering, the groundwater, and the seismicity of the zone. In the present study, a deep sensitivity analysis was performed to reproduce the failure mode to understand the failure mechanisms and the factors that triggered the landslide. The results suggest that the seismic activity and water caused the degradation of the shale. To make a close approximation of the real conditions a finite element analysis was carried out using patterns of joints and adopting different shear strengths for the joints. Finally, the failure mechanism was reproduced in a satisfactory form.

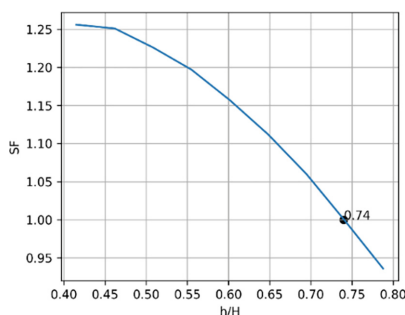
Fig. 1 Safety factor with different water table levels

To simplify the analysis a sensitivity analysis was performed, in which the mobilized friction angle of shale was set at 10 degrees and cohesion of zero. The height of the water table level (h) was varied, and the last level of shale was set as critical because, in situ, the failure was located at that level. H is the maximum height of the slope. The relationship between h/H and SF is non-linear, and a value of the relationship of h/H equal to 0.74 gives a critical pore water pressure, that produces SF equal to one (see Fig. 1).

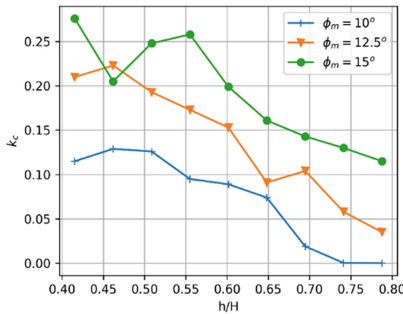
Figure 2 displays the results of the parametric analysis using the Morgenstern-Price method, the lines are erratic, and it is due to different critical failure surfaces obtained during the search. Values of critical seismic coefficients until 0.207 g were obtained for a mobilized friction angle of 15 degrees. The largest magnitudes of earthquakes in “Salsipuedes Bay” are of a magnitude of 4.5, with the potential for growth to 6 [5]. Then, according to the seismicity of the zone, the seismic coefficients for design should not be greater than 0.1 g. Considering k_c from 0.0 to 0.05 g values, it is possible to observe in Fig. 2, that the mobilized friction angles of 10 and 12.5° with the correct relationship of h/H for each one can cause failure.

Fig. 2 The critical seismic coefficient for mobilized friction angles

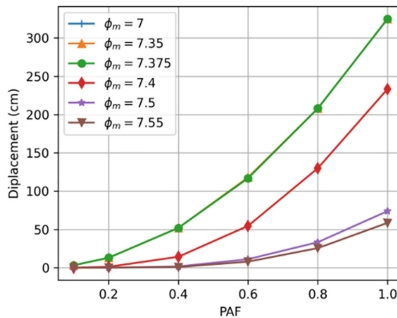
Figure 3 shows the results of the Newmark analysis; the horizontal axis represents the peak acceleration fraction (PAF) of 0.067 g. The maximum displacement is 324 cm for a mobilized friction angle interval of 7–7.375 degrees, and it decreases with the magnitude of the PAF. Parrish [5] considers that slopes with displacements greater than 100 cm are unstable. Interpreting the numeric simulation results of Fig. 3 regarding the Parrish limits, the natural slope is unstable for the PAF between 0.545 (0.036 g) and 0.72 (0.048 g) with mobilized friction angles of 7.0 to 7.4 degrees. There is a sudden decrement of the displacement for a mobilized friction angle of 7.5 degrees, then the condition to trigger the seismic failure is a frictional angle less than 7.5.

Fig. 3 Newmark Analysis for different peak acceleration fraction of 0.067 g

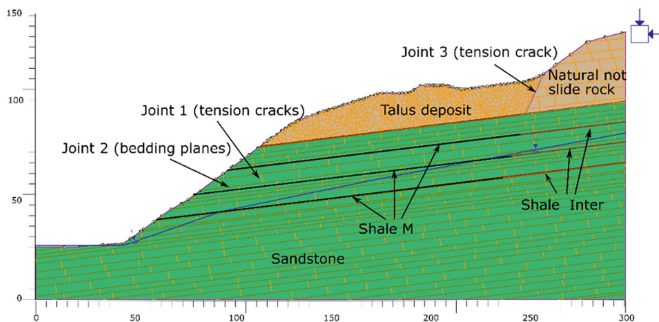
Field observations helped to conceptualize the representation of the model (Fig. 4). The idea is to adopt a joint set for representing the bedding planes in sandstone, like the mass rock in situ. Two main joint patterns were used: cross-jointed and Voronoi. The sandstone cross-jointed pattern is used and has two principal joint sets: the bedding set that is dipping 6.5 degrees out of the slope face and is the principal potential plane of failure; the set perpendicular to bedding, where tension cracks can develop. Additionally, there are three levels where the bedding planes are filled with shale and its mean thickness is 0.2 m. In Fig. 4 two types of shale are represented: a degraded shale (shale M) and non-degraded (shale Inter); these two types of shale were necessary for reproducing the landslide mechanism seen in situ. Talus deposit is simulated like a rockfill, with a Voronoi pattern that is a simplified form of a deposit, the number of Voronoi cells per square meter was 0.4. In the upper right side in the cross-section of Fig. 4, a cross-jointed pattern represents in situ jointed sandstone that is distinct from the talus. From the above analysis, a suitable groundwater level was chosen and remained consistent in the subsequent analysis.

Fig. 4 The pattern of Joints used for the simulation

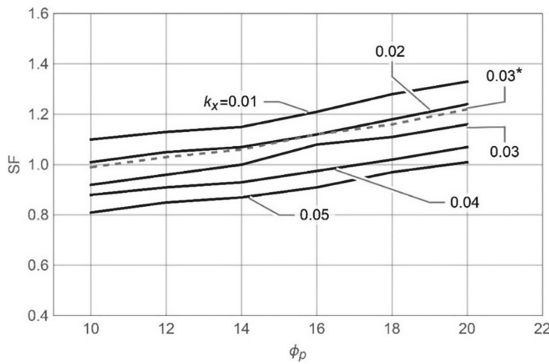
Fig. 5 Safety factor vs peak friction angle for pseudo-static SSR analysis

In this case, the in situ peak friction angle is not known, the previous analysis reveals that the failure occurred with a mobilized peak friction angle between the in-situ peak (24°) and residual angles.

The mobilized friction angle depends on the factors that trigger the sliding, such as seismic activity and the water table level. It's viewed in Fig. 5 that the seismic force overcomes the shear strength of the soil taking it to residual strength, with values as low as 0.02 g. The case of k_x equal to 0.03* in Fig. 5 corresponds to the analysis without the water table level, in this analysis, the SF is increased by about 7%.
