# Landslide Disaster Risk Reduction Through Slope Stabilization: A Case Study of eThekweni, KwaZulu Natal, South Africa

S. T. Mudenge<sup>1</sup>(✉), G. Fourie<sup>1</sup>, L. Sobhee-Beetul<sup>2</sup>, and D. Kalumba<sup>1</sup>

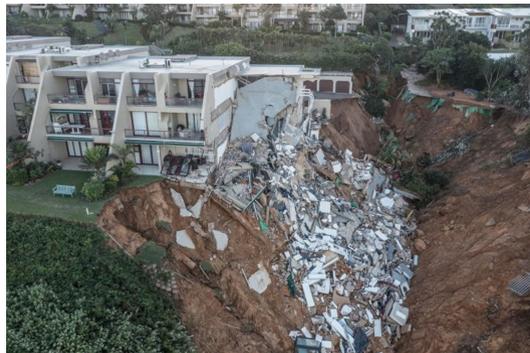
The 2022 landslides were the deadliest in South Africa, with a death-toll of 459 and displacing more than 40 000 people. Subsequently, rehabilitation techniques were required to remediate the widespread damage. The rehabilitation of areas that have been altered by landslides is an intricate process which often requires disaster risk reduction (DRR) approaches [7]. DRR procedures encompass identifying the landslide triggers, analyzing the stability of the residual slopes and implementation of landslide mitigation measures for unstable slopes. This study presents the DRR measures which were undertaken on one of the road embankments which represented similar failures that were caused by the landslides across eThekweni. Figure 1 presents the landslide damage at Umdloti beach which was one of the worst affected areas.

**Fig. 1.** 2022 eThekweni landslides – Umdloti beach [4].

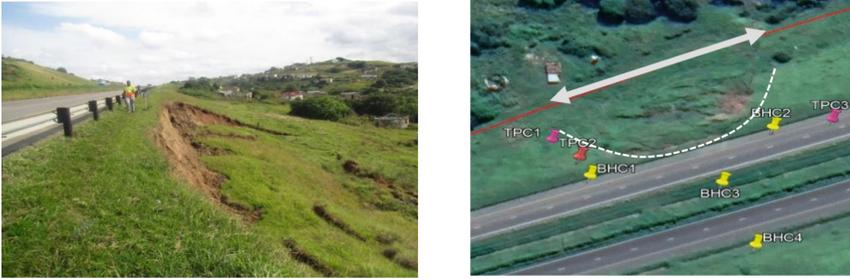
**Fig. 2.** Case study embankment a) Translational flow slide b) Borehole and tests pit positions

A translational flow slide developed on a 11 m high embankment of a highway which is adjacent to the Ngane River near Umkomaas. The failure surface of the embankment was approximately 3 m deep and 60 m long. The shape of the failure surface suggested that there was a firm underlying layer necessitating the depth to bedrock to be determined. The investigation comprised of core drilling 4 No. boreholes, test pits and geophysical surveys as shown in Fig. 2.

Longitudinal tension cracks were observed on the road shoulder which when filled with water increase excess pore pressures and reduce shear resistance. There was also water discharge from a damaged subsurface stormwater drainage pipe onto the fill material and this might have exacerbated the slope failure. From the soil profile, it was determined that the geology mainly comprised of 3 layers; silty sandy gravel fill up to an average depth of 5.5 m which was underlain by 1.8–3 m of Berea sand and gravel followed by a 12 m bottom layer of residual Pietermaritzburg shales. The location of this specific site on the contact zone between Berea sands and Pietermaritzburg shales could have also been a liquefaction trigger. In addition, the shales tend to have unfavorable dip angles (dip slopes) which are unstable.

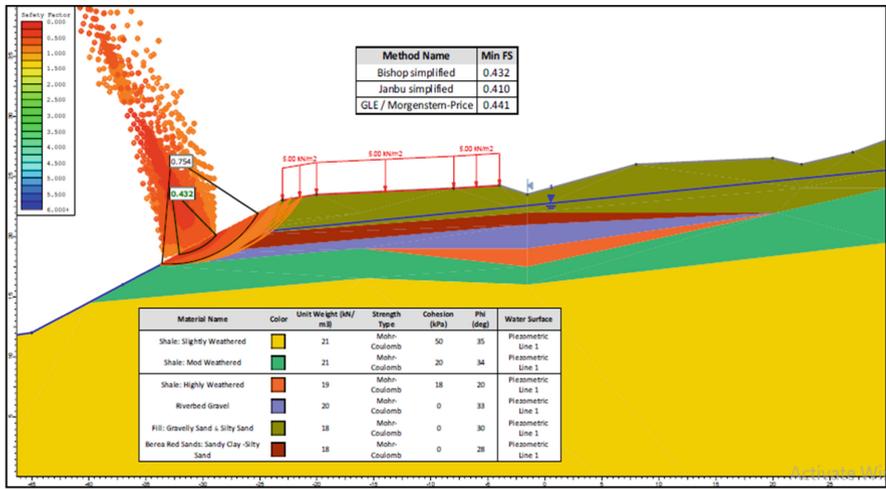
After identifying the possible failure causes, the second stage of the DRR procedure was to assess the stability of the residual slopes. The slope stability analysis was undertaken using RocScience Slide 2 software as shown in Fig. 3. Three limit equilibrium methods of analysis were considered: Bishop, Janbu and Morgenstern. The analysis showed that for internal stability, the residual slope was highly unstable with Janbu yielding a minimum factor of safety (FS) of 0.41. It was also observed that the failure plane was located between the Berea sands and Pietermaritzburg shales which concurred with the geotechnical investigation. For the global stability, the FS was 0.75. Hence, both cases yielded a FS less than (1) signifying unstable conditions. SAICE [5] stipulates that the minimum permissible FS for highway embankments is 1.5. Therefore, there was need for slope stabilization to protect the road and pavement from further collapse.

Fig. 3. Slope stability analysis of residual slope

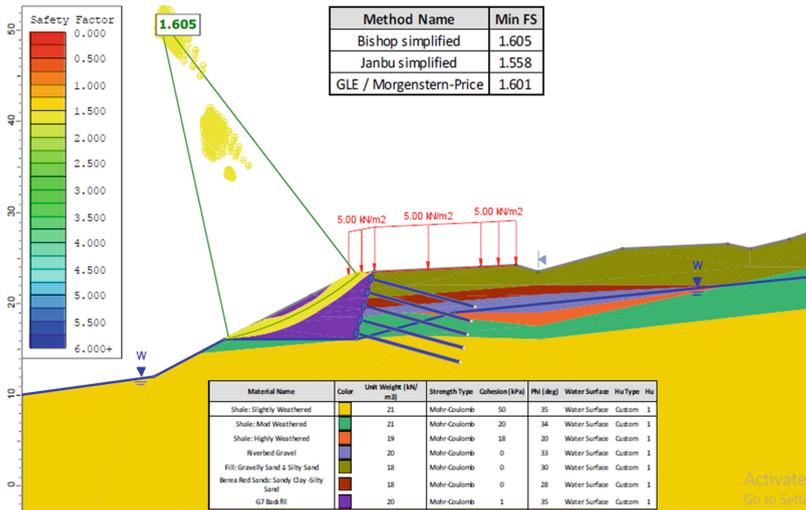
Figure 4 presents the ground anchor stabilized slope. It can be observed that the lateral earth support system increased the stability of the slope by approximately 4 times from 0.41 to 1.56. This implied that the embankment had been adequately stabilized and the DRR objectives had been achieved.

Fig. 4. Ground anchor stabilized slope

The final DRR stage was aimed at slope stabilization. Several factors were considered in determining the suitable stabilization system which included appropriateness for the site-specific geologic conditions, ease of installation, long-term performance and cost. Governed by these factors, it was determined that the slope would be stabilized using self-drilling grouted ground anchors with the following specifications:

1. The full depth of excavation of 7 m was to be undertaken in stages not exceeding 1.75 m.
2. An initial temporary lateral earth support system of self-drilling anchors with shotcrete facing. The 38 mm diameter and 12 m long ground anchors were to be installed in an inclined position of  $-15^\circ$  to the horizontal, spaced at 1.5 m horizontally and vertically.
3. Removal of saturated fill and backfilling with imported granular G7 material compacted to 93% maximum dry density in layers not exceeding 300 m.
4. Installation of vertical wick drains between the soil and shotcrete to prevent porewater pressure build-up behind the wall and horizontal drains to intercept ground water between Berea sands and Pietermaritzburg shales.
5. Permanent 150 mm grade 25 MPa shotcrete facing reinforced with welded steel mesh.
