Analysis of Slope Failure: A Case Study from the Pump House Cut Slope Wall of Lift Irrigation Scheme, Telangana State, India

Abstract. During the excavation of pump house-II of Kaleshwaram Lift Irrigation Scheme (KLIS) Link-II, sudden slope failure happened on the upstream wall from existing ground level +274.00 to +225.00 m level. In this paper the cause of slope failure at the upstream right-side wall of the pump house and support recommendations for the failure zone are discussed. 126 m long, 50 m wide (including annexe building) and 75.00 m deep, vertical shaft type pump house is being constructed for lifting the 361 cumecs water. Kinematic analysis was carried out to define the shape of the wedge, the orientation of the line of intersection and the direction of sliding. Equal angle projection was used for the analysis. Stability analysis was also done using the stability charts and Swedge RocScience software. The factor of safety (FOS) calculated using the stability chart is 0.44 and using Swedge is 0.4367. Mohr-Coulomb method of failure criterion is used for the analysis. After detailed analysis suitable engineering measures which include rock bolts, grouting and retaining R

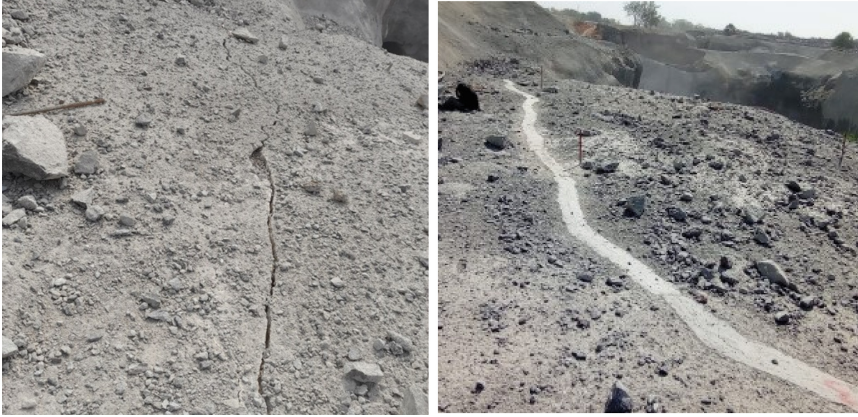
Fig. 1. Development of tension crack and before monitoring crack was sealed and glass strips were put

During excavation it was observed that from ground surface (EL 274.00 m) to EL 268.50 m, soil and highly weathered rock mass was there. Hence, excavation was done with 1:1 (H:V) side slope providing 6.0 m wide berm and there afterwards excavation was done vertically. During benching down from EL 225.00 m, crack was observed on the upstream right side wall top berm at RL 268.50 m. From the initiation of a crack 5 mm wide, the monitoring of the crack was started (Fig. 1). Further as the top layer consists of soils and highly weathered rock mass, it was decided to remove the overburden to avoid further development of widening of the crack. While removal of overburden, sudden wedge failure happened from existing ground level +274.00 to +225.00 m level i.e., for an average depth of 18 m having width 43 m at top and 3 m at bottom level +225.00 m. The failure happened despite preliminary protection works of 25 mm diameter, 6 m length rock bolts at 2.3 m c/c with 100 mm thick shotcrete with wire mesh/SFRS. After detailed investigations/analysis and site geological conditions suitable engineering measures were recommended and are being executed at site.

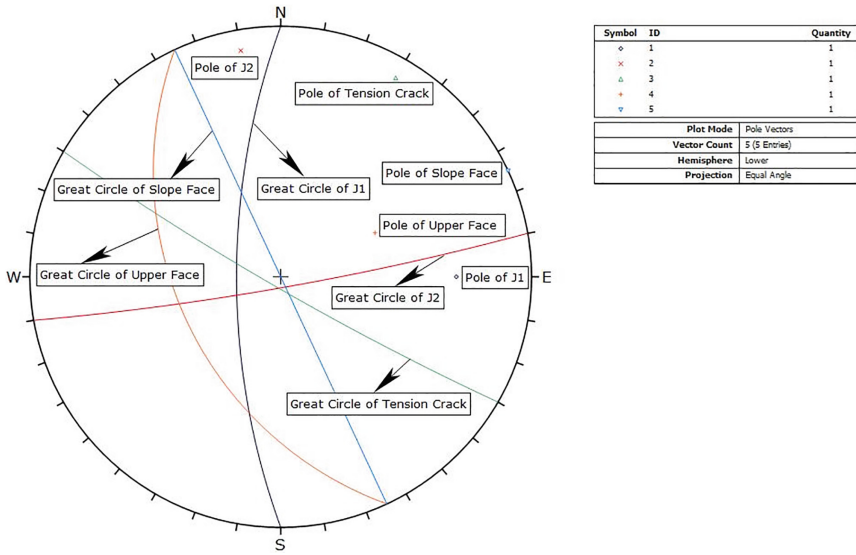
Kinematic analysis is carried out using RocScience Dips software to define the shape of the wedge, the orientation of the line of intersection and the direction of sliding. Kinematic analysis also gives an indication of stability conditions. Dips is a program designed for the interactive analysis of orientation-based discontinuities. Equal angle projection is used for the analysis. The plunge of the line of intersection is 68.45 degrees towards N247.19 direction (Fig. 2).

Fig. 2. Stereonet view showing the poles and great circles of joints, tension crack, slope face and upper face

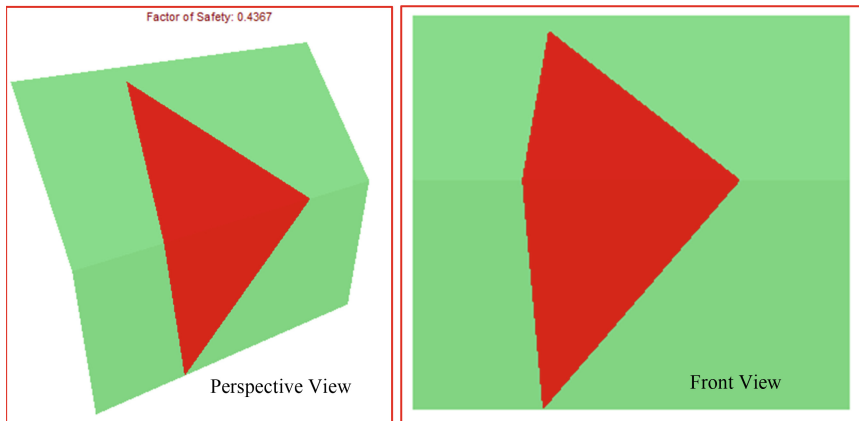
rock slopes, defined by two intersecting discontinuity planes, the slope surface, and an optional tension crack. Deterministic analysis is done for the determination of factors of safety. Mohr-Coulomb method of failure criterion is used for the analysis. The summary of the analysis result is given in Table 3. The factor of safety calculated is 0.4367 (Fig. 3).

**Fig. 3.** Schematics of the identified wedge

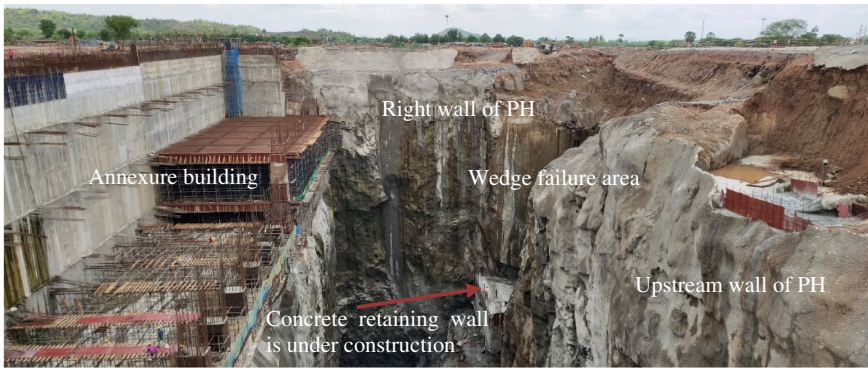
Fig. 4. View of wedge failure and concrete retaining wall is under construction

interval height, then again rock bolts were put then again muck was removed. From the top surface, 6.0 m long, 25 mm diameter tensioned rock bolts at 5-to-10-degree upward inclination ($F_e \geq 500$) at 2.0 m spacing on both joint planes were recommended. Curtain grouting (with 2.5 to 3.5 kg/cm² pressure) up to 25 m depth from the EL + 268.50 m was recommended using primary and secondary holes which will be done after the construction of the design concrete wall. 6 m spacing for the primary and 3 m for secondary holes was recommended. Grouting was recommended from 2.0 m away from the excavated face in a single row. After the completion of rock slope protection

measures, construction of a concrete retaining wall was recommended which is under construction (Fig. 4). Detail of a concrete retaining wall at different chainages is given in Fig. 5. For the different chainages i.e. from 80 to 85 m, 90 to 95 m, 100 to 115 m and 120 to 123 m details are given in the Fig. 5. It was recommended that lining above rock toe shall be taken up only after completion of lining below. For the design of slope stabilization measures, site geological conditions, the data from kinematic analysis and geometry of wall was taken into consideration and in view of importance of the structure, FOS 2 was taken.

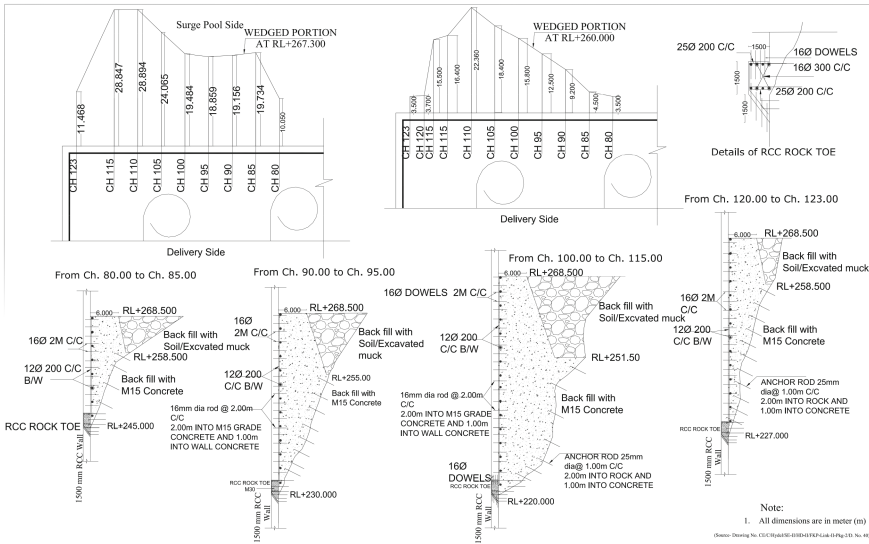
Fig. 5. Details of a reinforced cement concrete retaining wall at different sections
