# Infrastructure Management Based on Vulnerability to Landslides

**Abstract.** This study analyzed the vulnerability of the assets of an oil field exposed to landslides, based on the potential loss of value due to damage to people, the environment, property and/or business, with the objective of making visible, prioritizing, planning, and executing actions to address risk areas, through the application of digital technologies.

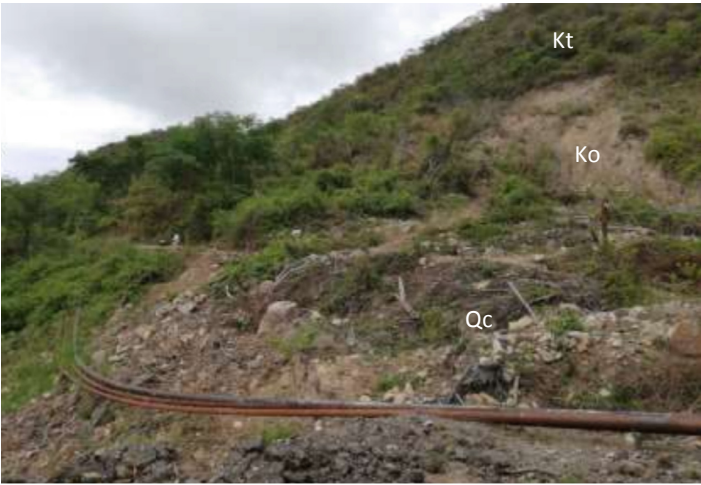
**Fig. 2.** Slip access road well AB-05

*Sliding access road to well location AB-05.* This sector is affected by a rotational slide presenting a midslope escarpment of the upper slope of the road with depth between 2.5 m and 3.0 m (see Fig. 2). Causes of the landslide basic: colluviums in high slope without drainage works. Detonating cause: strong rains saturated the colluvium.

Geological formations: in the upper part of the sandstone slope of the formation La Tabla (Kt), in the middle part of the Olini Group (Ko) and slope deposits of colluvial type (Qc) formed by the activity of the Bache fault.

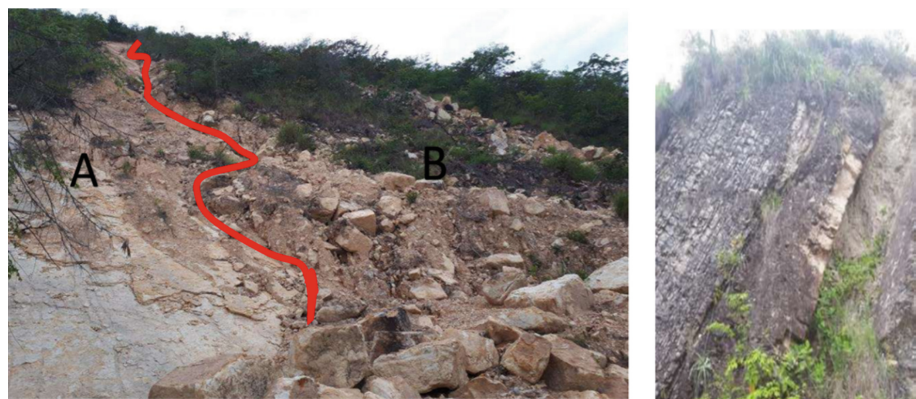
**Fig. 3.** Slip access road well AA-18 / rocks exposed in the slopes of the road

*Sliding access road to well location AA-18:* according to the classification of movements by Cruden & Varnes (1978) [2, 3], the studied slip is translational of blocks and detritus with planar fault surface, active, and is typical to present with fast speeds, two states are identified with zone A and zone B. The slope has an average inclination angle of  $29^\circ$  and the rock layer underlying the slide is competent and stable evidence (see Fig. 3) and simulated planar fault surface in Slide® (see Fig. 4).
