# Analysis of typical coal tunnel anchor network support accident cases in Huainan mine area and study of preventive measures

**Abstract.** The frequent occurrence of accidents in deep shaft engineering seriously restricts the safe and efficient mining of coal mines. In this paper, 193 cases of coal mine anchor network support accidents have occurred in Huainan mine since 2000, and the accidents are classified into roofing injury, roofing blockage, anchor breakage injury, rescue personnel casualty, revealing the mechanism of accidents, finding personnel, technical and management defects through unsafe actions, roofing accidents, and hidden dangers of work at all levels and managers. The research results can be used as a basis for the prevention of similar accidents in the deep ground. The results of the research can provide technical reference for the design of coal tunnel support schemes in similar deep strata and for the safe and efficient mining of mines.

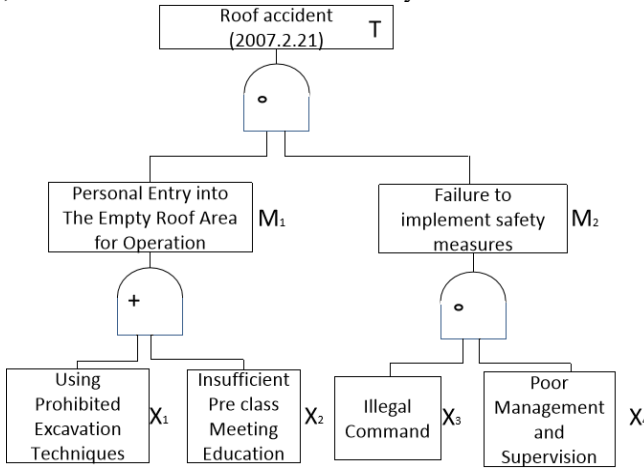
Fig. 1. Accident Tree Mind Map

The analysis of the accident tree means that instead of considering the amount of probability of occurrence of the system, only two states of the system occurring or not occurring are considered. By qualitative analysis of the accident tree, it is also possible to know the magnitude of influence of the occurrence of each basic cause event on the occurrence of the topside accident event. Using Boolean algebra to simplify the accident tree, the "2007.2.21" roof accident at Panyi Mine is shown in Figure 1.

The minimum cut set of accident occurrence after simplification is  $E_1=\{X_1, X_3, X_4\}$ ,  $E_2=\{X_2, X_3, X_4\}$ , from the analysis, it can be seen that there are two minimum cut sets for the occurrence of this roof accident. Calculate the importance of the basic event structure using formula (1):

From the ranking of the importance coefficients of various basic events, it can be seen that the causes of this roof safety accident are in order ① Illegal Command, ② Poor Management and Supervision, ③ Using Prohibited Excavation Techniques, ④ Insufficient Preclass Meeting Education. It can be seen that accidents occur in the subjective consciousness of individuals and site safety management are closely related.
