# Analysis and Handling of Water Inrush Accidents in Leading Conduit Construction in Working Shafts

**Abstract.** The construction of working shafts in shield tunneling projects is a challenging endeavor marked by deep excavation and intricate operations. It is further compounded by the frequent occurrence of water inrush accidents, particularly in regions where karst development is prevalent in the surrounding environment. These safety accidents during the construction of working shafts can have a cascading impact. They jeopardize the well-being of construction workers, pose threats to the lives and property of nearby residents, and disrupt the overall construction progress of the tunnel project. This paper is dedicated to a comprehensive analysis of the emergency response and monitoring strategies that come into play following a water inrush accident within a working shaft, with a specific emphasis on the context of constructing leading conduits in areas characterized by karst development. The specific content includes a technical analysis of the accident causes combined with geology and hydrology and the surrounding environment, and then formulating accident remedial measures a

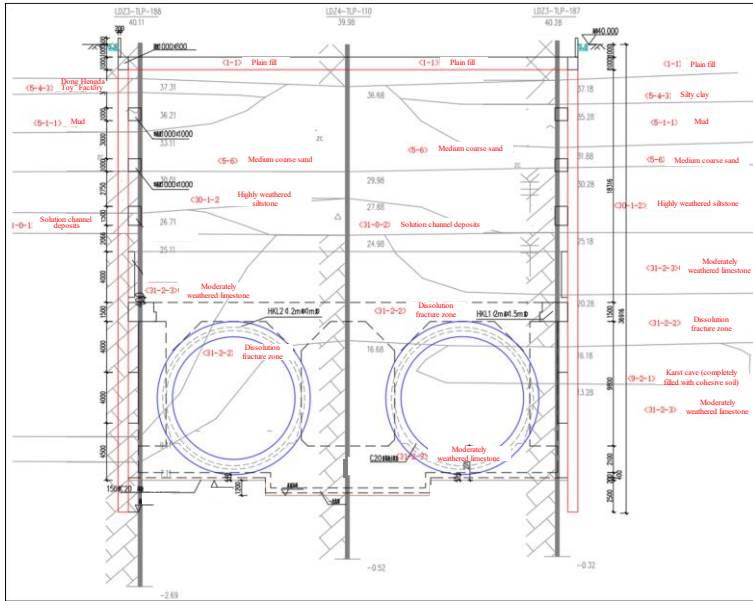
**Fig. 1.** Geological cross-section of working shaft

The stratigraphy within the pit, from the surface downward, encompasses plain fill, silty clay, mud, medium coarse sand, highly weathered siltstone, deposits in solution channel, moderately weathered limestone, and a dissolution fracture zone (Fig. 1).

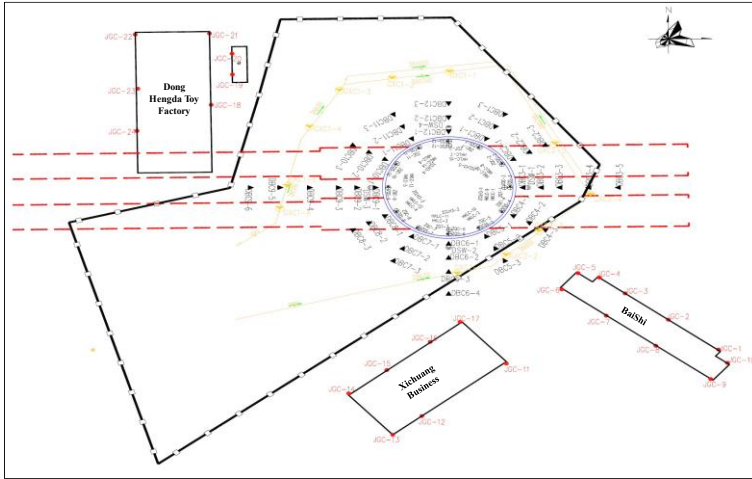
**Fig. 3.** ayout diagram of monitoring points

To ensure the safety and stability of the excavation pit and the surrounding infrastructure during shaft construction, as well as to promptly detect and report any changes in the surrounding area, we conduct monitoring of key factors. These include groundwater levels, surface settlement, building settlement, and pipeline settlement within and around the excavation pit. This monitoring serves as the basis for assessing the impact and managing potential accidents. The locations of monitoring points in the vicinity are illustrated in Fig. 3. Following the water inrush incident, the monitoring frequency has been increased to every 2 hours.

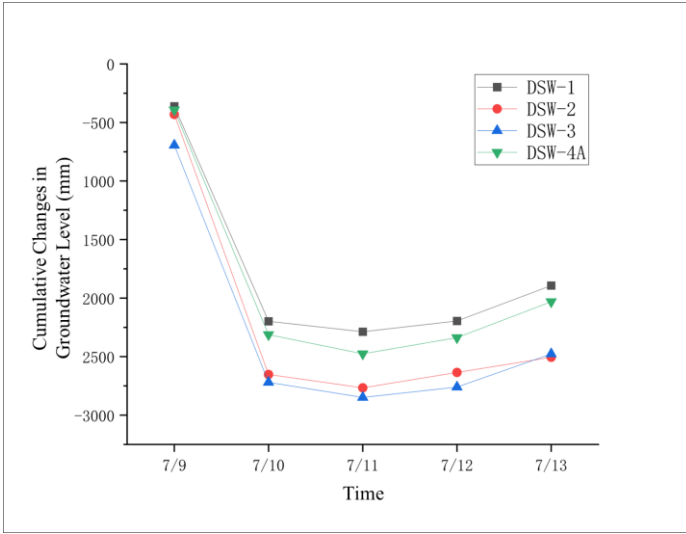
Fig.4. Variation curve of groundwater level

During the emergency response phase, a water inrush incident occurred in the excavation pit of the work well during the early hours of July 10. The water inrush was gradually brought under control by 13:00 on the same day. As depicted in Fig. 4, there was a significant decline in groundwater levels from the 9th to the 10th, with the maximum decrease measuring 2,221 mm. Importantly, all monitoring points exceeded their warning thresholds. Between the 11th and 13th of July, groundwater levels displayed minimal fluctuations and indicated a trend of rebounding. This effective management of water inrush in the excavation pit demonstrated clear results in the emergency response efforts.

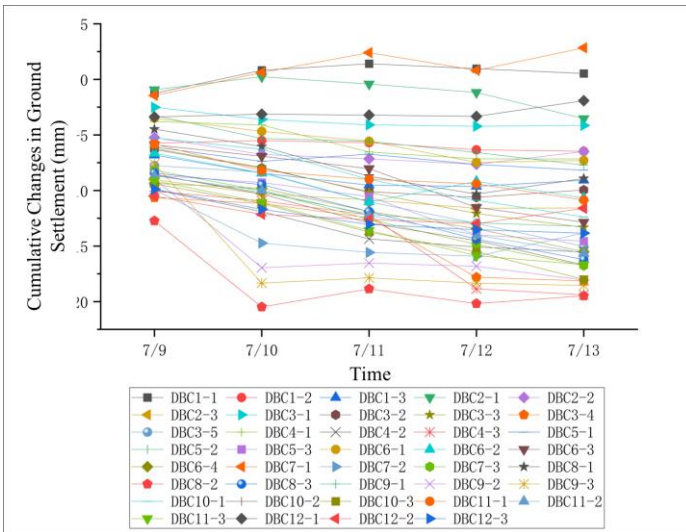
Fig. 5. Change curve of cumulative ground settlement in the surrounding area

As depicted in Fig. 5, between the 9th and the 10th, there were notable variations in surface settlement at a few monitoring points. Specifically, two monitoring points recorded settlement changes that exceeded the predefined warning thresholds. Following the emergency response measures, surface settlement in the subsequent days remained within the warning thresholds, and the cumulative settlement values did not surpass the control limits.

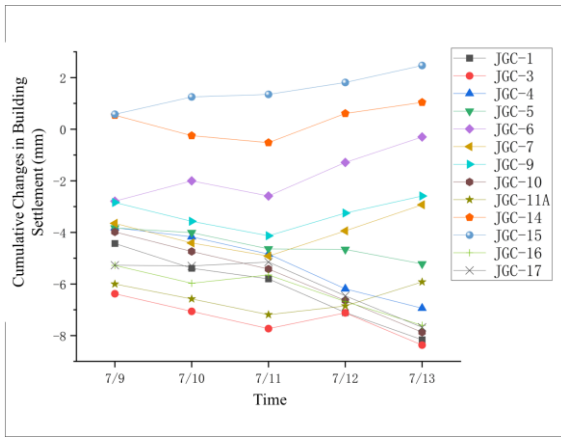
Fig. 6. Change curve in building settlement

Between the 9th and the 13th, the settlement rates of buildings surrounding the working shaft remained below the warning thresholds, and the overall settlement did not exceed the control limits, as depicted in Fig. 6.

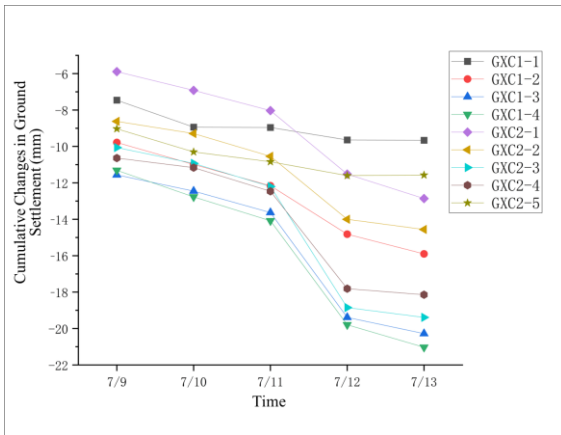
Fig. 7. Change curve of pipeline settlement

The overall trend in pipeline settlement changes displayed a downward pattern (Fig. 7). Notably, significant settlement occurred on the 11th and 12th, surpassing the warning thresholds. On the 13th, cumulative displacement at two locations, GXC1-3 and GXC1-4, exceeded the control limits.

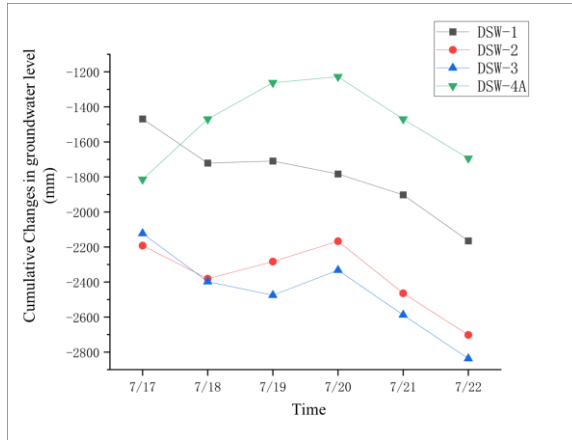
Fig. 8. Change curve of groundwater level

As illustrated in Fig. 8, the changes in groundwater levels around the working shaft during this period (from the 17th to the 22nd) exhibited minimal fluctuations and remained below the predefined warning thresholds. The cumulative changes in groundwater level closely resembled that observed during the emergency response phase, staying within manageable limits.

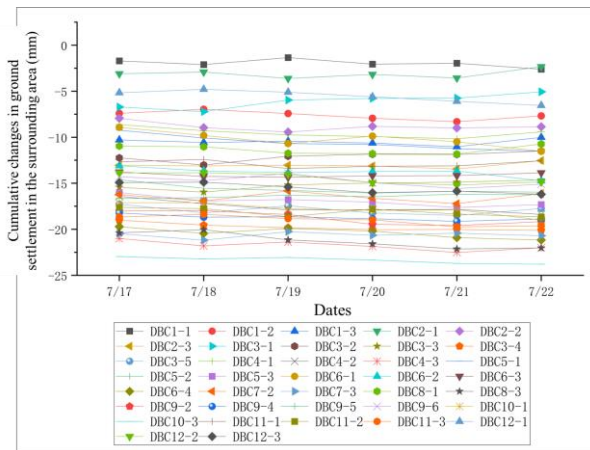
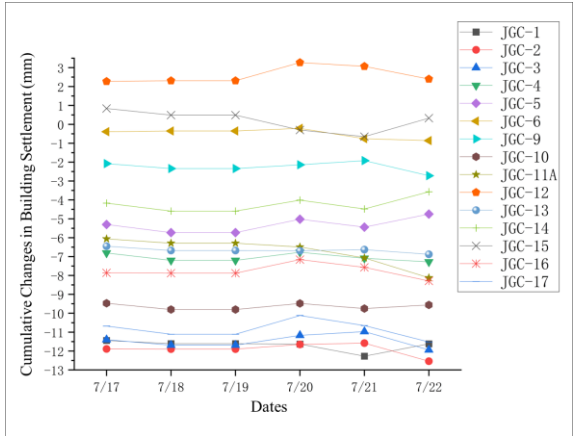
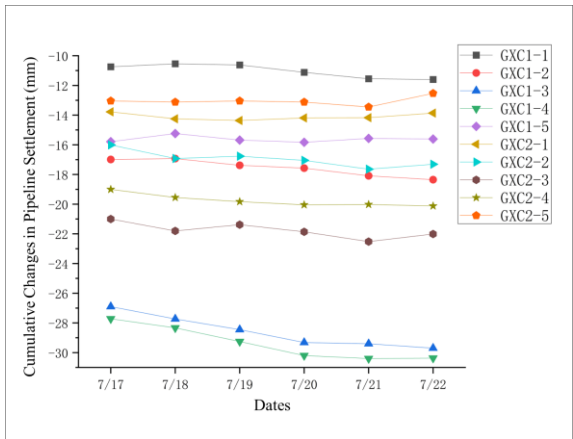
The settlement rates of the surrounding surface, buildings, and pipelines did not surpass the warning thresholds (Figs. 9, 10 and 11), and the cumulative settlement curves remained stable. However, at four monitoring points—GXC1-3, GXC1-4, GXC2-3, and GXC2-4—the cumulative values of pipeline settlement exceeded the established limits. Compared to the instances of exceeding limits observed on the 13th, the number of points exceeding the limits has increased, indicating the necessity for further monitoring.
