Trouble Shooting Steering Clutch on Builder Unit D155A-2 Komatsu

Al Amin, Hamka Munir, and Supriadin Supriadin
Dept. of Heavy Machine Equipment (Politeknik Negeri Nunukan. Nunukan,
indonesia)
alamintanari7@gmail.com

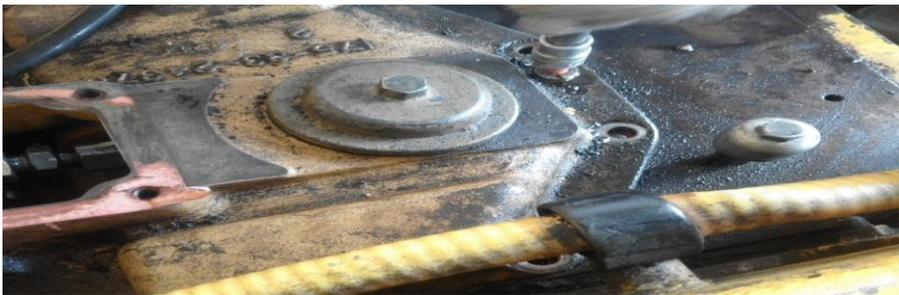
Fig. 1. Adjustment Bolt Rod Brake.

inspect the unit's condition. Afterward, the mechanics examine the unit to determine what issues have occurred, and the results are consistent with customer reports. In addition, mechanics perform more straightforward tests that are believed to be potential problems, such as linkage steering and justifying the bolt rod brake (Fig 1).

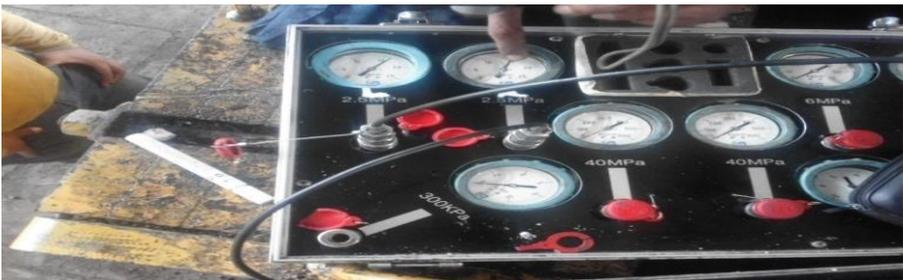
Fig. 2. Measurement steering full stroke.

They measure the pressure on the low-pressure right steering clutch with a pressure gauge when the engine is started at a high idle speed of 1500 engine revolutions per minute. The results of these measurements could be more satisfactory because they do not correspond to the standards outlined in the manual (Table 1). After measuring the steering oil pressure and determining unsatisfactory results, the steering right did not move with full force, and another measurement was taken (Figure 2).

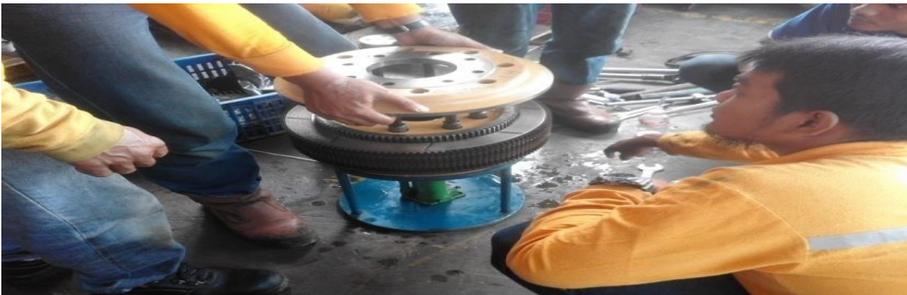
Fig. 3. Steering Clutch Assembly Removal.

Disassembling the proper steering clutch assembly, namely draining the oil from the steering case, removing the fuel tank, removing the hoses, bolts and so on, then lifting the steering clutch assembly using a lifting device (Figure 3). Next, place the steering clutch assembly component on the particular stand provided, place a jack under the steering clutch assembly component to hold the springs, and disassemble and inspect each steering clutch assembly element (Figure 4).
