# Fault analysis of fuel system on Komatsu PC200-8 excavator (case studies at PT Kaltim Plantation)

Denny Hendra Cipta

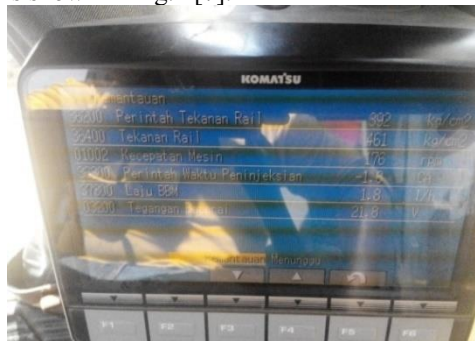
Fig. 1. Monitor panel of the troubled unit

In every event of a breakdown on a heavy equipment unit, the first thing to check is the monitor panel (if any) on the unit. The monitor panel system on Komatsu units is relatively sophisticated and makes it very easy for mechanics to analyze and diagnose disturbances on the unit. For the reading and explanation of the fault code displayed on the monitor panel, is referred to [8]. For the case of a fault on this unit, the monitor panel does not show any problem codes, as shown in Fig. 1 . This indicates that the fault that occurs is outside the scope of the unit's sensors. For this reason, a detailed inspection of the fuel system components is required. The schematic of fuel system components needed to be checked is shown in Fig.2 [7].

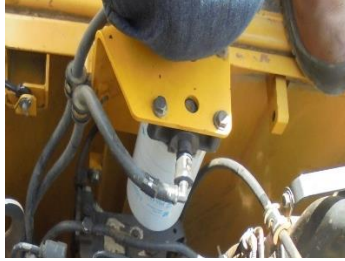
**Fig. 3.** Fuel filter installed on the troubled unit

important role in maintaining engine function because they function to separate impurities mixed with fuel before flowing to the next fuel system component. From the results of the check, it was found that the fuel filter installed was a third party production with the brand "Donaldson" which is not recommended by Komatsu as shown in Fig.3. However, the impurities found in the fuel filter are still relatively normal.

Visual Inspection	Standard	Actual
Monitor panel	No errors allowed	No errors
Fuel line	No leaks allowed	No leaks
Fuel filter	Genuine parts	Donaldson

To maintain the cleanliness of the fuel entering the fuel system, the fuel filter is replaced with a fuel filter that complies with the manufacturer's recommendations, as shown in Fig.9.

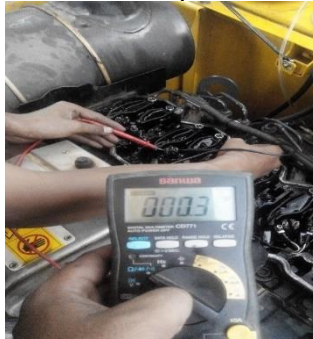
**Fig. 5.** Two way valve resistance measurement

#### 4. Measuring resistance on the two way valve

Two way valve resistance, injector 1 to 6	Max 2 $\Omega$	0,3 $\Omega$
Fuel return amount per 20 second	Max 200 ml/ minute at rpm 200	100 ml

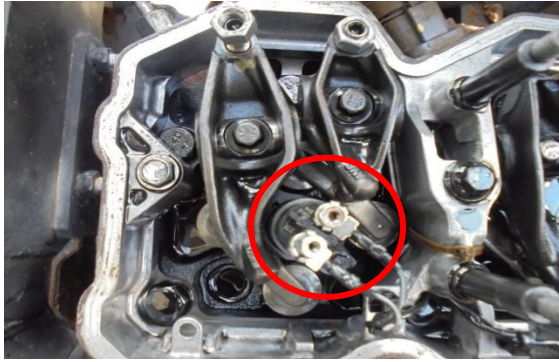
**Fig. 8.** Position of the injector in the cylinder head

Based on the results of the inspection and measurement process, it can be concluded that the faulty fuel system component is the fuel injector. The injector has too much internal leakage, so it cannot deliver high-pressure fuel into the combustion chamber. The lack of fuel supplied to the combustion chamber causes the engine to not start. The faulty injector is shown in Fig.7. For the problem solving, the injectors needed to be removed from the cylinder head, shown in Fig. 8.
