Corrosion analysis on grounding grid used for 220kV electrical equipment

Keywords: 220kV Electrical equipment; Grounding grid; Soil corrosion; Failure analysis.

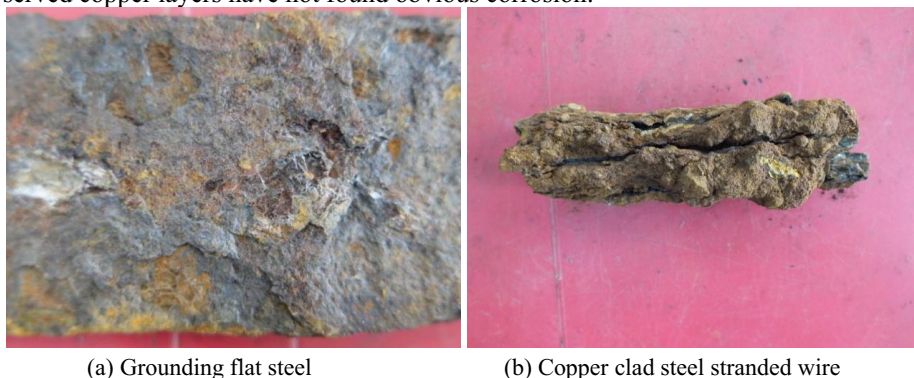
Figure 1 shows the macro morphology of the corroded grounding electrode and it was found that the grounding electrode was severely corroded and damaged. The galvanized layer on the surface of the buried part of the grounding flat steel has completely peeled off and undergone obvious corrosion and fracture, and some areas of the grounding flat steel have been severely softened and perforated. The yellow brown corrosion products are distributed layer by layer on the surface of the grounding electrode, and some of the corrosion products have fallen off without obvious mechanical damage or plastic deformation. Most copper clad steel strands have completely peeled off the copper layer from the steel core, causing severe corrosion of the steel core without copper layer protection. The corrosion products are yellow brown, and some steel cores have completely corroded. In addition, some steel strands with well preserved copper layers have not found obvious corrosion.

Fig. 1. The macro morphology of the corroded grounding electrode.

Firstly, it is necessary to strengthen the inspection of the electrical equipment grounding grid in the substation nearby the irrigated farmland of the Yellow River, and corroded or broken grounding flat steel and copper clad steel stranded wires should be replaced in a timely manner. The newly replaced grounding flat steel should be coated with hot-dip galvanizing technology for corrosion prevention, and the minimum thickness of the galvanized layer should not be less than 70 μ m and the average thickness is not less than 85 μ m. The substation located in the desert and

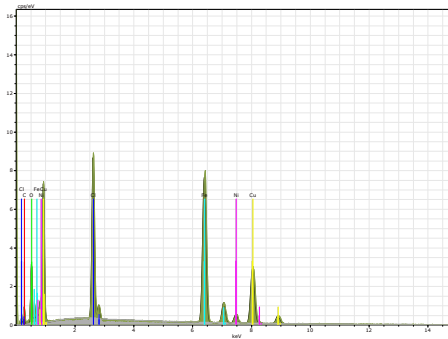
chart and results for corrosion products, and the results indicate that the corrosion products are mainly iron oxides and chlorides. Through analysis, the copper element should be caused by the mixing of corrosion products after the copper layer falls off.

Fig. 5. Energy spectrum analysis chart for corrosion products.
