Analysis and Treatment of Cracks in the Francis Turbine Runner of a Hydropower Station

Datang Yunnan Power Generation Co., Ltd., Kunming, Yunnan, 650103, China

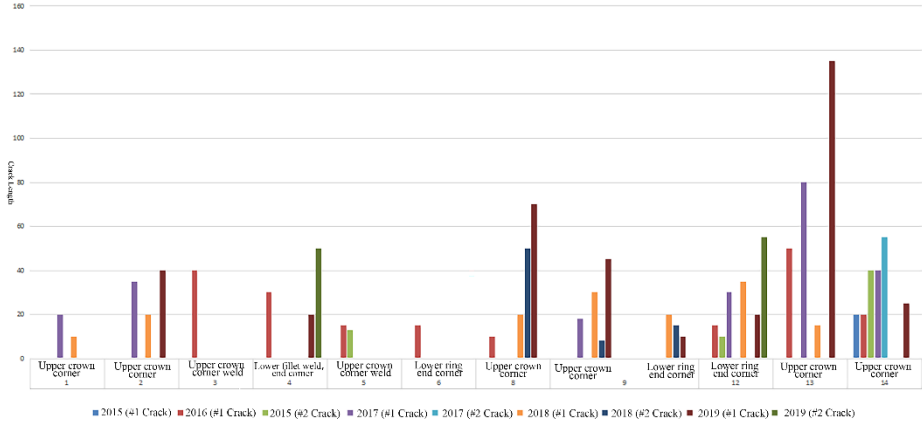
Crack Situation of Unit 1. The figure 1 shows the crack situation of each blade of the runner of Unit 1 from 2015 to 2019. From the statistics, it can be seen that the number of blades with cracks is large and the cracks are universal. Among them, blade 12 has experienced penetrating cracks for two consecutive years and blade 13 has experienced penetrating cracks for three consecutive years, and the penetrating cracks have no trend of decreasing and converging.

Fig. 1. Crack statistics of Unit 1 from 2015 to 2019

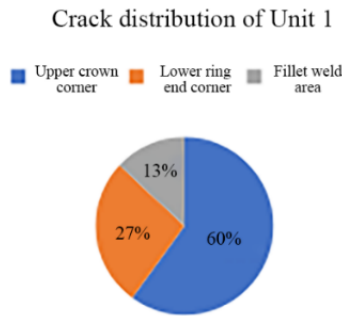
The figure 2 shows the statistics of the cracks in the runner of Unit 1 based on the location of occurrence. From the statistics, it can be seen that the cracks mainly occur at the upper crown end corner, lower ring end corner and fillet weld (flow channel) of the runner outlet. The cracks in the upper crown account for about 60%, and the cracks in the lower ring account for about 27%. The crack length is between 8~135 mm. Among them, the No. 12, No. 13, and No. 14 blades have crack defects in the same location.

Fig. 2. Crack location statistics of Unit 1

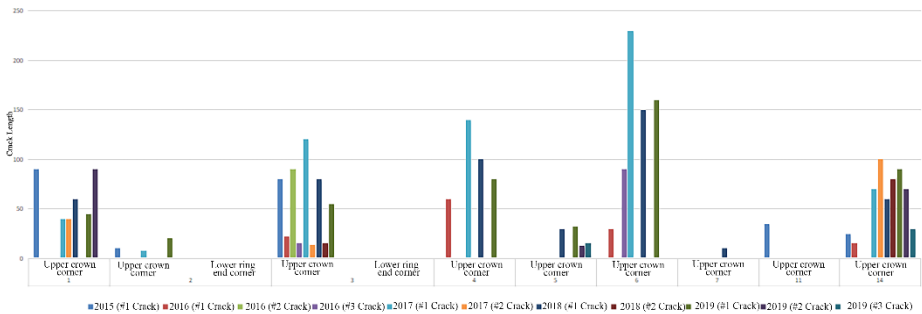
Crack Situation of Unit 2. The figure 3 shows the crack situation of each blade of the runner of unit 2 from 2015 to 2019. Similar to unit 1, 9 blades of unit 2 have cracks, including through cracks in blades 1, 3, 4, 6, and 14. Blade 3 has had through cracks for 5 consecutive years, and blade 6 has had through cracks for 4 consecutive years. There is no obvious convergence trend in the number and severity of cracks.

Fig. 3. Crack statistics of Unit 2 from 2015 to 2019

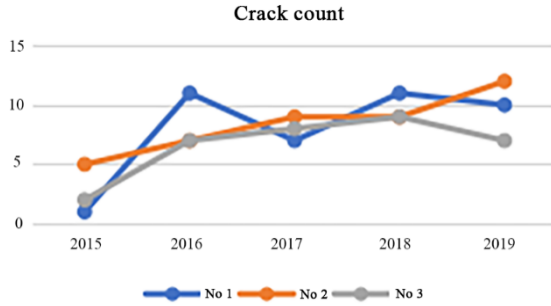
Overall Situation and Explanation of Cracks. The number of runner cracks (Figure 6) and cracked blades (Figure 7) of the three units were counted each year. From the trend chart, it can be seen that the number of runner cracks of the three units is on an upward trend, and there is no year-on-year decrease or convergence trend. This shows that the cracks in the runners of the three units are universal and are not caused by special reasons of a certain unit. At the same time, there is no convergence trend, and further analysis is needed from other influencing factors.

Fig. 6. Crack statistics of three units

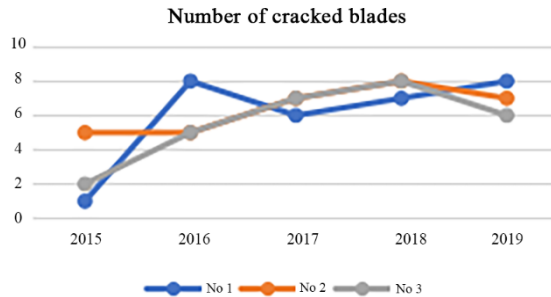
Fig. 7. Statistics of cracked blades in three units

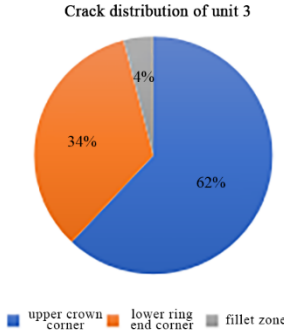
From the locations where cracks occurred in the three units, it can be seen that they are mainly distributed in the upper crown end corner and lower ring end corner areas at the water outlet of the runner, and the two areas account for 96% (Figure 8). Since the runners of the three units are made of martensitic stainless steel, the runner blades are welded to the upper crown and lower ring. Martensitic stainless steel has high strength, low plasticity and toughness, and insufficient thermal conductivity [2]. At the same time, the shape of the blade outlet joint is complex, and the residual stress after welding is large. After a period of operation, the cracks of the mixed flow turbine are mostly generated here [3-4]. Therefore, from the proportion of crack occurrence locations, the crack location of the runner is consistent with the manufacturing characteristics of the mixed flow turbine, which is related to the large residual stress of welding. However, cracks occurred again after on-site treatment, and there was no trend of decreasing year by year. Further analysis is needed from the aspects of runner design strength, operation, and welding repair process [5].

Fig. 8. Crack location statistics of three units

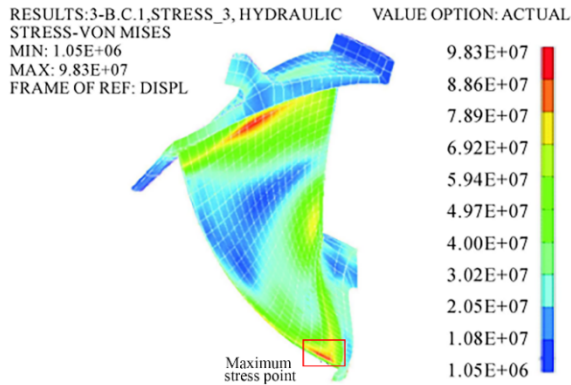
Strength Analysis. Ansys software boasts powerful multi-physics analysis capabilities, enabling it to simulate the complex working environment of hydraulic turbines under different operating conditions. This includes the interaction of multiple physics fields such as fluid dynamics, structural mechanics, and thermal stress, thereby more accurately reflecting the force conditions of hydraulic turbine runners during actual operation and providing more comprehensive data support for crack analysis. Since the turbine runner is a periodically symmetrical structure, a fan-shaped area including a complete blade is selected for calculation. The analysis selects two working conditions: the maximum head and maximum output conditions with greater stress during operation and the runaway condition at the extreme of the fault (Figure 9 and 10) [6]. The calculation results are shown in the following table 1. By calculating the maximum stress of the runner at the maximum head and maximum output, the maximum stress at the runaway condition is 98.3 MPa, and the maximum stress at the runaway condition is 113 MPa, both of which are less than the design strength of 100 MPa and 360 MPa. The stress strength during operation does not exceed the design range, and the design strength meets the requirements, so this factor can be excluded.

Fig. 9. Calculation of maximum head and maximum output conditions

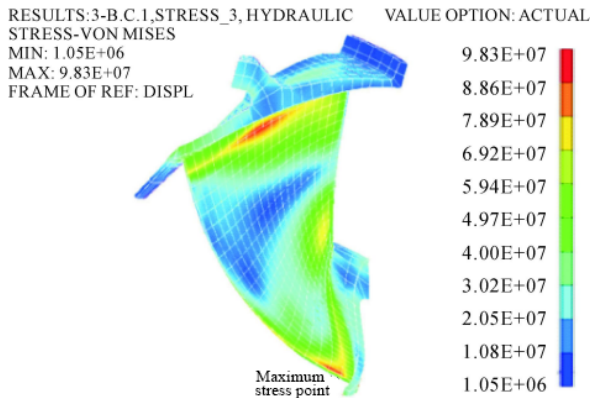
Fig. 10. Calculation of runaway conditions

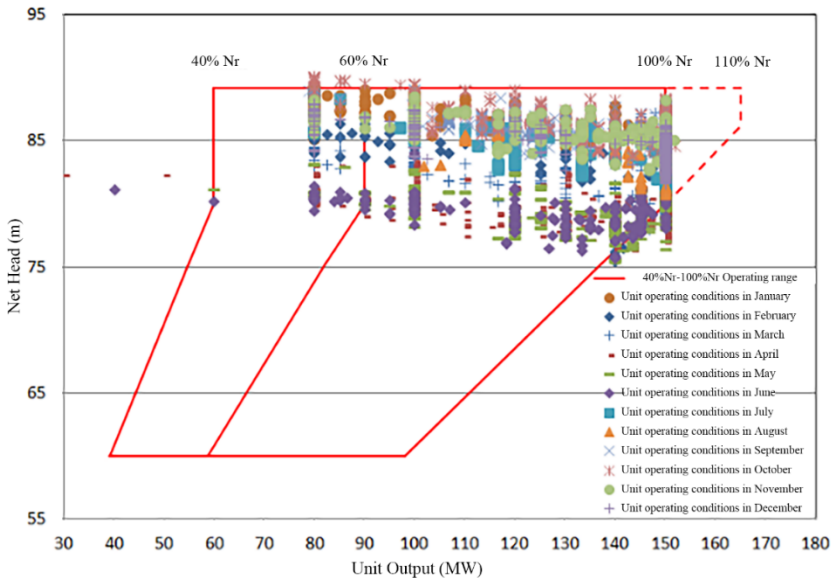
The load distribution of the units under different water levels in the two years of the plant was counted (as shown in Figures 13 and 14). It can be seen from the figure that the three units operated below 60% of the rated output for a certain period of time in the two years; at the same time, under the rated head of 80m, the load carried by the units in some periods exceeded the guaranteed output range of the runner, and there was a certain degree of overload operation.

The above two situations have a certain impact on the turbine, which will accelerate the fatigue of the blades and cracks. This factor is one of the factors affecting the cracks in the runners of the three units. During operation, it should be avoided as much as possible to operate under bad conditions for a long time. If the recurrence of cracks can be reduced by changing the operating conditions, no further structural optimization of the runner can be done.

Fig. 13. Unit load operation statistics in 2017

According to the load plan, optimize the unit startup combination, and try to avoid operating in the vibration zone to reduce the dynamic load on the runner blades and reduce the possibility of fatigue cracks on the blades [11-12].

Strictly follow the guaranteed output operating range given by the manufacturer, ensure that the load meets the manufacturer's requirements when the water level is low, and avoid long-term operation at excessive output.

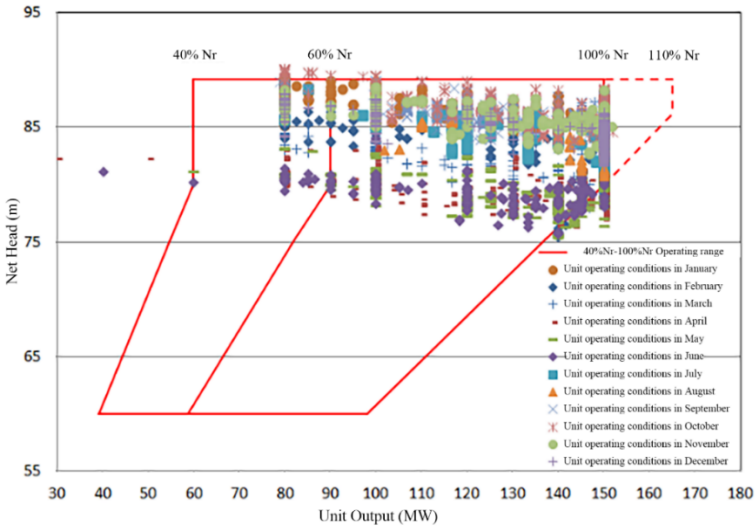
Fig. 14. Unit load operation statistics in 2018

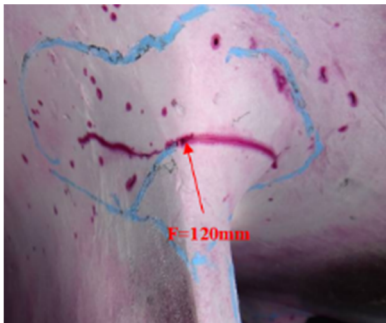
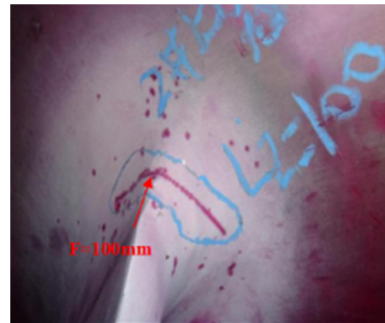
1. The quality of the runner welding repair process is poor. It can be seen from Figures 15 and 16 that some cracks have defects such as pores and pits after repair. During operation, cracks originate from these pores and pits and further expand. Cracks in areas with dense pores have the situation of extending in series along the pores.

Fig. 15. Blade cracks

Fig. 16. Blade cracks

In view of the shortcomings in welding quality and post-weld treatment, the welding repair process plan and operation control documents were re-formulated, and the manufacturer's welding personnel were invited to carry out the repair. The welding quality control was carried out well throughout the whole process, and the requirements for interlayer disinfection of welding were strictly implemented; the gouging area was preheated before carbon arc gouging, and the preheating temperature and interlayer temperature were strictly controlled during welding; after welding, it was immediately covered with insulation material and slowly cooled; the weld was polished, and stress

concentration points were not allowed to exist, and pits and bosses with a depth of more than 0.5 mm were not allowed to appear on the flow surface of the blades [10].

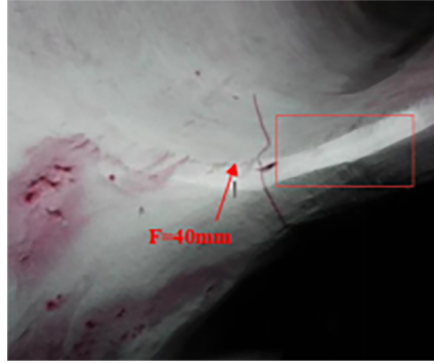
2. Poor grinding and shaping after repair welding. As can be seen from the figure 17, some cracks have angular surfaces and poor smoothness after repair and grinding, and there is no smooth transition. At the same time, the surface roughness of the repaired part is not good and does not meet the design requirements.

Fig. 17. Grinding after crack repair
