# Sediment Wear and Protective Measures for Turbine Overflow Components of a Hydropower Station

<sup>1</sup>Xizang Datang Zhala Hydropower Development Co., Ltd. Changdu, China

<sup>2</sup>Datang Hydropower Science & Technology Research Institute, Chengdu, China

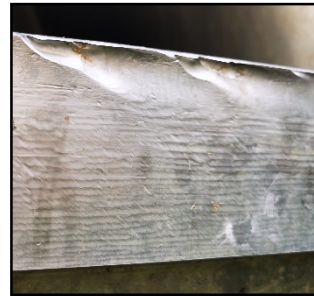
**Fig. 2.** Grooved erosion on the upper edge of the lower ring of Unit 1#

The most serious abrasion situation appeared after the first technological updating of the unit 1#, after the turbine carried out operation for two cycles, the back of the 13 blades near the lower edge of the water outlet edge have a regular and consistent typical honeycomb damage, and the surrounding anti-abrasive spray layer shedding serious, the location is shown in Fig. 1, the region is also a typical cavitation damage area of the mixed-flow rotor. The wear and erosion of the upper and lower edges of the lower ring as well as the lower edge of the upper crown are more complicated, with both fish scale-like sediment wear traces as well as deeper grooves after erosion, as shown in Figure 2. The improvement in the wear of the runner before and after the modification is not obvious, and the wear traces appear on the over-water surface of the rectified runner, especially in the lower ring, the weld seam between the blade and the lower ring, and the near weld region of the blade, where the herring-bone form sediment wear characteristics are very obvious, as shown in Fig. 3.

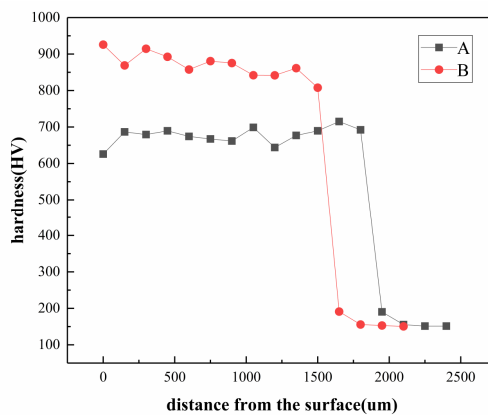
As illustrated in Fig. 4, the average surface hardness of the cladding layer on Sample A is 676.98 HV, while for Sample B, it is 869.81 HV. A clear stepwise hardness distribution is evident between the two materials. The hardness of the cladding layer is found to be 4 to 6 times greater than that of the base material. The three distinct hardness levels correspond to the cladding layer, the heat-affected zone, and the substrate, respectively. Notably, the hardness of Sample B is slightly higher than that of Sample A, which can be attributed to the higher carbon content in Sample B. This increased carbon content leads to enhanced hardness in Sample B compared to Sample A.

**Fig. 4.** Microhardness of A and B materials
