Gamma Transmission Technique to Inspect Trays Condition of Distillation Column: An Experiment at Refinery Plant

Megy Stefanus^{1,*}, Bayu Azmi¹, Indra Milyardi¹, Norman Pamungkas¹, and Rahmad Ramdani Sambari²

¹Research Center for Radiation Process Technology-ORTN BRIN, Jl Puspiptek Muncul, Setu, Tangerang Selatan, Banten 15314, Indonesia

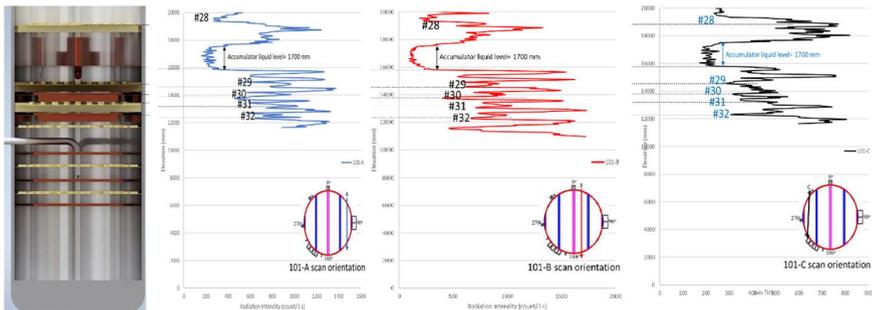
Fig. 2. Scan data A-C.

Scan A, B, and C as shown in Fig. 2 are to detect trays #28 - #32. The data shows that trays #28 - #32 are detected and they are in their position. Trays # 29 - #32 carry approximately the same amount of liquid, whereas tray # 28 holds a relatively large amount of liquid. There are no significant problems and these trays functioning properly according to scan data.

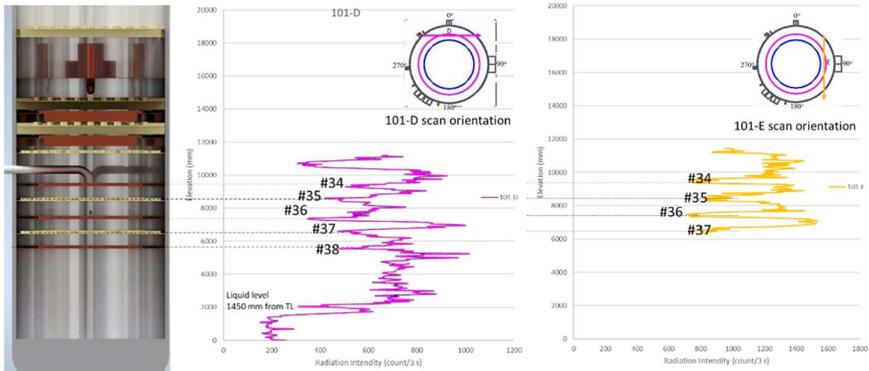
Fig. 3. Scan data D and E

Scan D and E are shown in Fig. 3. Scan D is to detect the performance of trays #33 - #38. The data shows that trays #33 - #38 are detected as indicated by consecutive scan patterns with the same space distance between adjacent tray's positions. Trays # 33 - #38 carry approximately the same amount of liquid. According to the scan data, these trays are functioning properly. Moreover, the liquid level is detected at an elevation of 1,450 mm from TL.

The aim of scan E is to detect the performance of trays #33 - #38. The trays #33 - #38 and their position are detected as indicated by consecutive scan patterns with the same space distance between adjacent trays. Trays # 33 - #38 carry approximately the same amount of liquid. There are no problems encountered from this scan data.

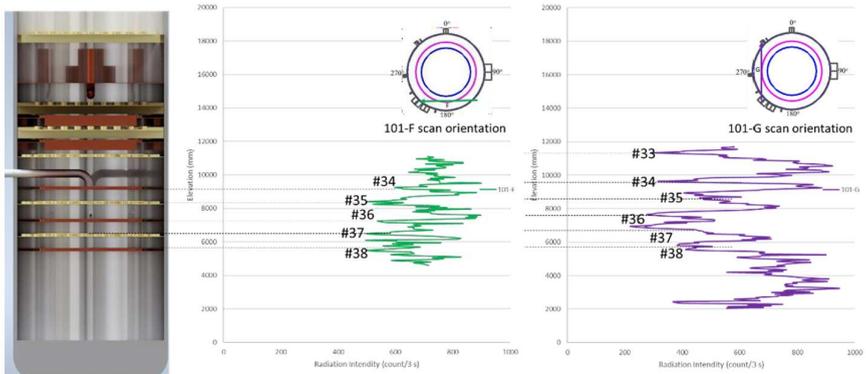
Fig. 4. Scan data F and G

Scan F and G are shown in Figure 4. The scan data F is to detect the performance of trays #33 - #38. Both trays and their positions are detected as indicated by consecutive scan patterns with the same space distance between adjacent tray's positions. Trays # 33 - #38 carry approximately the same amount of liquid. These trays are working properly as viewed from the scan data.

The scan data G is to detect the performance of trays #33 - #38. The data shows that trays #33 - #38 and their position are detected as indicated by consecutive scan patterns between adjacent tray's positions. Trays # 33 - #38 carry approximately the same amount of liquid. These trays function properly according to scan data. The scan data H is to detect the performance of trays #33 - #38 as shown in Figure 5. Both trays and their positions are detected as indicated by consecutive scan patterns with the same space distance between adjacent tray's positions. Trays #33 - #38 carry approximately the same amount of liquid. These trays work properly based on scanning data. The Tray #34 pattern shows the radiation intensity is higher than others, suspected partially damaged at that position.

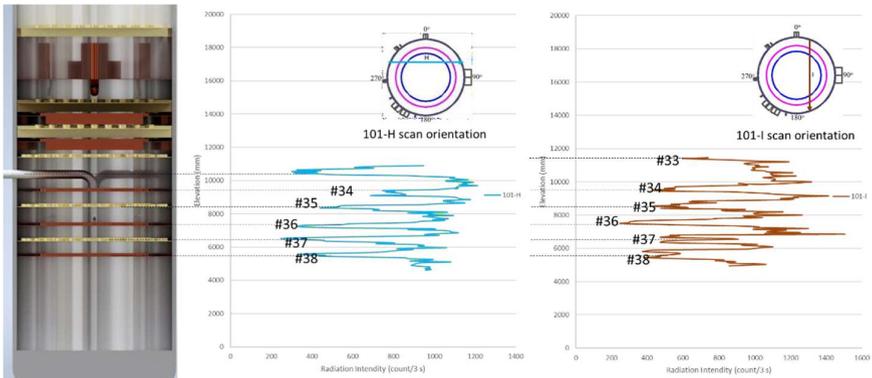
Fig. 5. Scan data H and I

The scan data I is to detect the performance of trays #33 - #38 as shown in Figure 5. Both trays and their positions are detected as indicated by consecutive scan patterns

with the same space distance between adjacent tray's positions. Trays # 33 - #38 carry approximately the same amount of liquid according to the scan data.

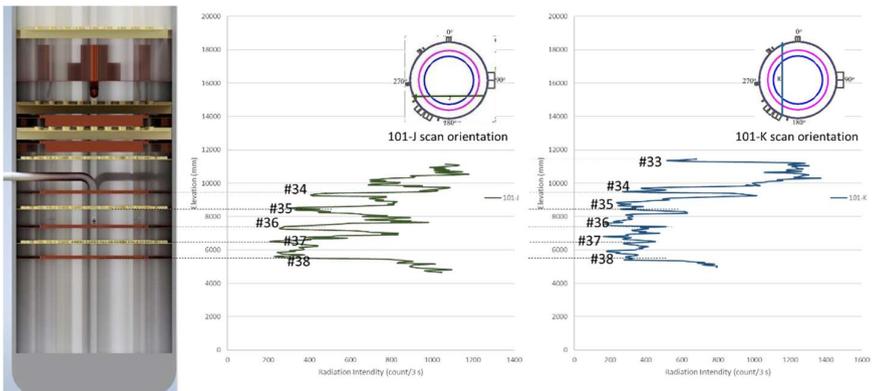
Fig. 6. Scan data J and K

Figure 6 presents the scan data J and K are to detect the performance of trays #33 - #38. Both trays and their positions are detected as indicated by consecutive scan patterns with the same space distance between adjacent tray's positions. Trays # 33 - #38 carry approximately the same amount of liquid. These trays work properly by referring scan data.

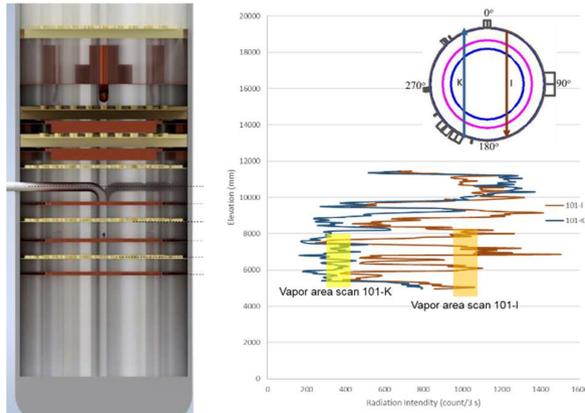
Fig. 7. Comparison of K and I scan data.

Figure 7 is intended to compare the K and I scan data, because there is a considerable difference in radiation intensity profile, mainly in the area trays #37 and #38. As can be seen, radiation intensity at the scan line K is lower compared to its counterpart on profile radiation intensity obtained from the scan line I. Lower radiation intensity indicates more gamma rays are absorbed by materials in this area. It is believed that there are problems in the area between trays #37 and #38. Meanwhile, the profile of radiation intensity shown by trays #33 - #36 are considerably similar, indicating that there is no problem in this area.

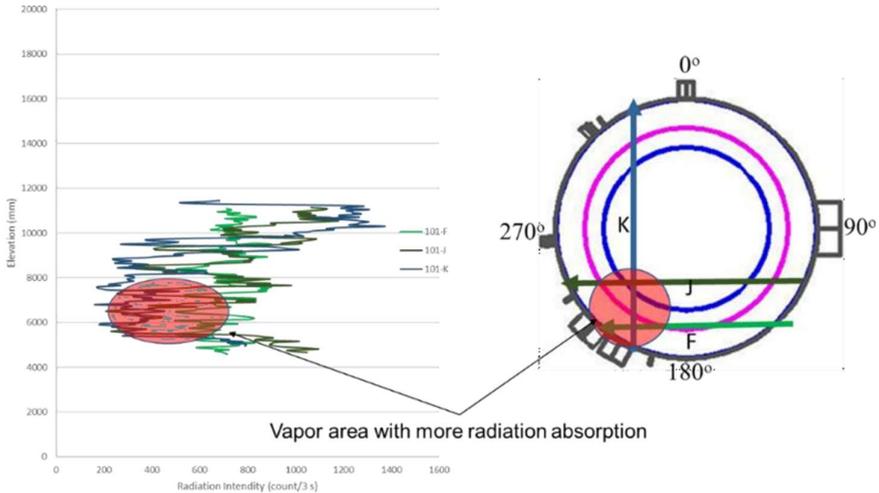
Fig. 8. Comparison of F, J and K scan data.

Figure 8 is to emphasize the location and source of the problem based on the interpretation of Figure 7 above. Lower profile intensity in the scan line K indicates the presence of the tray's material and fluid derived from tray #37 that fell onto tray #38.

In this regard, tray #37 is suspected to be partially damaged and could not hold fluid on it.

There is a suspicion of a material that absorbs gamma radiation at a position as shown in Fig. 8. The radiation- absorbing material can be massive water flowing in the area or unknown material like coke or others.

The gamma-ray scanning technique has been applied to determine the condition and performance of tray #28 -#38 in the distillation Column. Eleven measurements have been conducted to determine the condition of the trays. The measurement concludes that all trays are still in their positions, Trays #28-#36 are functioning properly, there is suspected partial damage at tray #34. Tray #37 was suspected to have suffered partial damage so that it could not hold the fluid on it. Damage to tray #37 causes an impact to tray #38 due to fluid spills and material faults on tray #37 resulting in flooding on tray #38. There is a material that absorbs the gamma radiation observed in scan 15-C-101-F, J, and K as shown in Figure 8. It can be caused by massive water or unknown material like coke.
