Experimental Study on Mechanical Properties of Dike Fill and Settlement and Deformation of Jingjiang Yangtze River Embankment

Chunyang Yin, Zhiqiang Wu*, Kai Xu, Zhilei Sun

Geotechnical Engineering Department, Nanjing Hydraulic Research Institute, Nanjing, Jiangsu, 210024, China

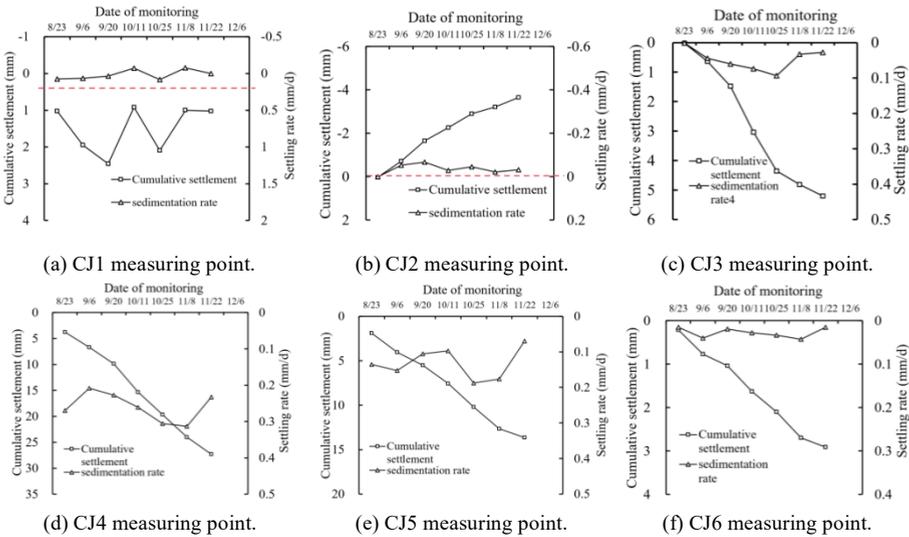
Fig. 6. On-site top-of-embankment settlement monitoring results.

As displayed in Figure 6, the settlements at measuring points CJ1 and CJ6 is minimal, with cumulative settlement within 3mm. Measuring point CJ2, located on the landward shoulder of the embankment, showed a sustained minor uplift, with the amount of uplift within 4mm. Measuring points CJ3, CJ4, and CJ5 demonstrated varying degrees of cumulative settlement, with maximum settlements of 5.20 mm, 27.28 mm and 13.64 mm respectively. Notably, CJ4 and CJ5 showed significant settlement (27.28 mm and 13.64 mm, respectively), warranting reinforced continuous observation in the future.

(2) Settlement of the embankment exhibits significant spatial variation. CJ1 and CJ6 showed minimal settlements, both within 3 mm; CJ2 displays minor uplift, within 4 mm; and greater settlements occurred at CJ3, CJ4, and CJ5, which are 5.20 mm, 27.28 mm, and 13.64 mm respectively.

(3) Measuring point CJ1 experienced repeated cycles of settlement and uplift, likely influenced by tidal water levels at the time of measurement. The minor uplift at measuring point CJ2 may be attributed to its location on the landward shoulder of the embankment. Greater cumulative settlements were observed at points CJ4 and CJ5, suggesting the need for continuous monitoring at these locations.
