# Safety Assessment of Road Railing on UB–Nalaikh Road

Dashdavaa Tuvshintur<sup>1</sup>, Sungchil Lee<sup>2\*</sup>, Odbileg Norovrinchen<sup>2</sup>

**Abstract.** Road traffic accidents along the Nalaikh–Ulaanbaatar road have raised serious concerns regarding the adequacy of existing safety measures, particularly the effectiveness of safety railings. This research investigates the structural integrity and performance of these railings with the aim of enhancing road safety and reducing accident severity. The study employs a mixed-methods approach, including on-site assessments, consultations with local authorities and road safety experts, and an in-depth review of international safety railing standards. The evaluation reveals that while the current railings comply with certain Mongolian national standards, they fall short in effectively mitigating accident impacts due to shortcomings in design, material durability, and maintenance practices. Based on these findings, the study proposes a series of improvements, drawing on advanced international design standards and advocating for stricter maintenance protocols. These recommendations aim to improve the railings’ ability to prevent

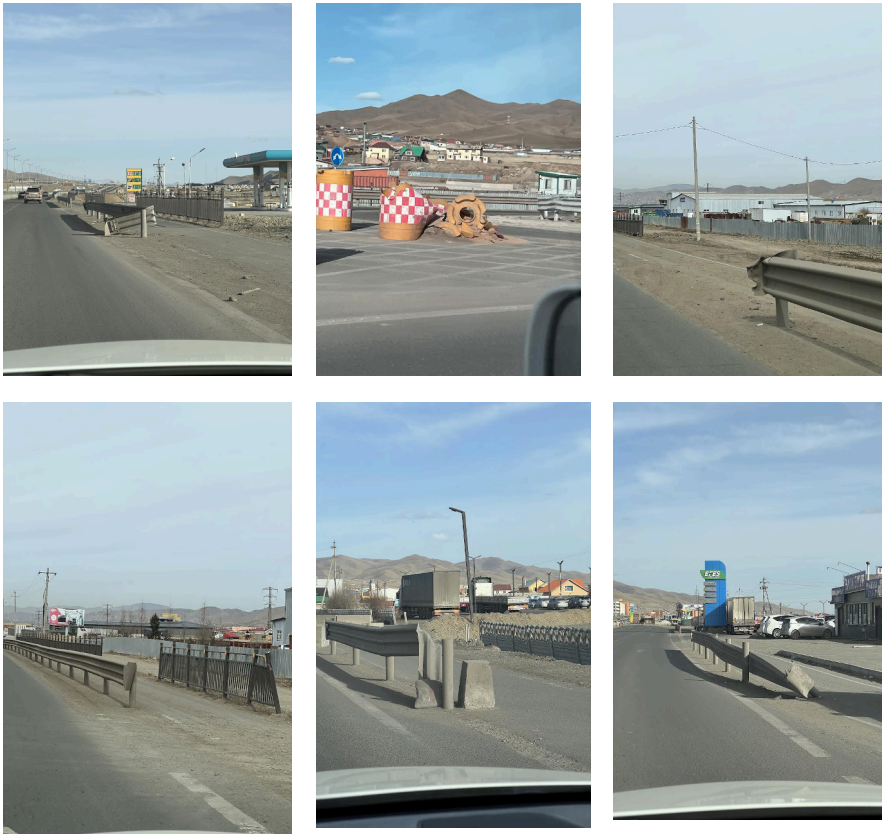
The condition assessment of the safety railings along the Nalaikh–Ulaanbaatar road revealed a troubling and widespread state of disrepair. Figure 1 shows the current state of the safety railings. A series of systematic field surveys conducted over multiple sections of the road documented numerous instances of visible deterioration, physical damage, and even complete absence of safety barriers in high-risk zones. These findings point to a significant degradation of this essential safety infrastructure, which could severely undermine road user protection and increase the likelihood of serious accidents. The most commonly observed issues were categorized into the following areas:

**Structural Damage:** A considerable number of railing segments exhibited extensive impact damage, likely resulting from past vehicular collisions. These damages ranged from bent and twisted steel sections to fully detached or collapsed railings. In many cases, the damaged railings were left unrepaired, thereby losing their capacity to contain or redirect errant vehicles—an essential function in preventing vehicles from leaving the roadway and crashing into surrounding hazards.

**Corrosion:** A pervasive issue identified during the assessment was the widespread corrosion affecting metallic components of the railings. Many of the barriers showed advanced rusting, particularly at the base where water accumulation and poor drainage may have accelerated degradation. The loss of metal due to rust not only weakens the railings structurally but also makes them more prone to failure upon impact, especially in the cold and humid climate conditions typical of Mongolia's harsh winters.

**Vandalism and Theft:** In several locations, parts of the safety railings appeared to have been deliberately removed, damaged, or tampered with. Reports from local authorities and visual evidence suggested instances of theft, likely driven by the resale value of metal components. Such actions significantly compromise the continuous protective function of the railings, leaving dangerous gaps that pose serious hazards to drivers, particularly at night or during poor weather conditions.

**Lack of Maintenance and Repair:** One of the overarching issues identified was the apparent lack of routine maintenance and timely repair efforts. Damaged or missing components were not replaced, and corroded sections had not been treated or reinforced. This neglect has allowed minor issues to evolve into serious structural vulnerabilities, rendering the system ineffective in many areas.

**Fig. 1.** The current condition of safety railings (guiderail) conditions.

The cumulative effect of these deficiencies raises serious concerns about the safety railings' capacity to perform their intended protective functions under current traffic and environmental conditions. Without urgent intervention—through repairs, replacements, and the implementation of a robust maintenance regime—the railings along the Nalaikh–Ulaanbaatar road are unlikely to prevent accidents or mitigate their severity effectively. This situation necessitates immediate attention from transportation authorities, infrastructure planners, and policymakers to prioritize improvements in roadside safety features and to ensure long-term reliability of such critical infrastructure.
