Analysis on the Old Gob Water Inrush Accident of Kunlun Mine in Zibo

Abstract: This article was based on the serious water inrush accident of Kunlun Mine, Kunlun Town, Zichuan County, Zibo City. According to the old gob water inrush mechanism, combining with the results of the numerical simulation, it analyzes the causation and the conditions of this accident, discloses the evil consequence result in seeking economy benefit only and ignoring safety, and provides warning for future coal mining safety.

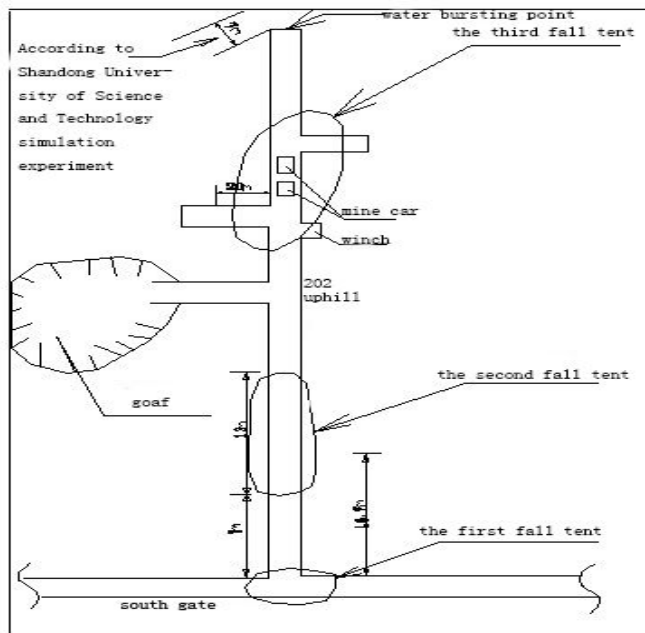
Fig. 1 Diagram of Kunlun coal mine gob water outburst accident

arranged three places for 103 downhill (province agreed to resume the assessment group all acceptance trial production bases), 2 layer coal south drift 202 uphill, 202 maser downhill. Water occurred in 202 south drift uphill advance head. The head began in April 2003, before the accident, the roadway has been heading 67.5 meters. This section of the roadway left has 2 residual mining heads, right has 1 residual mining head, water bursting point in 202 uphill head-on. As shown in Fig. 1.

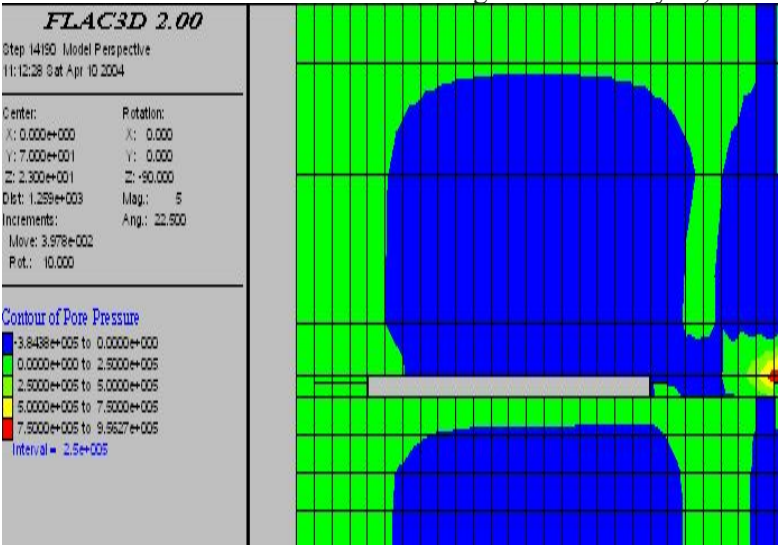
Fig. 2 The results of numerical simulation research

Zibo city had formed -200.1m - 137.2m, a large area of water for a long time in 1996-1998, and did not make the region hydrological analysis, enforce strict probe drainage system, Open 101 main roadway of downhill without authorization, reach outside the place of acceptance location to mining operations. South drift 202 uphill head mined to the edge of water area, the thickness of the coal and rock pillars insufficient, strength not enough. The study of the numerical simulation of Shandong university of science and technology experts indicated that the

distance between old gob water and coal wall only 7 m (Fig. 2 The results of the numerical simulation research), causing the water intrush because of the old gob water breaking through coal wall. Meanwhile, drawings painted not in time and accurate that was also one of the causes of the accident. The place of water intrush accident belonged to south drift 202 uphill coal roadway, interlinking with old gob water districts which located the south of 2 coal north drift 202 uphill, and the elevation of water intrush was 195.3 m. From the analysis of data and field survey,

the distance between a south roadway head marked on the original mining planar graph and 2 coal south drift 202 uphill head coal roadway was 60 m, but the reality was that the place was half coal and rock roadway on original drawing. The mine mined forward in the original half coal and rock roadway head, but the length of mining in front of head, tilt up and down mining width, and others were not marked out on the drawings.

4. Strengthen the management of mine technology, especially paint the drawings in time, reflect the real mining activities, and provide the basis for safety production.

5. Adhere to the "there is doubt that will explore, first probe after digging" principle, do the job of prevention and control water effectively, make the drain plans for the mining area, old gob, and area of water threaten, and set up special
