Forensic Investigation of a Breakdown Waste Water Pipeline off Penghu Islands, Taiwan

Abstract. The causes and mechanism inducing the breakdown and follow up displacement of an outflow pipeline off Penghu Islands, Taiwan was investigated. Based on the information illustrated in the high resolution side-scan sonar imagery, it was concluded that the breakdown of the pipeline was initiated by a large external pulling force. In addition, this pulling force dragged the breakdown pipeline westward with a net displacement of about 100 m. After the pulling force disappeared, environmental forces such as tidal currents interacted with the floating section of the breakdown pipeline caused a further and complex displacement pattern of the breakdown pipeline especially in the portion near the outlet. At the moment of this forensic investigation, the overall appearance of the breakdown pipeline illustrated an irregularly-shaped circle. Further displacement of the breakdown pipeline in accordance with sea states is highly expected.

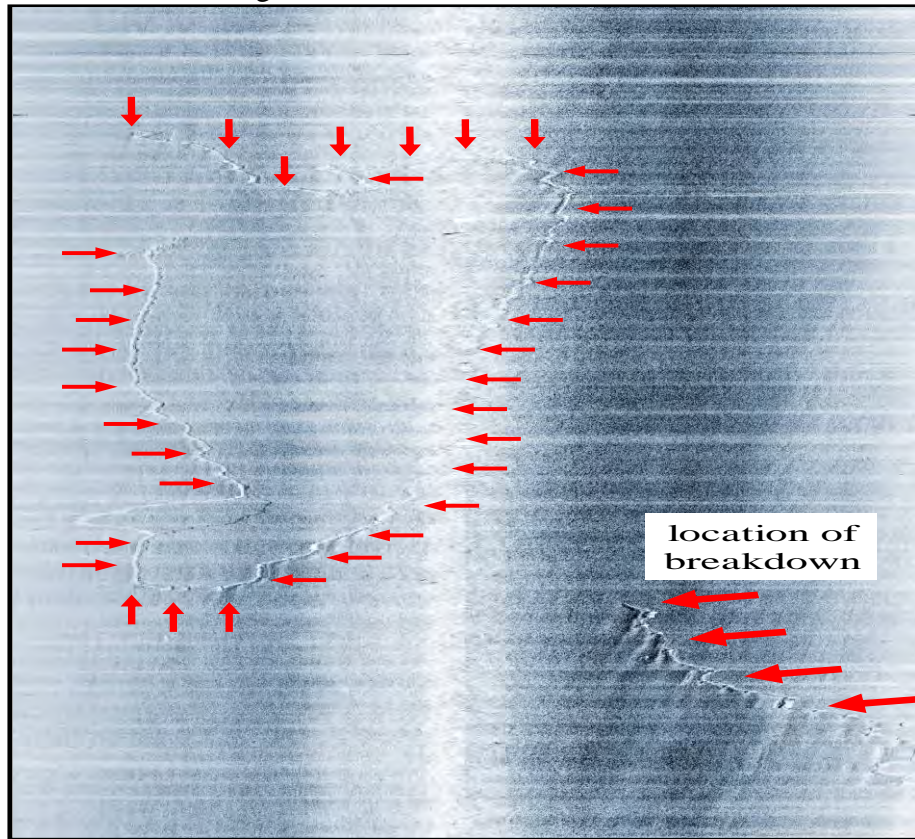
The breakdown pipeline, with total length of 500 m and overall appearance of an irregularly-shaped circle, was located at a minimum distance of 50 m to the north-western direction of the initially recorded breakdown point (Fig. 1 & Fig.2). Both ends of the breakout pipeline (i.e., breakout point and outlet) were located at the north-western corner of the circle area. Concrete loading blocks were intact and regularly distributed along the pipeline.

Fig. 1 Side-scan Sonar Imagery of the Breakdown Pipeline which Illustrated an Irregularly-shaped Circle. Red Arrow Indicates the Location of the Concrete Loading Block

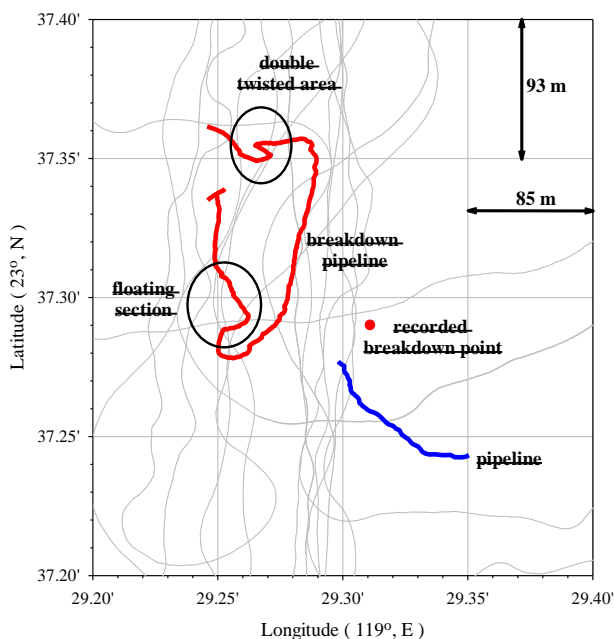
Fig. 2 Geographic Location and Overall Appearance of the Breakdown Pipeline

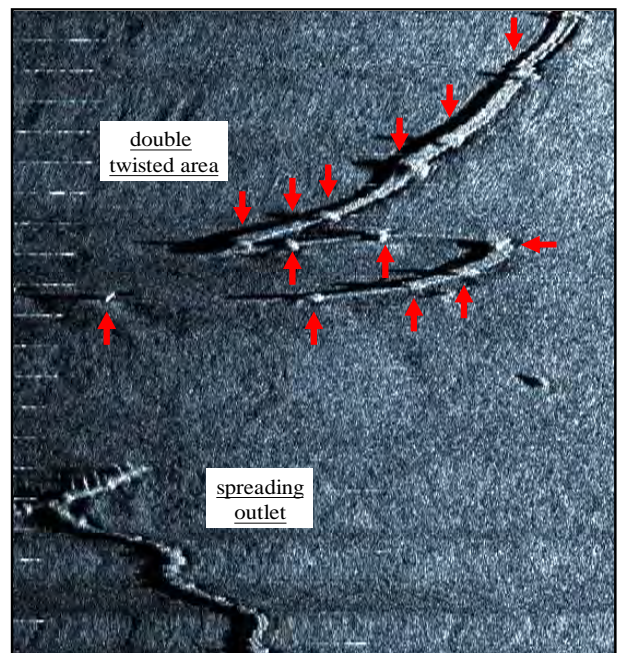
Two prominent features were detected along the breakout pipeline which included a double twisted area with extraordinary sharp angle (Fig. 3) and a section of pipeline floated off the seafloor (Fig. 4 & Fig.

5). The double twisted pipeline area is located close to the breakdown point and the straight line distance in between is about 70 m. On the other hand, the floating pipeline area is located close to the outlet and the minimum straight line distance in between is about 80 m. The section of the floated pipeline, where at least 10 evenly spaced concrete loading blocks were identified, extended approximately 30 m horizontally and the maximum height off the seafloor is about 8.5 m.

Fig. 3 Double Twisted Pipeline Area with Sharp Angle

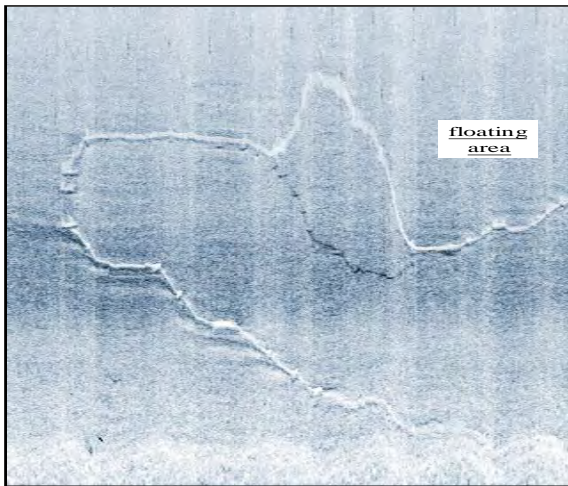
Fig. 4 Section of the Pipeline Floated off the Seafloor-1

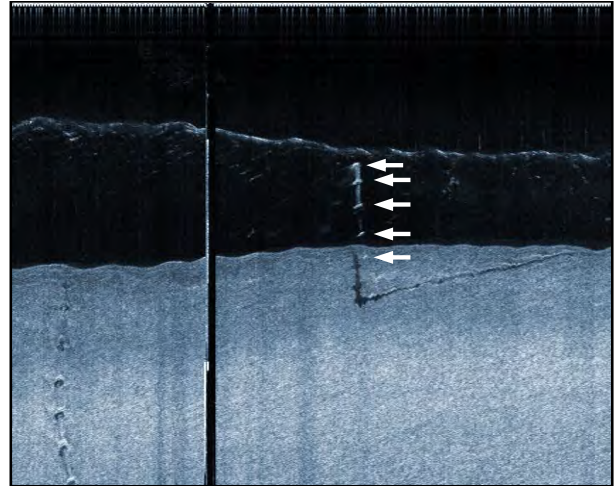
Fig. 5 Section of the pipeline floated off the Seafloor-2
