Analysis on the Causes of the Erecting Fault - Wide Concrete Continuous Bridge by Short Line Method

Abstract. This paper based on Quanzhou bay cross-sea bridge. Quanzhou Bay Bridge Northern Approach, width 20m, was erected with the "T" structure cantilever assembly method. "T" configuration closure may occur Faulting phenomena. Analysts predict that the weight of precast segments, inelastic deformation of segments, pier top block mounting accuracy, wiping glue thickness between segments of the cantilever beam greatly affected the maximum elevation. In addition, temperature effect, the main beam material properties, asymmetric temporary load also have some impact on the maximum cantilever state. Effective measures should be taken to eliminate the error.

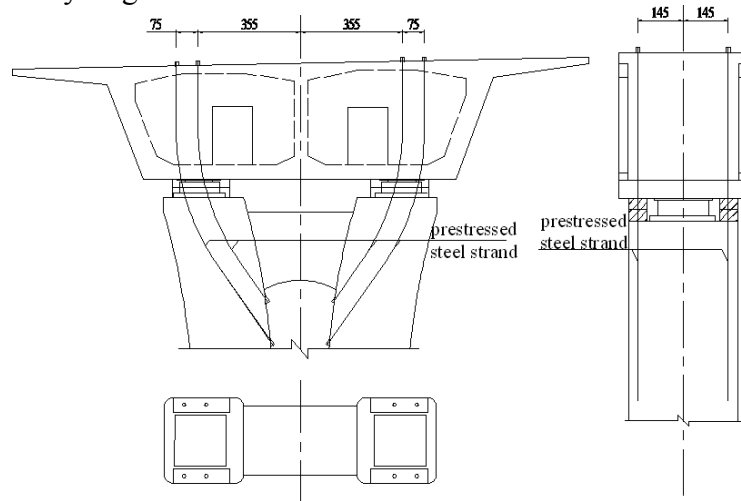
Fig. 5 Pier Top Block Anchorage

To install a "T" configuration, firstly we need to install the pier top block, accurate positioning was adopted, then the tendons and other measures will be used to fix the top pier block (Fig.5). In the adjusting of the elevation of the top block pier, for various reasons, the final outcome and the theoretical requirement makes some difference. Subsequent segments of the installation, are affected by matching to the pier top block. It is assumed that after the top of the pier blocks properly installed, the axial direction of the front and rear elevation measuring point error of 1mm (Fig.6), measured pitch pier center 1.45m, bridge span 70m, "T" configuration closure wet seam 20cm, so the cantilever elevation deviation caused by pier top block with the theoretical difference is:

$$\Delta H1=1\text{mm}\times 34.9/1.45=24.07\text{mm} \quad (1)$$

Due to precision of measuring instruments and harsh winds environmental impact, pier top block construction accuracy of 1mm error is very common, so pier top block deviation on T largest the cantilever structure is very large elevation.

- (3) In the installation stage, the top pier block error should be minimized as much as possible;
- (4) The glue must be uniform;
- (5) Temporary load should be symmetrical on the top of the block and close to the pier top block.

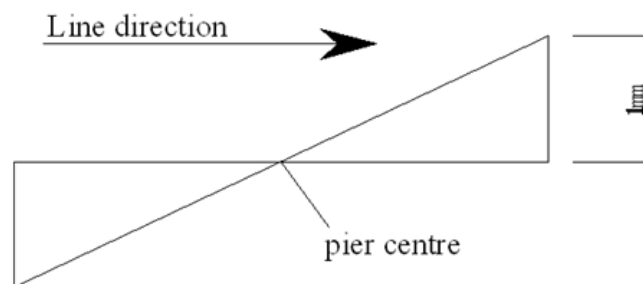
Fig. 6 Pier Top Block Displacement

Table 1 shows the comparison of the Pier block of Qanzhou Bay bridge, where the secondary cast is top block horizontal beam pier pouring. 1, 3, 2, 4, respectively, are the front and rear points. As can be seen from the table, after the overall elevation, error of the front and rear points elevation measurement point in the secondary cast (not the subsequent segments installed) is 2mm (as shown in Table 1), which consistent with the above calculation analysis of the situation. In addition, top of the block overall elevation or reduce would impact the maximum height of the cantilever end the "T" structure little, and this article will not take particularly calculation.

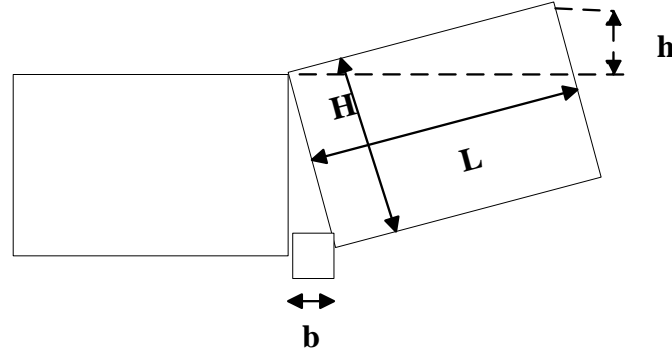
Fig.7 Calculation Principle of Elevation Changes

During the Construction monitoring process, it is found that the construction site generally use artificial means to wipe glue, so that the thickness id inevitably uneven (Fig.7); temporary tensioned prestressed sync will also cause uneven glue on thickness.

Suppose, in extreme cases, from the top block to the maximum cantilever 10 # block, thickness of the glue between all segments of is uneven, and the thickness of the higher edge is thicker than the lower edge for 1 mm, then the elevation error of the largest cantilever end is:

$$\Delta H_2 = (33.1 + 30.3 + 27.2 + 24.1 + 21 + 17.5 + 14 + 10.5 + 7 + 3.5) \times 1 \text{ mm} / 3.4 = 55.3 \text{ mm} \quad (2)$$

Because this study is considering the most extreme cases, the elevation error caused by uneven thickness of plastic will not up to the calculation of 55mm. Uniform glue thickness affects only the beam length, which is part of the error can usually be offset by considering the beam in precast segmental shortening and wet seams have enough surplus amount to eliminate some errors of beam length, so this article does not consider it.

As in Figure 6, an epoxy resin between the top or bottom edge of the two sections based on the formula (3) and (4) to adjust the elevation. If the prediction error of the elevation is positive, then add gasket at the upper edge; prestressed tension order adjustment may also make sense.

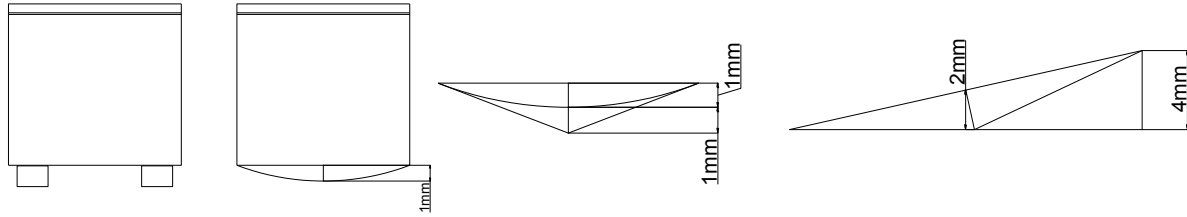
Fig. 8 Non-elastic Deformation

After precasting beams on the prefabricating pedestal, the stock was moved to the pedestal to place when concrete strength got a certain value, generally is about 1 to 2 days from pouring concrete to move to keep beams pedestal; for various reasons beams keeping time is too short, or winter conservation is not proper, resulting in a certain deflection along the bridge , some of which caused by shrinkage and creep which is unrecoverable deformation. Site measurement showed an

upward growth trend of error.

Block 1# is now assumed that the central non-elastic deformation is 1mm (Fig.8), since the deformation occurs with respect to the segment length is very small, it can happen that the upturned end sections of 4mm, the maximum error occurs in the cantilever end is:

$$\Delta H_2 = -4\text{mm} \times 33.1/2.8 = -46.7\text{mm} \quad (5)$$

Extreme conditions were considered in this study, 1# block inelastic deformation, the deformation of the segments on the maximum cantilever end elevation impact is very large by calculation, if this situation occurs to several segments, the elevation error will increases rapidly, and difficult to control.

- (1) In the precast stage, instruction should be adjusted to eliminate the error; pouring concrete should use properly conservation, especially in cold seasons, and sufficient strength should be assured before moving to keep beam area. When the template is deformed, recalibrated immediately to eliminate distortion;
- (2) Shall the beam-keep pedestal flat, all the force required to support in a same plane;
