## Leakage Causes Analysis on a Boiler Enclosure Wall Superheater

**Abstract.** The leakage reasons for a boiler enclosure wall superheater were discussed based on experimental results of macro fracture observation, chemical composition analysis, metallurgical microstructure examination, SEM and EDS analysis. It was presumed that weld flaw firstly formed due to large weld process parameters, then propagated under long period fatigue stress and developed to penetrated crack, leading to final leakage. It was suggested that boiler supervision and four-tube inspection should be enhanced.

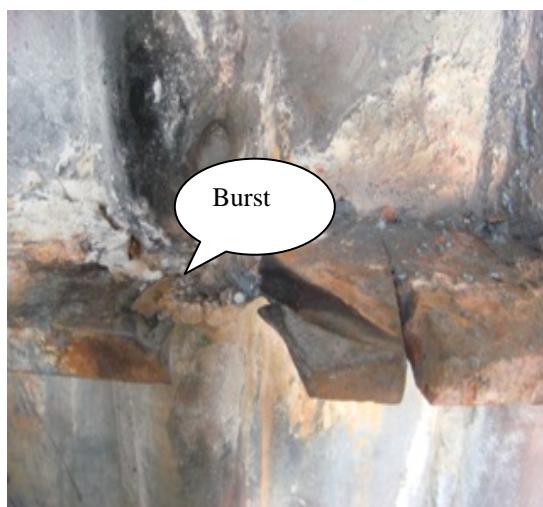
The macro photograph at the leakage position of the failure tube was given in Fig.1.

Fig.1 The macro photograph at the leakage position of the failure tube

Based on macro observation result, the burst located at the weld of supporting brick plate, where was prone to form stress concentration due to temperature change for unit starting, stopping and load increasing or decreasing[5]. In addition, it was suggested that tube was hurt and induced weld defect because of overlarge welding process parameters. Under conditions of both weld defect and thermal stress, the defect propagated due to long time converted stress, became penetrating defect and finally led to tube leakage.

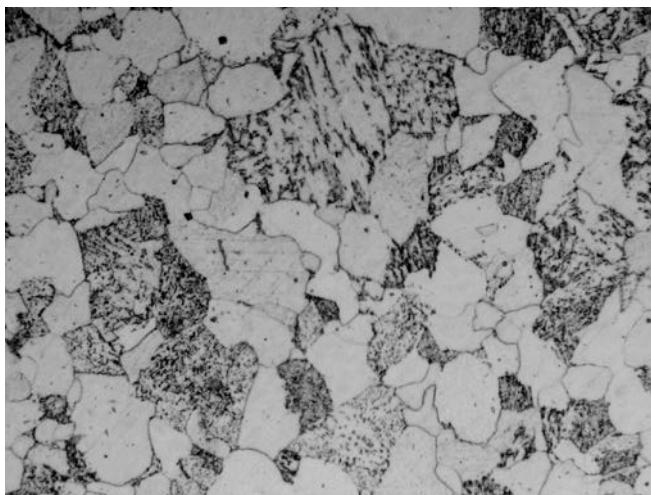
Fig.2 Metallurgical microstructure of the failure wall enclosure tube

From Fig.2 it was concluded that the tube exhibited microstructure of ferrite and pearlite with degree 2.5 of nodulizing grade, meaning no abnormal phenomenon.

Results of chemical composition of the enclosure wall tube met with the requirements of relative standard, and its metallurgical microstructure as ferrite and pearlite with degree 3 nodulizing grade was normal. EDS indicated certain quantity of sulfur existing on the tube surface at its leakage position.

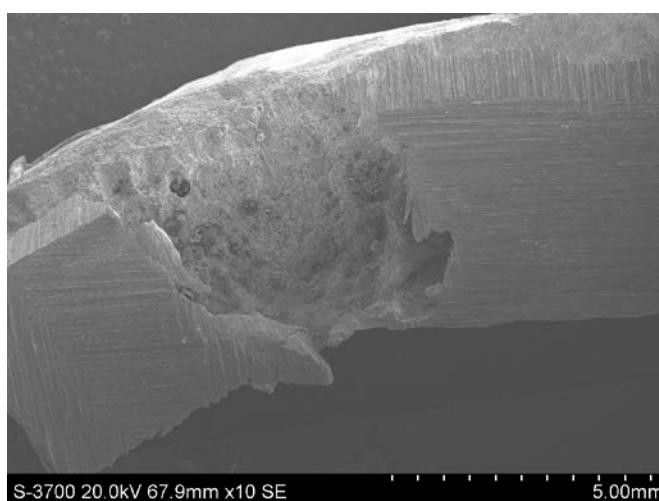
Further observation on the tube leakage position was shown in Fig.2 and Fig.3. The leakage morphology suggested that there maybe existed weld defects such as pinhole, blowhole.

Samples were taken at the leakage position and surface morphology was observed by way of SEM. The SEM photo of the tube leakage position was illustrated in Fig.3. It was found there existed sign of drifting from inside to outside.

Fig.3 SEM morphology at the leakage position of the wall enclosure tube

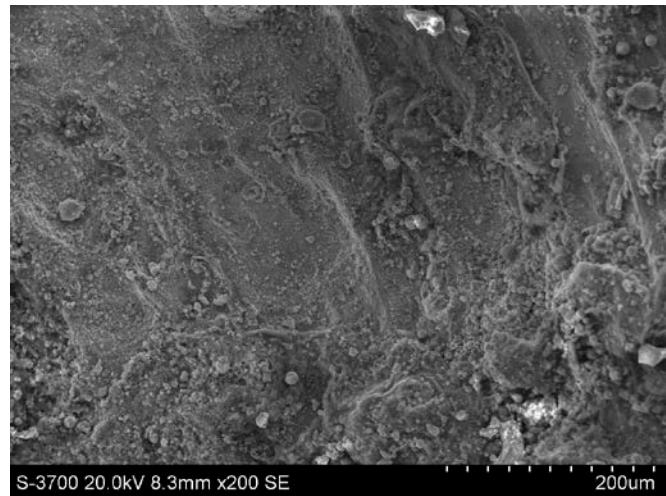
The surface chemical composition was analyzed by EDS, the morphology of the examined area was shown in Fig.4. It could be seen that corrosion products covered the tube surface.

Fig.4 SEM morphology of examined surface of the failure tube

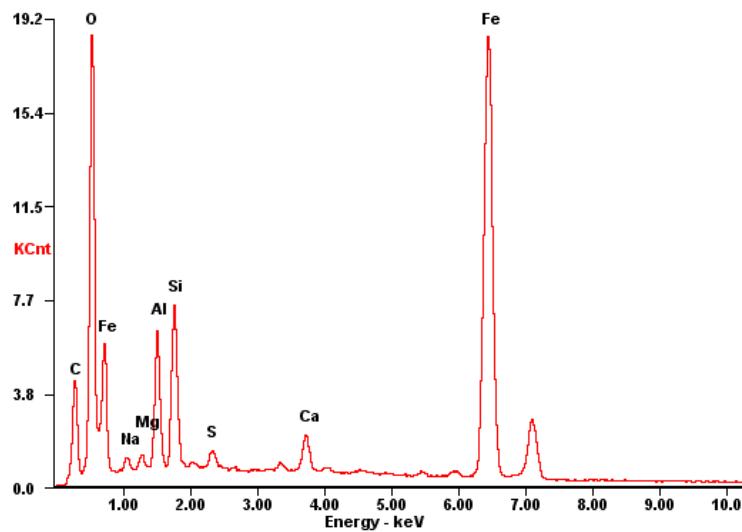
The EDS spectrum diagram and semi-quantity analysis of the examined surface were given in Fig.5 indicating a quantity of sulfur about 0.72% existed in the leakage position.

Fig.5 The EDS diagram of the examined tube surface

Although there was sulfur containing on the tube surface at the leakage position, its low quantity suggested that was because of sintering products deposition.
