## Mechanism Analysis of Hydrogen Blisters on the Surface of a Gas Tank and Research on Its Preventive Measures

**Abstract.** Serious blisters were found on the shell surface of the gas tank which operated in wet H<sub>2</sub>S environment during a regular inspection. Gas sampling device was used to determine that the gas in the blister is hydrogen. The causes of blisters were analyzed and investigated by means of chemical analysis, metallographic examines, scanning electron microscopy (SEM) and energy dispersive spectroscopy (EDS). The results revealed that the elongated MnS inclusions are the important reason for the hydrogen blisters. The preventive measures of the hydrogen blisters are put forward based on the above study.

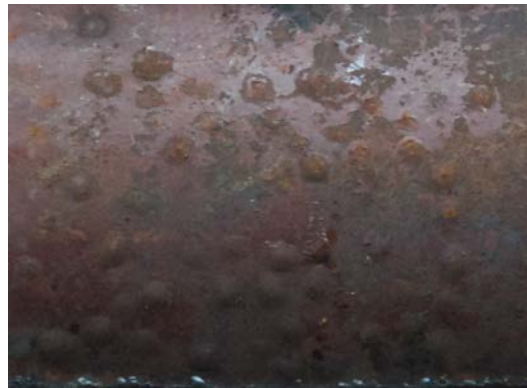
As shown in Fig.1, the blisters which have different sizes and drum convex degree are distributed in the tube wall. All blisters defects occurred in the cylinder of 360°circumference. Some blisters have led to cracks under the gas pressure. And the depth range of blisters is large and there may be a

lot of internal delamination defects. These are dangerous potentially to the safe operation of the equipment.

Fig.1 The macroscopic figure of blisters

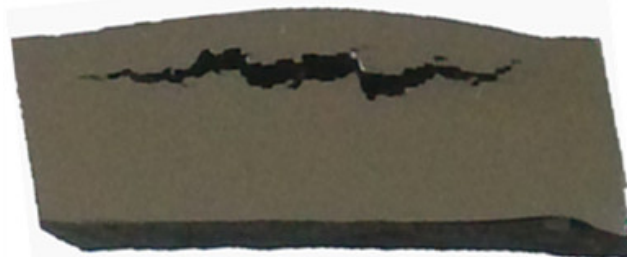
**The Fracture Test of the Blister.** Fig.3 shows the section morphology of the hydrogen blister which is cut along the center of the hydrogen blister. By measurement, the convex thickness of hydrogen blister is 8 to 10mm and the diameter is about 20mm. The blister appears at the outside surface of the shell and the initiated position depends on the non-metallic inclusions on this areas.

Fig.3 The section morphology of the hydrogen blister

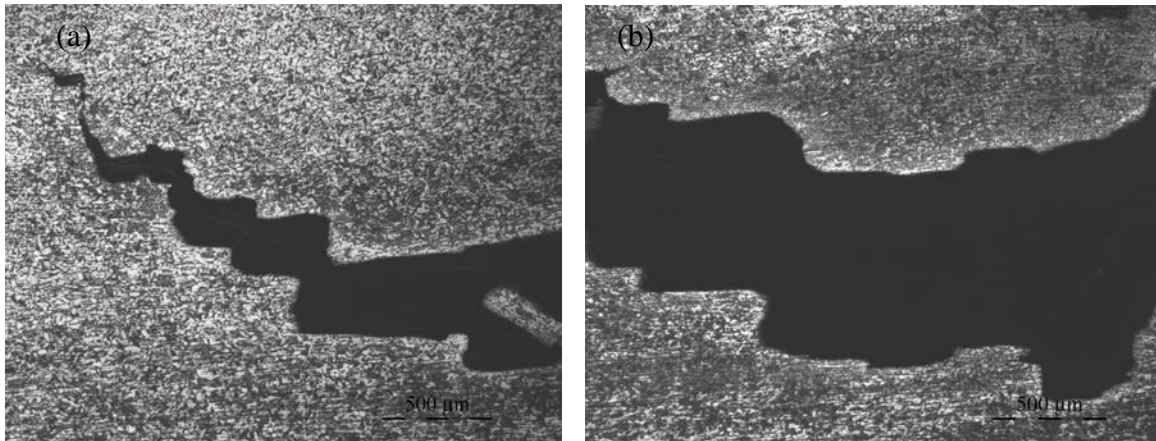
Fig.4 shows the morphology of the hydrogen blister. The edge of the cracks is jagged and the edge surface is uneven. It's obvious that the plastic deformation was happened in the material and the crack tip was torn off obviously under high pressure.

Fig.4 Blister morphology(a)Morphology of crack tip(b) Jagged stratification

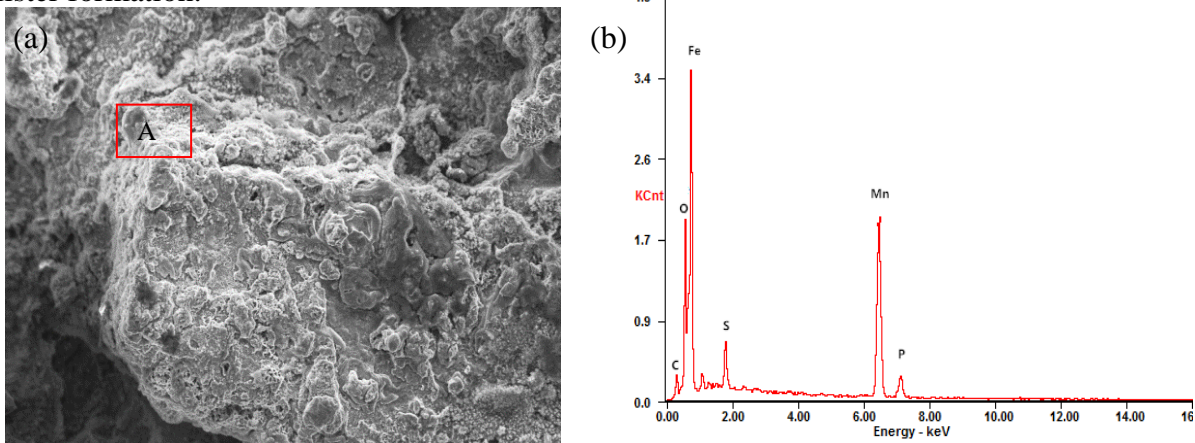
The interface of hydrogen blister was torn off artificially. Fig.5 (a) shows the fracture surface of a broken blister where the point A is the initiation site of the blister and the hydrogen induced crack propagates radially from the initiation site, resulting in a quasi-cleavage fracture on the initiation site. In order to identify the mechanism of the initiation site of the blister, the point A was examined by energy dispersive spectroscopy (EDS). Fig.5 (b) shows the EDS mapping of the initiation site, and the results showed that the main composition in point A is element O, Fe, Mn, S, P and so on. Then it was found that hydrogen blisters or hydrogen induced cracking could be correlated with the MnS inclusions and FeO inclusions as well. The defects concentration around the elongated MnS inclusions far outweighs the matrix, which provide the bases for hydrogen absorption, aggregation and blister formation.

Fig.5 Surface morphology of a hydrogen blister (a) Macroscopically fracture of the blister, point A is the initiation site; (b) EDS of site A

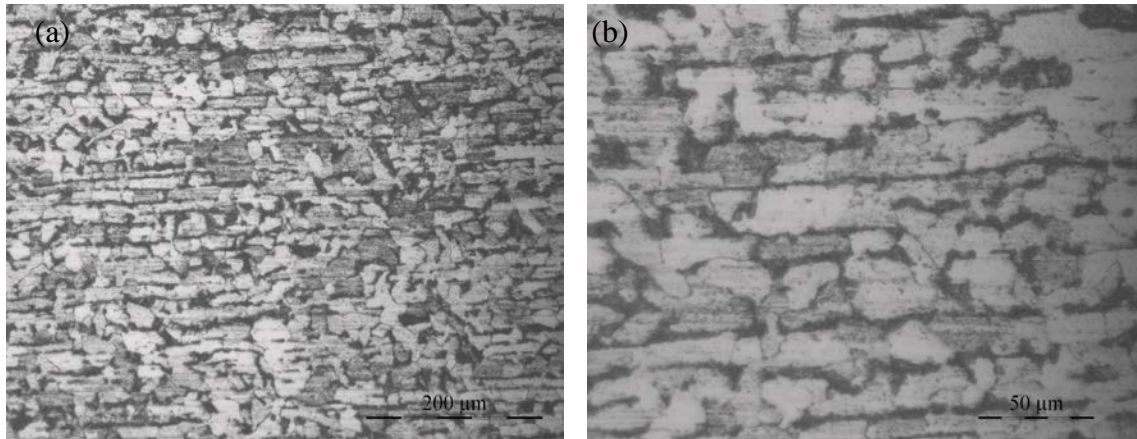
**Microstructure Analysis.** Sampled from the shell surface, the specimens were ground with silica and mesh number 1200 in a grinding machine, then polished processing, and etched by 4% nitric acid alcohol solution. After etching, samples were observed under the electron microscope. As shown in Fig.6, the microstructure is ferrite + pearlite, and there are a large number of elongated inclusions. According to the characteristics of the chemical composition of steel and inclusions, the inclusions are MnS. It can be seen from the diagram, the elongated MnS inclusions were distributed along pearlite, the inclusions embedded in the matrix and formed inclusion/matrix interface. These can weaken the bonding force between the metal atoms.

Fig.6 Microstructure (a) The elongated MnS inclusions (200X) (b) Magnification of the MnS inclusions (500X)

**The Causes of Hydrogen Blisters.** According to the above comprehensive analysis, there are many causes which induced the hydrogen blister. However, there are mainly two aspects: the steel plate material and the medium. Because the contents of S and P in the steel exceed standard and there are many MnS inclusions in the steel, which are the main reasons for the formation of the hydrogen blisters. However, hydrogen sulfide and aqueous solution are the medium conditions for forming hydrogen blister.

They are chemical inclusion shape control (Ca, or rare earth treatment) and /or the production of steels with extra low sulphur (lower than 0.002%).

Using protective coating on the surface of a container to prevent hydrogen atoms from diffusing into the steel.
