## Failure Analysis of Fixed Frame Screw for a B-Phase Spindle of Breaker

**Abstract.** The fracture causes of fixed frame bolt for a B-phase spindle of breakers were discussed based on results of macroscopic inspection, chemical composition analysis, metallurgical microstructure examination, SEM fracture analysis. It was concluded that the screw deformed and cracked under shock load. Suggestions were provided in order to prevent similar accident.

During acceptance monitoring of a transmission and distribution project, two fixed frame screws for B-phase spindle of breaker of a 220kV composite apparatus were found to fracture. The failure causes were discussed in this paper and suggestions were provided.

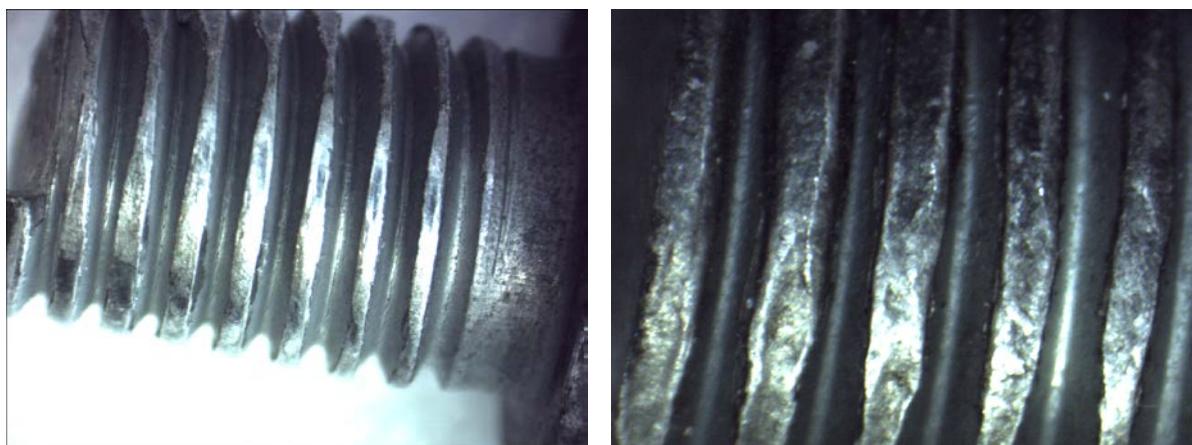
**Macro inspection of the fractured screw.** The macro morphology of the fractured screw was shown in Fig.1. It could be seen that the thread tips at the root were damaged severely with about 15mm in length, not surrounded the entire circle, and somewhere remained well.

Fig.1 Damaged thread tips at the screw root Fig.2 Damage morphology on the thread surface

The damaged position was magnified for further observation indicated in Fig.2. From Fig.2 it could be found that the surface abrasion were not caused by rotating operation but by blunt beating.

Combining the results of Fig.1 and Fig.2, the scratches on the screw were not induced during the installation process. They were presumed to form afterwards.

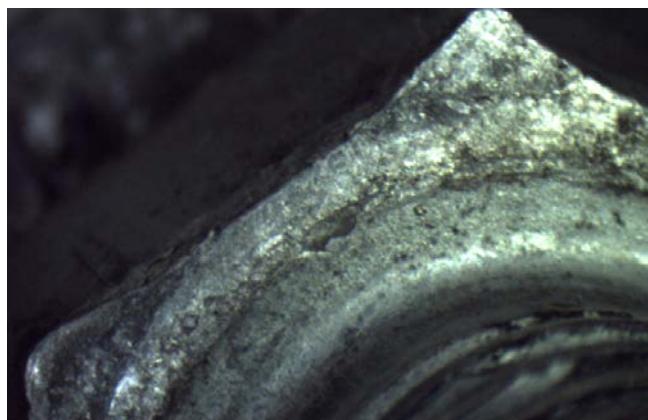
Fig.3 showed the condition of matching surface between screw and header. It illustrated serious squeezing traces. Whereas, of the hexagonal matching surfaces, only two surfaces in bilateral symmetry inhibited squeezing marks as indicated in Fig.4.

Fig.3 Damaged matching surface between screw and header

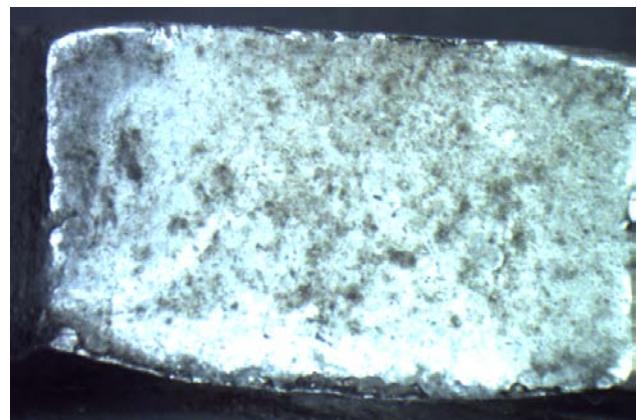
Fig.4 Squeezing traces in hexagonal matching surface matched to wrench

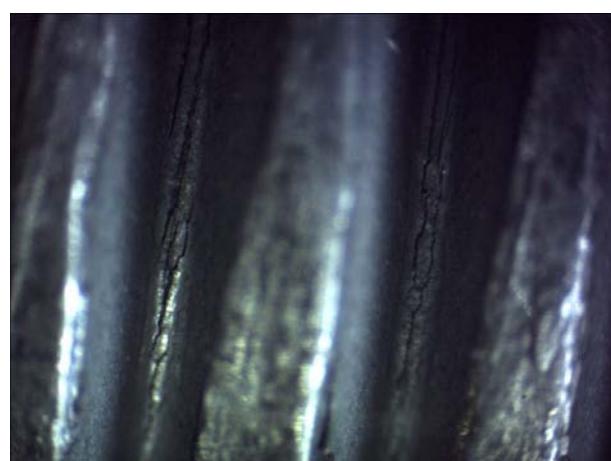
Further examination on screw root found that the zinc coating had cracked as shown in Fig.5, meaning that the screw happened plastic deformation. Magnification inspection found the crack did not propagate to base metal, therefore the zinc coating cracking was not the main cause of the screw failure.

Fig.5 Zinc coating crack at the screw root

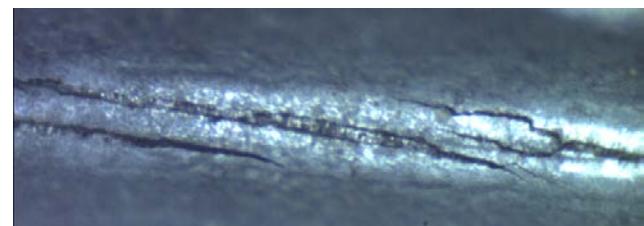
Fig.6 Zinc coating crack not propagating to base metal

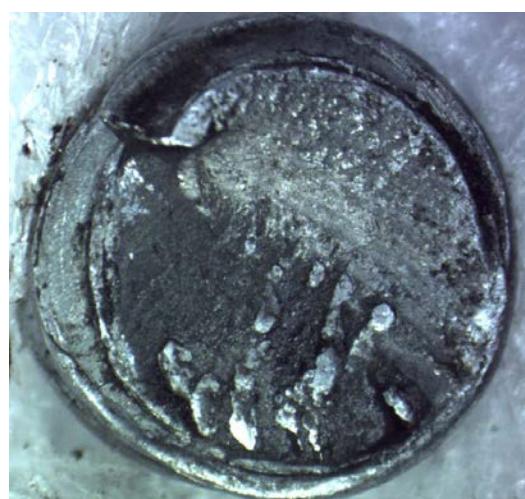
Finally, the screw fracture was observed and shown in Fig.7. It was found from Fig.7 that it contained two areas with different morphologies, flat area and waffle area. Both of them appeared gray color. In addition, the morphology of fracture surface denied the possibility of twist off.

Fig.7 Fracture morphology of the screw

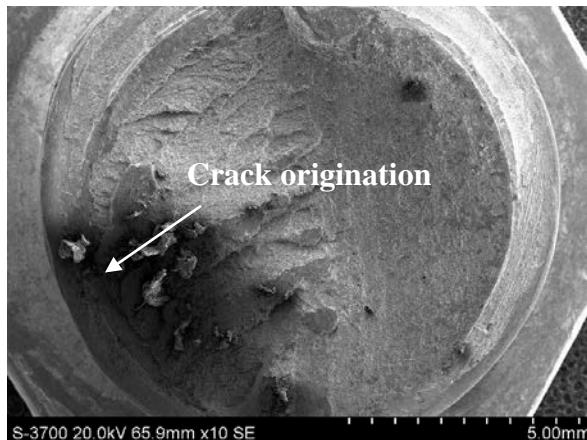
**SEM observation on the fractured screw.** SEM observation was carried out on the screw fracture. It was found that the crack originated from the screw root on the waffle side, and the origination area had been squeezed to flat as shown in Fig.8. Fig.9 was the SEM morphology of propagation area of screw crack. It could be seen that there existed many cleavage planes with small tearing ridges, meaning that the propagating rate was high. Fig.10 illustrated a lot of dimples in the area of final crack stage.

Fig.8 SEM morphology of the bolt fracture

Macro observation showed that the screw endured violent lateral forward impacts leading to deformation and damage at the root. According to the estimation of connecting dimension, the crack position was on the verge of screw hole of the fixed frame, where not only bore maximum stress under impact but also was stress concentration position. When the screw was impacted heavily, flaw

The failure of the screw was because that the screw deformed and relaxed under large impact stress and finally fractured. Many elements such as improper choose of dimension, inadequate strength and relax may lead to screw fracture. It was suggested that larger screw be chosen and tightly rotated.

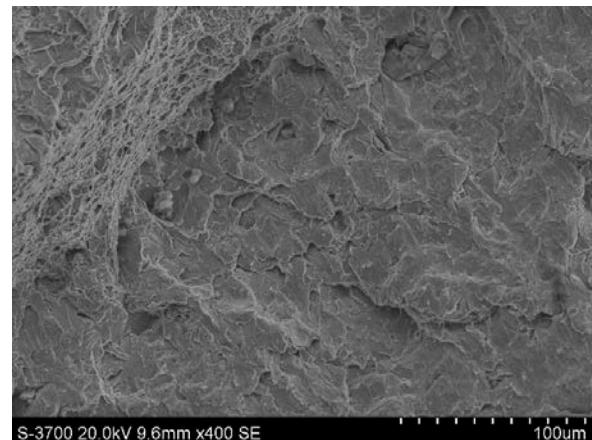
Fig.9 SEM morphology of crack propagation area

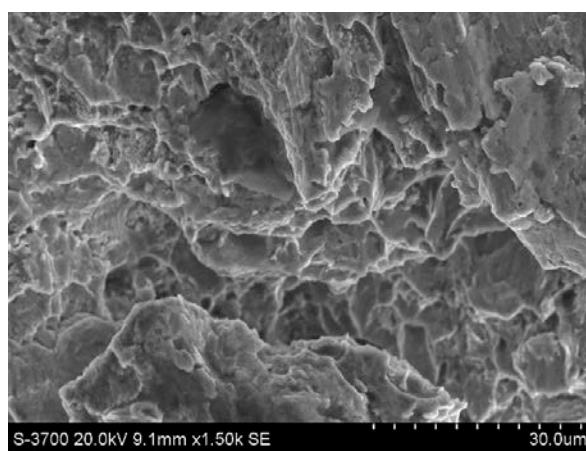
Fig.10 SEM morphology of the later stage of bolt cracking
