Analysis of 220kV Main Transformer Screens Dendritic Discharge Fault

Fushun Power Supply Company, Liaoning Electric Power Company Limited, State Grid, China,
fushunpowersupply@163.com

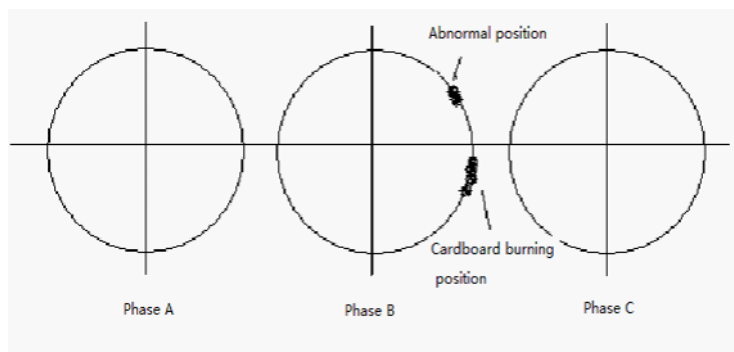
Opened the B phase high-voltage folding screen, the B phase to carry on the thorough inspection, found that the most layer of the cardboard, there are a large number of branches discharge one cardboard discharge severe burns. And cardboard 2 corresponding parts (bread from down to up for 5 to 10) coil block tip discharge traces, and wire and block Angle cable paper in black. The coil block point discharge plan sketch is shown in Figure 1; the coil position to screen mild discharge through the cushion block is shown in Figure 2; the insulating cardboard dendritic discharge is shown in Figure 3.

Figure 1 The coil block point discharge plan sketch

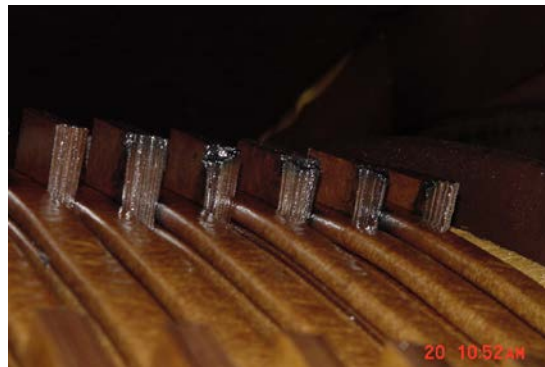
Figure 2 The coil position to screen mild discharge through the cushion block

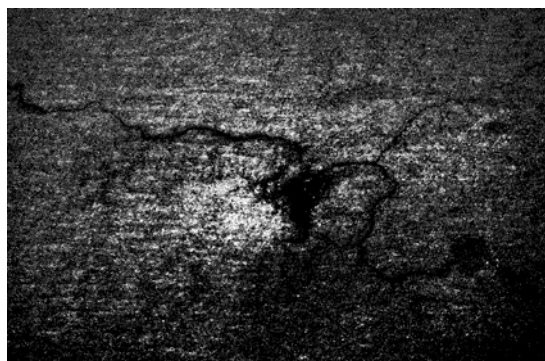
Figure 3 The insulating cardboard dendritic discharge
