Analysis of the Transformer Exceeding DC Resistance Unbalance Rate

Xu Jianguo, Pei Yujie, Wang Qinghao, Zhang Xiaoshu, Li Na, Li Bo, Liu Xiao, Huang Dongwei, Su Yang, Mou Ying, Jin Jing

Fushun Power Supply Company, Liaoning Electric Power Company Limited, State Grid, China,
fushunpowersupply@163.com

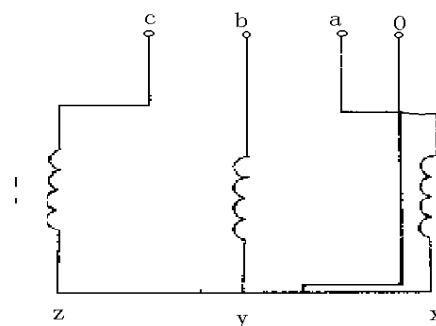
Figure 1 Transformer secondary lead wire structure diagram

From Table 1, because of the influence of the lead wire will cause unbalance rate exceed in the transformer winding. Combined with the report data of the factory test and according to the actual experience to judge the effect of lead wire resistance, the DC resistance of the transformer although exceed (the rules < 4%), but it can be put into operation. The transformer has been put into operation more than 2 years, without abnormalities. For the three-phase winding DC resistance are very similar in the transformer, both a and c phase winding DC resistance has been the biggest

influence of the lead wire, therefore, the unbalance rate easily to exceed[4, 5].

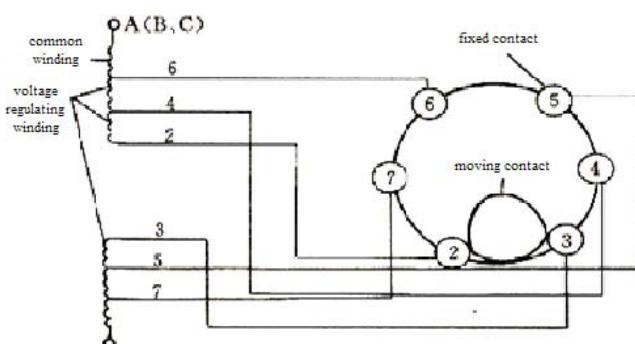
Figure 2 The tap switch connecting with the transformer winding

In the transformer insulation test, found that the high voltage winding DC resistance are serious imbalance, and the B phase DC resistance has a problem, since I - V gear value presented by big - small - less - more irregular arrangement, the test results are as shown in Table 5. Through analysis to consider that the B phase gear disorder, decided to inspection for cover lifting, when hanging the

cover lifting, the maintenance personnel will put in the switch connecting rod, it has no check nails and rotates freely. Then according to the correct position of the B phase adjust the tap switch, make the check nails keep off the block gear, measured the three-phase DC resistance are balance and meet the requirement of limit value. Test results are as shown in Table 6.

In order to eliminate tap switch finger refers to a shift of the position pointer caused by the DC resistance unbalance rate exceed, before the factory it should do the tap switch test, check whether the tap switch position is right. After maintenance the tap switch, it should also check.
