The Analysis of Marine Electrical Equipment Common Faults

Key words: Ship electrical;Insulation fault;ACB fault;Generator fault;

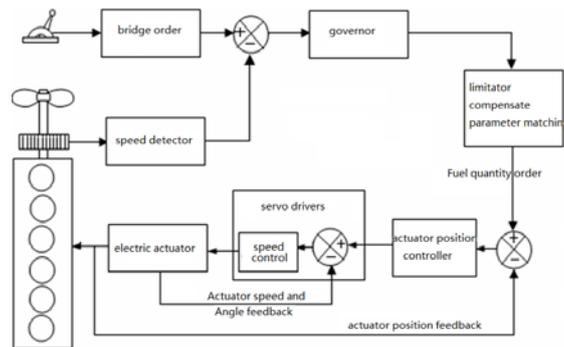
Fig.1 DGS8800e digital speed control system principle block diagram

A ship the governor actuator appears locked occasionally in the current position, the electronic governor for the wheel is the DGS8800e type, the system principle block diagram as shown in fig.1. The electronic governor in the work process if the rotational speed signal loss or error occurs actuator locked in the current position. DGS8800e electronic speed governor speed detecting part is composed of two groups of pulse pick-up speed detection unit which is installed on the front end of the flywheel, a group of run another group of backup. In the process of working if a group of fault system will automatically switch to another group of work, in order to ensure the normal operation of the main engine. Duty engineer found in the case of actuator locking fault and not action and alarm detection system switching speed appeared. So can eliminate the faults of speed sensor, speed sensor machine intermediate junction box and DGS8800 panel serial port connection of control room subsequent examination found no abnormalities. Because it is a sporadic fault unable to carry on the investigation, can only further observation in navigational watch process.

Do daily cleaning and maintenance of the main engine at a port in the main cabin found platform next to the cable bracket is provided with a cable insulation layer of serious wear and tear. The electric engineer to check to confirm that the cable is the main engine speed signal cable, basically can be identified governor actuator lock fault is thus insulation damage caused by the rotational speed signal interference and overrun, make the system that the rotational speed signal error which issued the lock actuator commands. The cable insulation has repaired, sailing in the process does not occur actuator locking phenomenon, explain the cause of the malfunction judgment is correct.

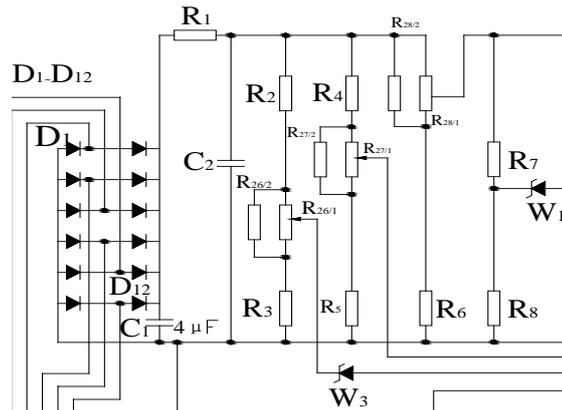
Fig.2 Electronic trip part line

The automatic air circuit breaker is used in generator being called the main switch. It abbreviate ACB. The No.2 generator ACB on a ship without warning repeatedly tripping, resulting in the whole ship loss of power, the main switching panel display abnormal trip alarm. After reset, the reclosing can run normally. But this has seriously affected the safe operation of the ship. Factors leading to the ACB tripping are overload, reverse power, external short circuit, loss or lower voltage and false tripping etc. Installation fault detecting instrument in the main switch panel, the voltage and the protection switch signal access, real-time monitoring and fault locking. Run a voyage, fault detecting instrument display second alarm, namely the ACB over-current protection action. According to the parameters of the running state of power plant did not happen the flow phenomena, determine the over-current protection trip should be false action. The following key check the ACB electronic release current detection and over-current triggering part, part of the circuit for the electronic release as shown in fig.2. Three phase current of the generator through a current mutual inductor test, the D₁-D₁₂ diode rectifier, followed by C₁, C₂, R₁ filter, through three groups of

parallel divider will change the current signal generator with proportional to the DC voltage signal. For an instant super short circuit protection signal detection via R_2 , $R_{26/1}$, $R_{26/2}$, R_3 partial voltage; second via the R_4 , $R_{27/1}$, $R_{27/2}$, R_5 partial voltage of short-circuit short delay protection signal detection; third via the $R_{28/1}$, $R_{28/2}$, R_6 partial voltage of overload long-time delay signal detection. Each detection signal by a diode connected to the output consists of a single junction transistor and thyristor control circuit, when to trigger action value output circuit to control the loss of voltage coil power loss so as to realize the protection action. The inspection found the over-current triggering part divider resistor $R_{28/1}$ breakdown cause over-current triggering voltage higher than normal, thereby causing the switch with part load after overload trip. Replacement of the resistance, and run a few post voyage without malfunction trip phenomena, troubleshooting.
