Failure Analysis of Stainless Steel Bolt

Abstract. Two stainless steel bolts of the motor components assembly fractured after serving for eight hours. The fracture feature and cause of the bolt were analyzed by appearance observation, micro and macro observation on fracture surfaces, metallographic examination, hardness testing. The results show that the fracture mode of the bolts is hydrogen brittleness fracture. The high intensity and biggish assembly stress led to the hydrogen brittleness fracture of the bolt. Meanwhile, there is a lack of dehydrogenation disposal after inactivating technology in the entire technological process. It is proposed that the intensity should be in the range of criterion requirements, and the dehydrogenation disposal should be disposed after passivation technology according to standard. What's more, the assembly stress should be controlled strictly to avoid early stage damage of bolt.

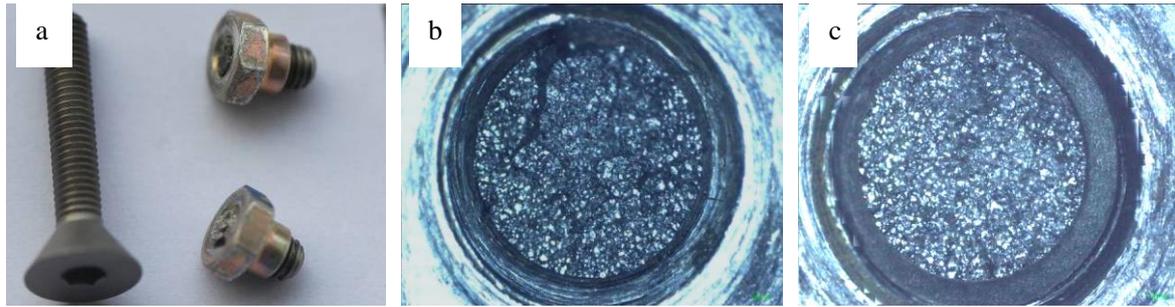
The bolts appearance and fracture surface macroscopic morphologies were shown in Fig.1.

For describe simply, the two failed bolts classed as bolt A and B. The same batch bolt classed as bolt C. The fracture position initiated at the intersection of the bolt and the net. The fracture surface was flat and crystal granular, and presented obvious reflecting small facets. No obvious plastic yield was seen at the region.

Fig.1 Appearance and macro-morphology of the fracture surface of the failed bolts
 (a) Appearance and fracture position of the bolt; (b) Macro-morphology of the fracture surface of the failed bolt A; (c) Macro-morphology of the fracture surface of the failed bolt B

In order to enhance the application reliability of bolts and to prevent re-occurrence of such failure, it is suggested that the intensity should be in the range of criterion requirements, and the dehydrogenation disposal should be disposed after passivation technology according to standard. What's more, the assembly stress should be controlled strictly to avoid early stage damage of bolts.

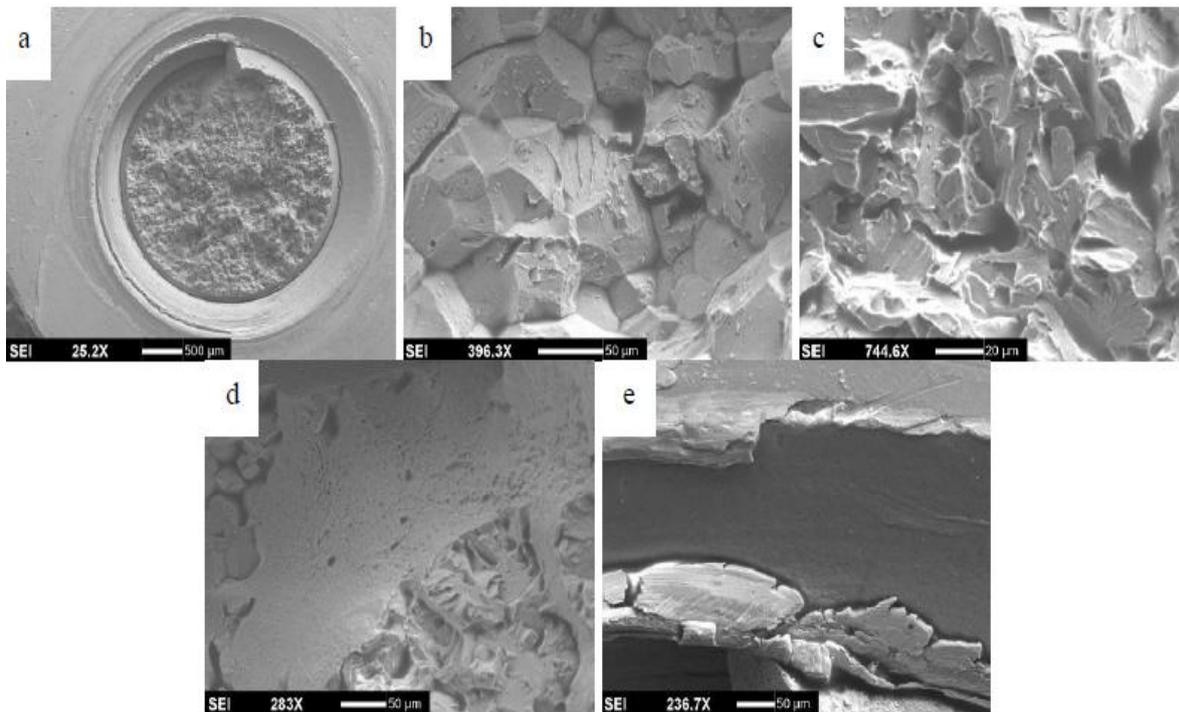
The microscopic morphologies of the fracture surface and the screw face of the failed bolt A were shown in Fig.2.

The fracture surface can be divided to three regions. Intergranular and tearing edges feature can be seen at zone 1. High-magnification appearance showed that quasi-cleavage at zone 2. Typical Dimples feature existed at the final fracture region(zone 3). Obvious extruding trace can be seen at the screw face.

Fig.2 SEM morphology of the fracture surface of the failed bolt A
 (a) Low-powered morphology of the fracture surface; (b) Intergranular feature of zone 1; (c) Quasi-cleavage feature of zone 2; (d) Dimples feature of zone 3; (e) Extrusion impression of screw surface

Furthermore, according to the obvious extruding trace at the screw face, it can be assumed that the assembly stress of bolts is biggish and may cause early stage damage. In addition, the fracture position initiated at the root radius of first screw, which had wider stress concentration and be propitious to hydrogenous diffuse. With the stress effect, hydrogen atomic which located at the lattice gap may diffuse to the position of stress concentration. When the dislocation lines were fixed, the basal body would become fragile, because of the interaction of the hydrogen atomic and dislocation [8].

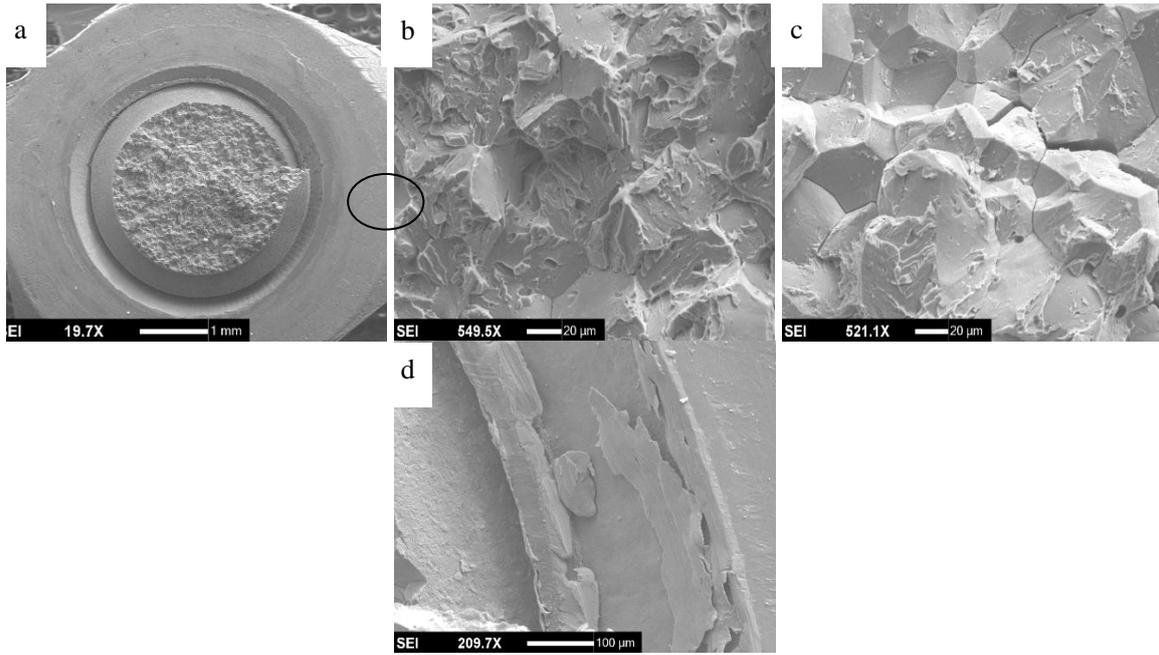
Fig.3 SEM morphology of the fracture surface of the failed bolt B

The microscopic morphologies of the fracture surface and the screw face of the failed bolt B were shown in Fig.3.

The fracture surface can be divided to two regions. High-magnification appearance showed that quasi-cleavage and small quantity dimples feature existed at the center region. Intergranular and tearing edges feature can be seen at the rest regions. Obvious extruding trace can be seen at the screw face.

(a)Low-powered morphology of the fracture surface; (b)Intergranular feature; (c)Quasi-cleavage and dimples feature of center; (d)Extrusion impression of screw surface

According to the intergranular and tearing edges character at the fracture surface, it can be assumed that the fracture mode of the bolts is hydrogen brittleness fracture. In addition, according to the quasi-cleavage and dimples at the fracture surface of the artificially broken bolt, the temper brittleness failure mode can be eliminated.

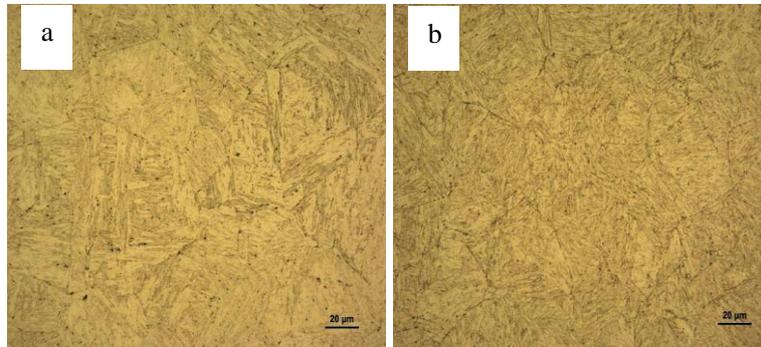
Fig.4 Metallographic microstructure of the bolts

Metallographic specimens perpendicular to the fracture surface of bolt A and bolt C were cut down. The results show that the microscopic structure of bolt A and bolt C are composed of martensite, shown in Fig.4.

(a) Metallographic microstructure of the failed bolt A; (b) Metallographic microstructure of the bolt C
