Failure Analysis of Internal Combustion Exhaust Valve

Yanpeng Feng^a, Haijun Tang, Chunguang Li, Xiaoming Ma and Mingli xie

China Academy of Civil Aviation Science and Technology,

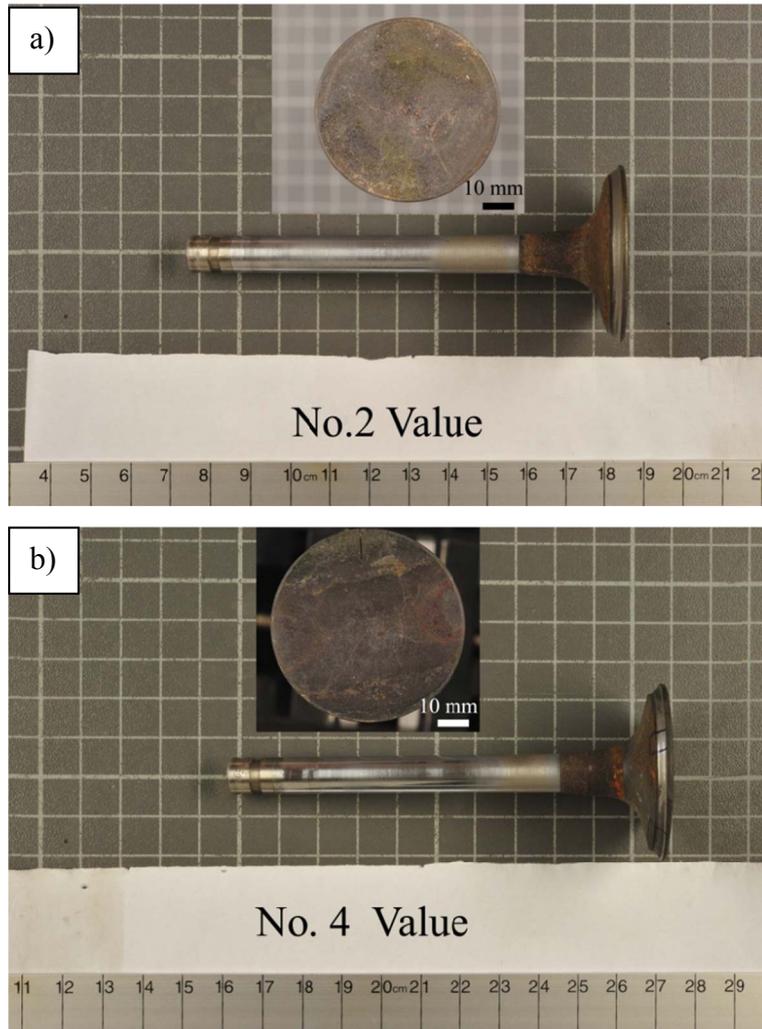
The base nomenclature used for exhaust valve is shown in Fig. 1, normally, exhaust valve include head, stem and seal face. During to valve train dynamic, seal face contact with seat under axial repeated loading. The failed exhaust valve are shown in Fig. 2(a and b), inside with corresponded head. Cracks initiated from the tapered plane and propagated toward head, which made the valve distortion and deformation.

Fig. 2 Photograph of failed exhaust valves, inside with corresponded head

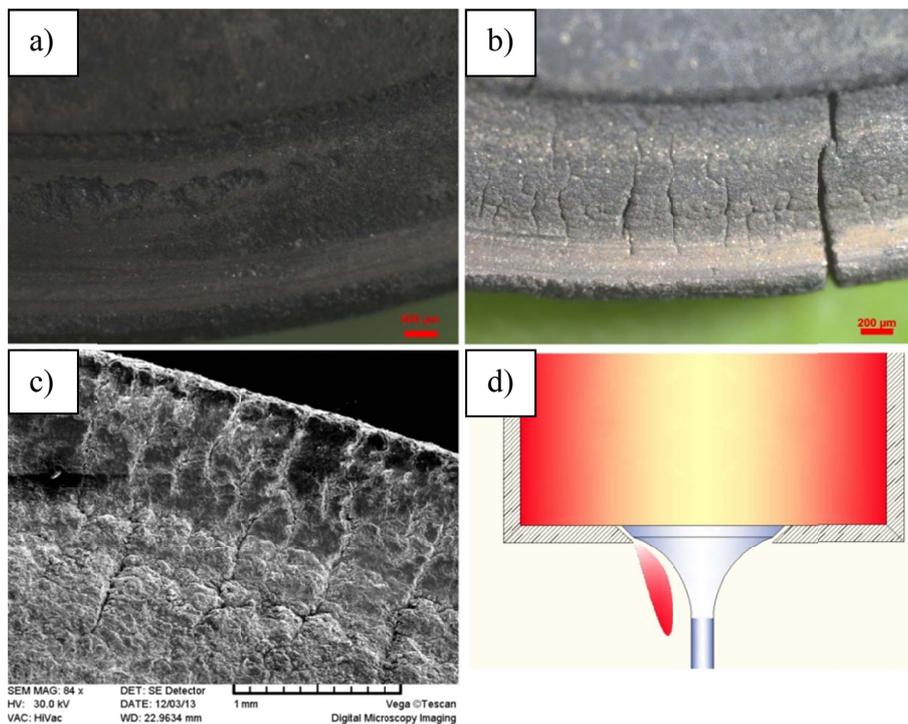
Microstructure photograph of failed valves are shown in Fig. 3. Some concave pits were formed on the seal face of No.2 valve, and cracks initiated and propagated along radical direction on the seal face of No.4 valve. Advanced investigation with Scanning electron microstructure (SEM) shows that, even in relatively flat surface of No.4 valve, many micro-cracks were found. And no scratches are found on the surface. During dynamic operation process of internal combustion engine, flaming gas with high temperature and un-burned fuel flow along the cracks, as gas welding cut the head of exhaust valve, along radical direction.

Cutting samples from head of failed valve, along with crack, and compared with new valve. It was found that the seal face of failed valve is wear-out form surface. And fracture face of crack show different color indicated that high temperature gas had flow and washing the crack. That was also proved by the microstructure of the fracture face, in accord with fig. 3d.

Fig. 3 Microstructure photograph of the seal face. a) No. 2 failed valve; b) No. 4 failed valve; c) Scanning electron microstructure of failed seal face; d) Schematic diagram of burning flame sour the seal face

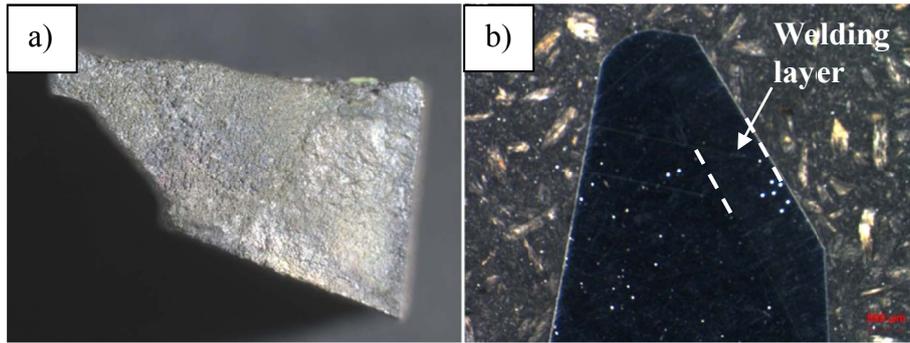
Cross section samples were carefully fabricated by cutting from the cracks along radical direction, and compared with new valve in fig 4a and fig 4b. Homogeneous microstructure and smooth seal face of the exhaust is found in the new valve. While significant depressed fracture is found in the welding layer along the seal surface, that mean seal face was wearing and dropped. Then, different color gradient change from seal surface to matrix may affected by the flame temperature's change that flow along the gap of crack.

Fig. 4 Cross section of valves, a) failed valve (No. 4) and b) new valve

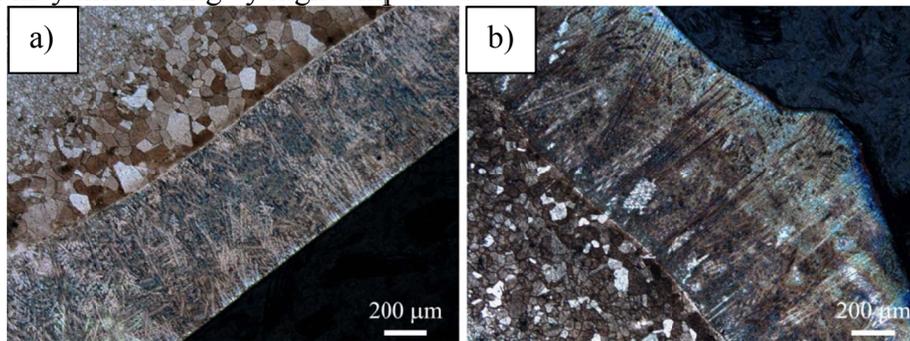
Metallographic sample were carefully cut from failed valve and new valve, and grinding with finishing papers, then polished, and etched with corresponding solution. The metallographic photographs are shown in fig. 5. Result show that surface of seal face is a weld hard face with stellite alloy, which is a cobalt chromium based alloy. And it is specifically designed for internal combustion valve, with high hardness and resistance to erosion and high temperature oxidation. Affected by the high temperature, the grain size of matrix materials is gradient change from deep to interface. Grain of welding layer with significant dendritic structure distribute from interface to surface, which may influencing by high temperature.

Fig. 5 Metallographic photograph of new valve and failed valve, a) new valve, b) failed valve

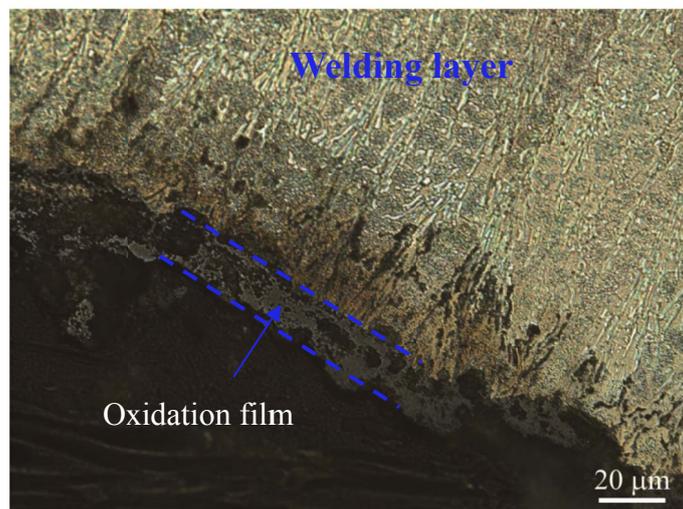
The microstructure of welding layer of failed valve is show in fig.6 on cross section. The outermost layer about 20 μm appears spotty and full of cavities. The layer is formed by the combustion process, from the original welding layer and combination of oxidation and residual of combustion. The matrix material nearby the surface with many cavities too, is eroded or oxidized along the flow lines.

Fig. 6 Metallographic photograph of welding layer (stellite alloy) of failed valve on polished cross section
