Corrosion Failure of Stainless Steel Tube during Storage

Abstract. Corrosion failure of the stainless steel tube was analyzed through the methods of field investigation, chemical composition and metallographic analysis, tensile test, surface morphology and micro elements analysis. The quality accords with the standard of ASTM A688, and the stainless steel tube corrosion was due to the storage in open air environment for long term. The pitting corrosion is caused by enrichment of chloride and sulfide and may also be caused by sulfide microbial corrosion.

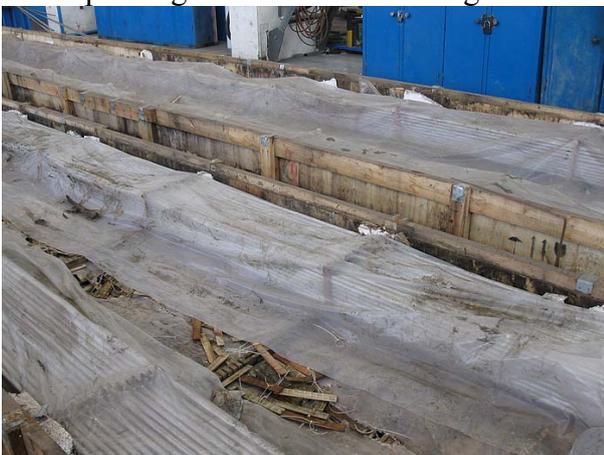
The field survey found that stainless steel tube and its packaging wooden boxes have been placed outdoor for about 6 ~ 7 months, which were experienced the rainy and hot summer. There was obvious sign of the water in the packing wooden cases which were moldy and rotten. Moldy and rotten packing cases are shown in fig.1.

Fig.1 Moldy and rotten packing cases of stainless steel tube

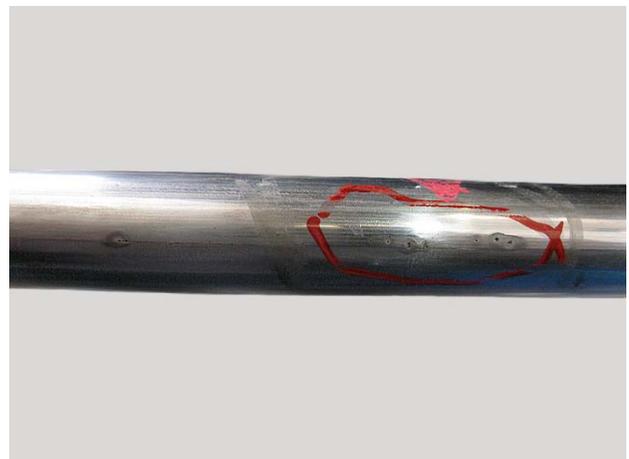
Fig.2 Corrosion pits of stainless steel tube

Some stainless steel tubes were taken out for inspection and some of them had corrosion pits. As shown in fig. 2, corrosion pits distribute randomly along the axial. Stainless steel tube material grades

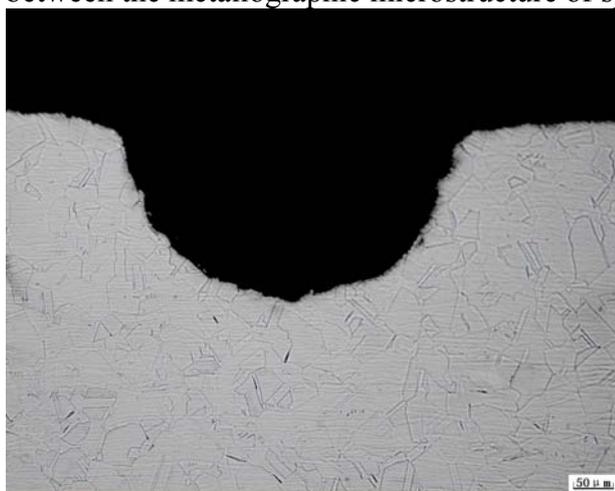
According to the literature [5], profile specimens sampling from the area where have and not have corrosion pits of the tube were observed under a microscope after the embedding and polishing. Metallographic microstructure of corrosion specimen is shown in fig.3, and metallographic microstructure of no corrosion specimen is shown in fig.4. Fig.3 indicates that the metallographic microstructure of the specimen is austenite. In addition to the corrosion defect, matrix of metallographic microstructure itself do not see obvious flaw. Fig.4 shows that metallographic microstructure of the corrosion profile specimen is also austenite, and no obvious difference is found between the metallographic microstructure of specimen which has corrosion pits.

Fig.3 Metallographic microstructure of corrosion specimen

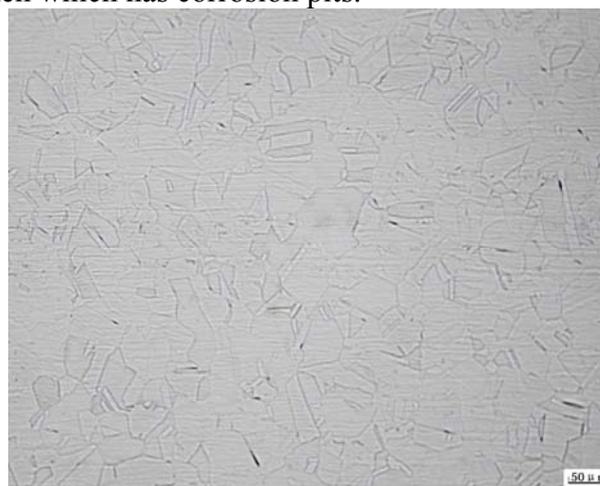
Fig.4 Metallographic microstructure of no corrosion specimen

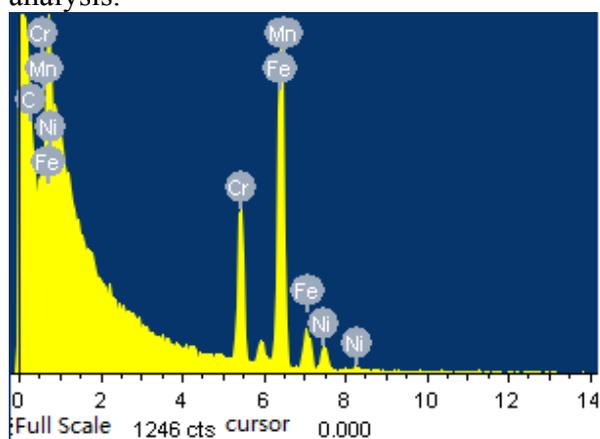
Fig.5 EDS analysis diagram of the no corrosion specimen

1. The content of the elements such as Cr, Ni in stainless steel is consistent with the results of chemical analysis.

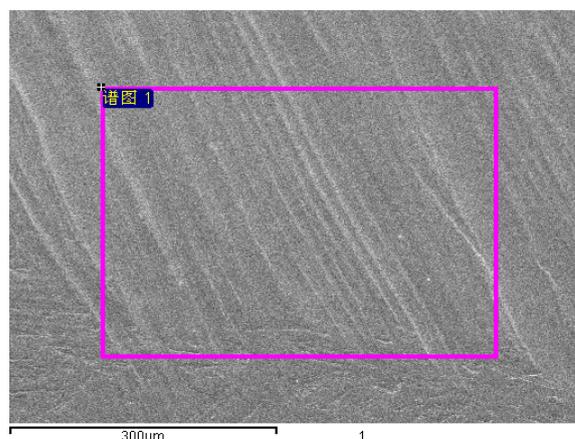
Fig.6 SEM images of the no corrosion specimen

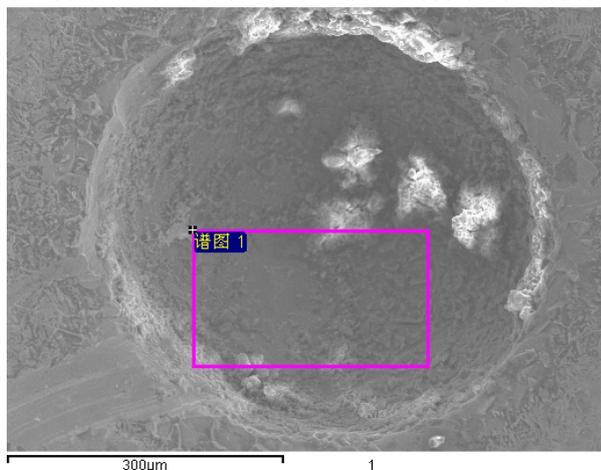
2. There is big difference between the elements content of stainless steel matrix and pits. In corrosion pits, there are many components which are not shown in stainless steel matrix. The components not only contain chloride, but also have a number of the S element. Cl and S can cause corrosion of stainless steel tube easily. In consideration of the bilging, mildewing and rotting of packaging wooden box, the existence of S element may also be induced by microbiologically corrosion of Sulfur. In addition, there are elements such as K and Ca which indicated salts existence. O element content is higher which is suggested the existence of oxide and oxygen acid salt, such as sulfate, etc.

Since stainless steel tube is stored in open air for a long time, the components which are not shown in stainless steel matrix in corrosion pits are supposed to come from the environment, such as rain. Due to the insolation and rainfall, chloride and sulfide assemble in stainless steel tube surface, which cause the corrosion of the stainless steel tube.

Fig.7 Analysis range and SEM image of the corrosion pit 1-1

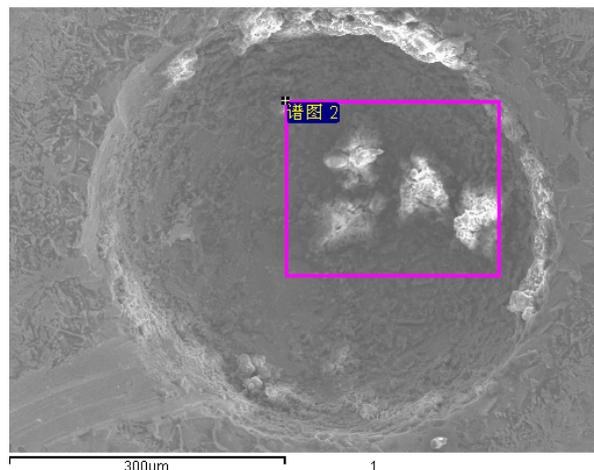
3. The element content of different corrosion pit is different, but the difference is not obvious. The elements also have differences when EDS specimen with different range in the same corrosion pit.

Fig.8 Analysis range and SEM image of the corrosion pit 1-2
