# Study on the Surface Quality Defects and Repair Measures of Composite Wallboard after Stripping

Chunyi Xu<sup>1, a\*</sup>, Shengdong Li<sup>1, b</sup>, Chunlei Xu<sup>2, d</sup> and Hui Cao<sup>1, c</sup>

<sup>1</sup> School of Civil Engineering, Shenyang Jianzhu University, Shenyang 110168, China

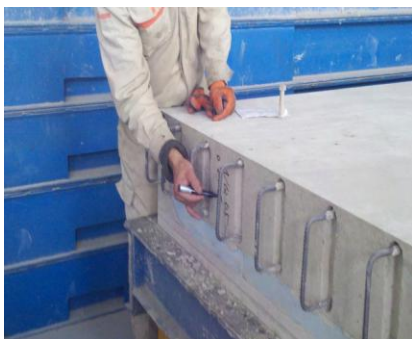
All of the qualified wallboard will be sent to storage areas after rinse and marked, As shown in Figure 1.

Fig. 1 Temporary mark. Fig.

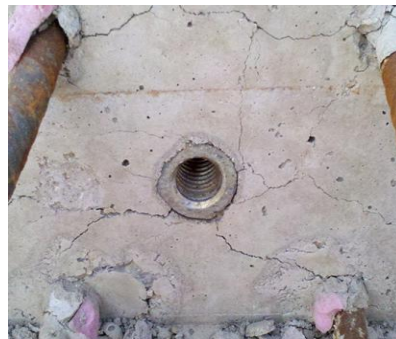
Embedded parts where stress concentration, a greater constraint on the concrete stress, and the thermal expansion coefficient of concrete with embedded parts have a certain margin, when such binding and temperature stress is greater than the concrete tensile stress, will be in the pre-buried member surrounding a stress fracture, as shown in Figure 2.

2 Stress crack Fig.

Patch 3: cracks should select the appropriate processing method according to the degree of serious and harmful: little effect on the structural strength of a width of less than 0.2mm, can be used for waterproofing repair, but when the crack width of more than 0.2mm, cracks need to be closed slurry coated with epoxy resin processing.

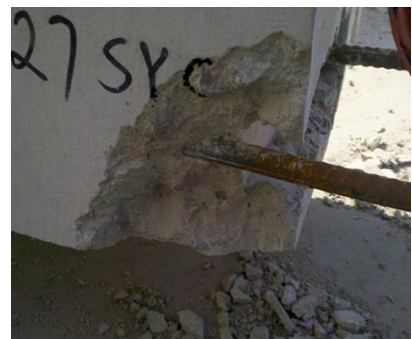
**The missing edge off angle.** Missing edge off angle is the missing edge off angle phenomenon refers to the structure or members of local falling concrete corners, irregular, angular defects. The causes are: Form removal violently, resulting in prefabricated corners are knocked; form removal is not properly protected, so that member edges and damage by external force or with heavy impact[6], As shown in Figure 3.

3 Missing edge off angle

Patch 4: for relatively small angular missing edge off angle phenomenon, if you do not affect the overall quality and appearance requirements, can not handle; prefabricated angular rupture, rinse with water after taking partial formwork, use of prefabricated units higher than the original a grade of cement formulation 1: 2 or 1: 2.5 cement mortar repair, wiping solid form flattened corners, and conservation.
