Investigation of failure of tubular joint of lightning rod

Keywords: Substation; Lightning Rod; Tubular joint; Finite element analysis

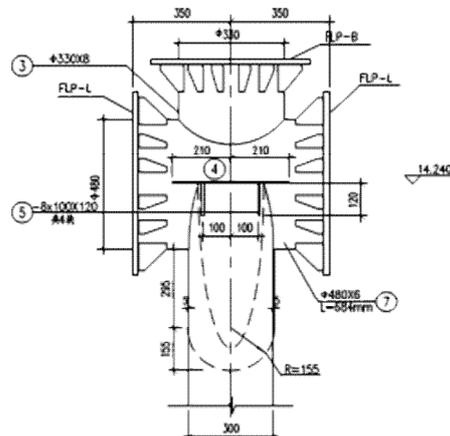
Fig.1 The structural form of the tubular joint of lightning rod

The event that some lightning rod was fractured and collapsed at the tubular joint of lightning rod occurred in some transformer substation recently. The bottom of the lightning rod is steel tube with diameter of 330mm and thickness of 8mm (Q235B). The supporting tube is steel tube with diameter of 480mm and thickness of 6mm (Q345B). The elevation of the top of the lightning rod is 40m. The lightning rod described above with typical tubular joint is shown in Fig. 1. The horizontal supporting tube ($\Phi 480 \times 6$) is connected to the lightning rod ($\Phi 330 \times 8$). The top of the lightning rod shown in Fig.1 is connected to the upper part of the lightning rod by the flange plate. The two sides of the horizontal supporting tube are connected with the frame beams and the bottom is connected with Herringbone column.

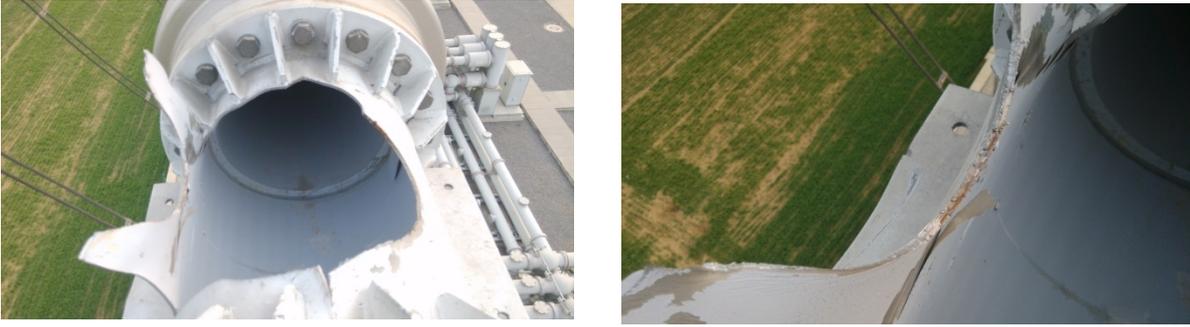
Fig. 2 The photograph showing the failure of the tubular joint of lightning rod

It has been approved by careful calculation that the welding joint strength of the tubular joint of the lightning rod and horizontal supporting tube satisfies the requirements of the code. The photograph of the fractured section of the tubular joint is shown in Fig. 2. It is obvious that the failure at the tubular joint was mainly caused by the tearing of the horizontal supporting tube near the tubular joint. After the occurrence of the accident, to ensure the normal operation of the substation, the collapsed lightning rod is required to be recovered as soon as possible. This paper explored the mechanical behaviour of the tubular joint by finite element analysis based on the structural characteristic of the tubular joint of the lightning rod and the frame structure. The finite element software ABAQUS is

By observing the fractured section, especially an old weld seam with a length of 390mm, it was found that the fracture of the bottom of lightning rod was not caused by one static loading, but is a typical fatigue failure. It was concluded that:

- (6) The welding position at the tubular joint area subject to complex forces of flexure, compression and shear. The thermal influence area of the side of the steel pipe having imperfections is easy to crack, and the plasticity and toughness of the steel in the heat affected zone decrease under the cyclic stress, and the fracture mode is changed from plastic fracture to brittle fracture.

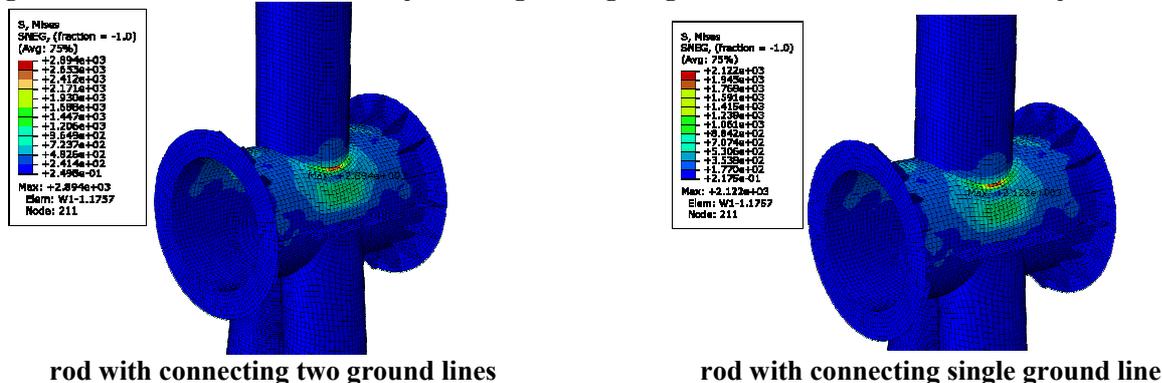
Fig.4 Stress contour of the tubular joint of lightning rod with connecting two ground lines Fig.5 Stress contour of the tubular joint of lightning rod with connecting single ground line

Based on the most unfavourable load case with lightning rod connecting two ground lines under wind loading, the stress contour of the tubular joint of lightning rod is shown in Figure 4. The figure shows that the stress concentration occurs at the position of tubular joint with the maximum value of stress

2894MPa. The average stress at the area of tubular line is 1700MPa or so which is much larger than the design strength of material.

Based on load case with lightning rod connecting single ground lines under wind loading, the stress contour of the tubular joint of lightning rod is shown in Figure 5. The figure shows that the stress concentration occurs at the position of tubular joint with the maximum value of stress 2211MPa. The average stress at the area of tubular line is 1250MPa or so which is much larger than the design strength of material.

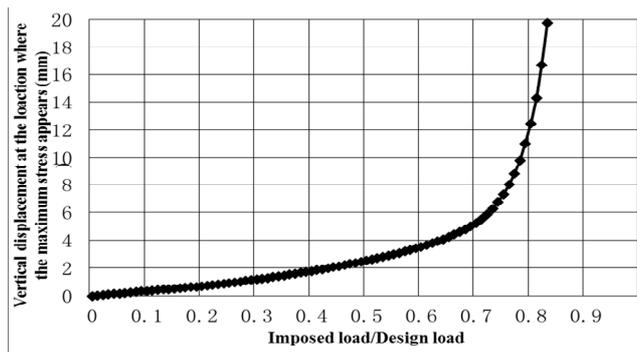
Fig.6 Relationship between the vertical displacement at the location where the maximum stress appears and the dimensionless load

The results of elastic-plastic analysis for lightning rod with connecting single ground line are shown in Fig. 6. The curve shows the relationship between the vertical displacement at the location where the maximum stress appears and the dimensionless load which is the ratio of imposed load to design load.

Due to there is no clear principle to determine the local instability for steel tubes subject to outplane bending, so based on clause description 10.3.4 in “Code for Steel Structure Design” (GB 50017—2003), the load corresponding to a local concave deformation of 1D/100 (4.8mm) is regarded as the load capacity for serviceability limit state and the value is 0.68 times design load from Fig.6. Similarly, the load corresponding to a local concave deformation of 3D/100 (14.4mm) is regarded as the load capacity for ultimate limit state and the value is 0.83 times design load from Fig.6. It is obvious that both serviceability limit state and the ultimate limit state is not satisfied for current design of the tubular joint of the lightning rod.

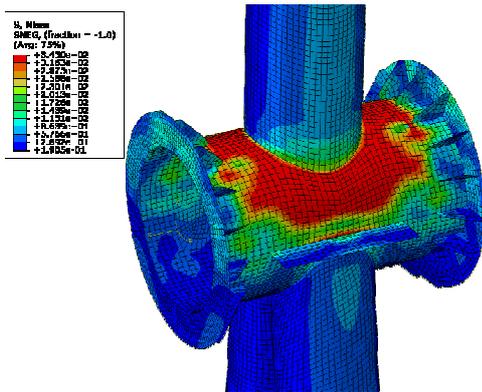
Fig.7 Stress contour of the tubular joint

The stress and deformation contour of the tubular joint of lightning rod corresponding to a local concave deformation of 1D/100 (4.8mm) is shown in Fig.7 and Fig.8.
