Numerical Analysis of strengthened tubular joint of lightening rod

Chen Lei^{a*}, Li Hongbo^b, Peng Yiliang^c

HeNan Electric Power Survey&Design Institute, Zhengzhou, 450007, China

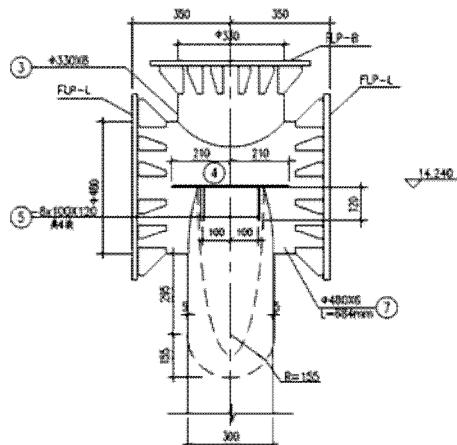
Fig.1 The structural form of the tubular joint of lightning rod

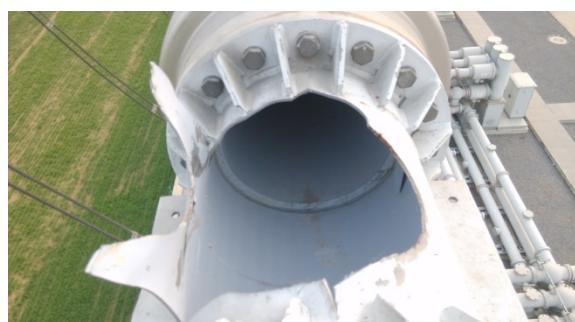
The event that some lightning rod was fractured and collapsed at the tubular joint of lightning rod occurred in some transformer substation recently. The bottom of the lightning rod is steel tube with diameter of 330mm and thickness of 8mm (Q235B). The supporting tube is steel tube with diameter of 480mm and thickness of 6mm (Q345B). The elevation of the top of the lightning rod is 40m. The lightning rod described above with typical tubular joint is shown in Fig. 1. The horizontal supporting tube ($\varnothing 480 \times 6$) is connected to the lightning rod ($\Phi 330 \times 8$). The top of the lightning rod shown in Fig.1 is connected to the upper part of the lightning rod by the flange plate. The two sides of the horizontal supporting tube are connected with the frame beams and the bottom is connected with Herringbone column. The photograph of the fractured section of the tubular joint is shown in Fig. 2. It is obvious that the failure at the tubular joint was mainly caused by the tearing of the horizontal supporting tube near the tubular joint.

Fig. 2 The photograph showing the failure of the tubular joint of lightning rod

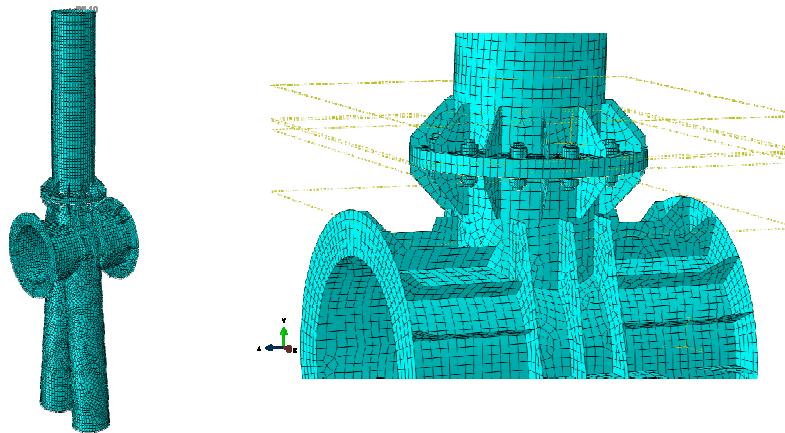
Fig. 3 Recovered model for collapsed lightning rod

The principle of restoration and strengthening of the tubular joint of lightning rod is: to avoid the stress concentration of the tubular joint at the heat affected zone; the maximum stress of the control members for the restored lightning rod is no larger than the design strength and the maximum average stress is no larger than 70 percent of the design strength; the maximum stress of the control members for the strengthening lightning rod is no larger than the design strength and the maximum average stress is no larger than 70 percent of the design strength;

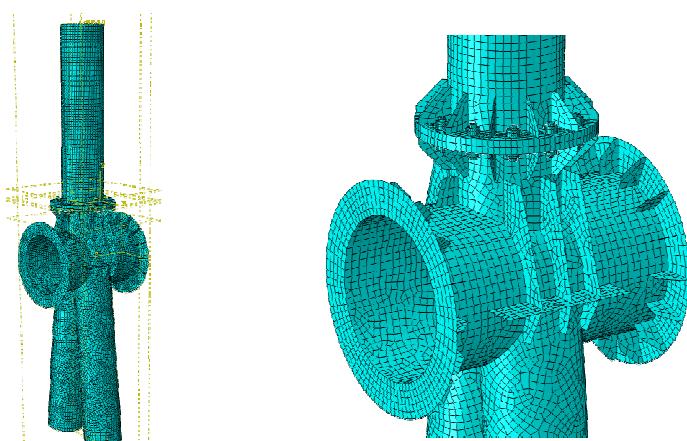
Fig. 4 The strengthening model for lightening rod with normal operation

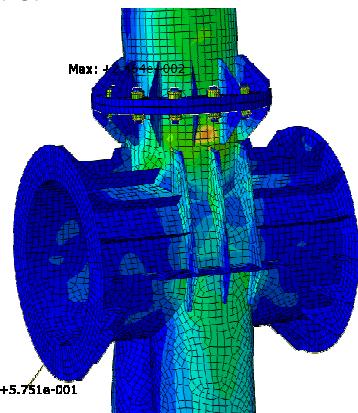
Fig. 5 Stress contour for recovered model

- 2) As Figure 5 shows, the maximum stress for recovered model appears at area above the middle stiffener. The maximum stress at stiffener area is $226.1 \text{ MPa} < 310 \text{ MPa}$ and the maximum average element stress is $150.5 \text{ MPa} < 0.7 \times 310 = 217 \text{ MPa}$ which satisfies the requirement of not exceeding the 70 percent of design strength. The maximum stress at lightning rod is $196 \text{ MPa} < 310 \text{ MPa}$, and the maximum average element stress is $172.2 \text{ MPa} < 0.7 \times 310 = 217 \text{ MPa}$ which satisfies the requirement of not exceeding the 70 percent of design strength.

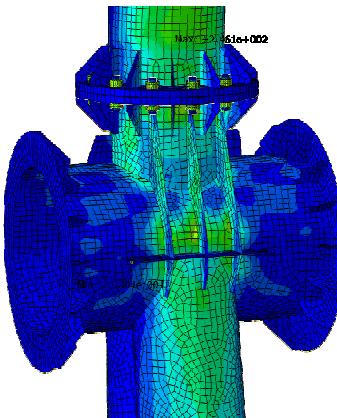
Fig. 7 Stress contour for strengthened model

- 3) As Figure 7 shows, the maximum stress for strengthened model appears at local area of one nut which does not affect the stability of the whole model. The maximum stress at horizontal pipe is $182.7 \text{ MPa} < 215 \text{ MPa}$, and the maximum average element stress is $145.6 \text{ MPa} < 0.7 \times 215 = 150.5 \text{ MPa}$ which satisfies the requirement of not exceeding the 70 percent of design strength.

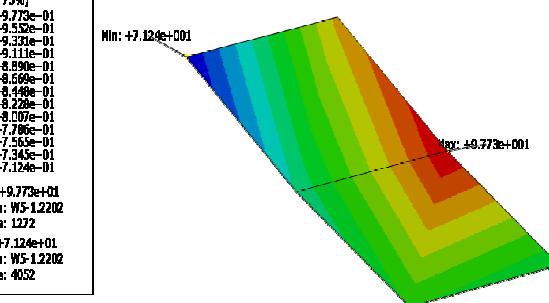
Fig. 8 The maximum stress at connecting area of lightning rod and horizontal pipe (strengthened model)
