## CAUSE OF FAILURE OF A CERTAIN BUILDING AND STRATEGIES

**Abstract:** Soil nail shotcrete-bolt supporting scheme is adopted in pit supporting, while side slope will destabilize and collapse because drainage of soil nail shotcrete-bolt supporting design fails to meet the design requirements. The effect required by the engineering is fulfilled by adopting the design and construction treatment scheme of light well point precipitation, gravity retaining wall outside and adding soil nail on the west side of side slope platform. This treatment method adopted can provide effective design and construction basis for pit supporting engineering.

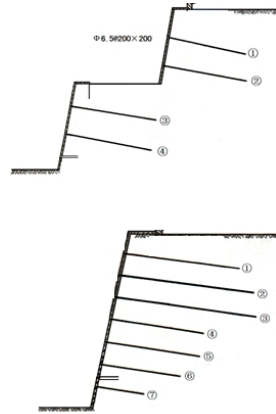
Figure 1 Supporting design profile of side slope

**Supporting scheme:** The selection of the foundation pit excavation scheme depends on the surroundings, according to the conditions of this site, due to the impossibility of the adoption of a simple slope excavation scheme and unallowance of greater deformation of soil mass around foundation pit in the process of the engineering, in this engineering, 2-floor bolts, 1.5 m longitudinal spacing and 2 m horizontal spacing, both 12 m in length are set in the eastern, southern, and western sides slope; 5-floor soil nail, 1.5 m longitudinal spacing, 2 m horizontal spacing, soil nail length: 8 m in length of the first floor; the second and third floor : 6 m in length; the fourth floor: 5 m in length; the fifth floor: 3 m in length . In the northern side slope of foundation pit, 4-floor soil nails are designed, that is to say, 2 floors above and below step respectively, 6 m in length of all soil nails. Aperture of bolt and soil nail drill hole is 150 mm for each; the surfacing is  $\Phi 6.5 @ 200 \times 200$  steel meshes with 100 mm shotcrete in thickness. In the northern side slope of foundation pit, 4-floor soil nail are designed, 2 floors above and below step respectively, of which the length are all 6 m. Aperture of bolt and soil nail drill hole is 150 mm for each; the surfacing is  $\Phi 6.5 @ 200 \times 200$  steel meshes with 100 mm shotcrete in thickness (Figure 1a.b in reference).

(a) east, west, south

(b) north
