Research of Vehicle Electrical Fire Authentication Based on Metallographic Analysis

Gu Yangyang^{1, a*}, Xi Ming^{2, b} and Wang Zheng^{3, c}

^{1 2,3}China Automotive Technology & Research Center, China

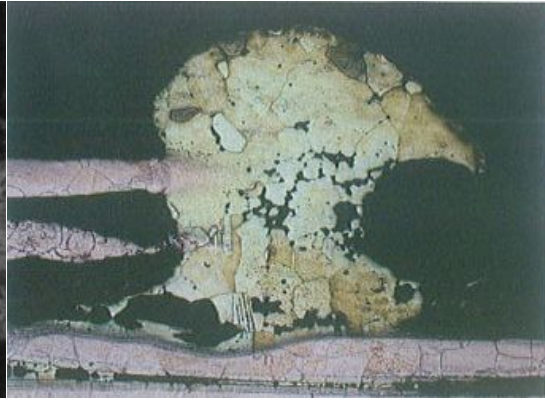
In vehicle fire, if the flame temperature was higher than the melting point of copper wire, the copper wire will form melting scar, this was burning melting scar. The metallographic microstructure of the burning melting scar presented coarse equiaxial crystal, smooth surface slicing, less holes (figure 3). This was related to the forming environment, which was high temperature. Copper wire temperature rised relatively slow in the environment, it is conducive to the formation of crystal nucleus, so the metallographic microstructure was coarse equiaxial crystal. At the same time, the cooling speed of wire was slow, lead to the solidification time was longer, this caused the burning melting scar in the process of solidification can happen redox reaction with the surrounding oxygen, fully absorbed the oxygen, formed copper oxide, nitrogen and other gases in chemical reactions, there are plenty of time to escape, to form a smooth surface. So metallographic specimen grinding surface was smooth and less holes .

Figure 3 the burning melting scar metallographic microstructure of 100x

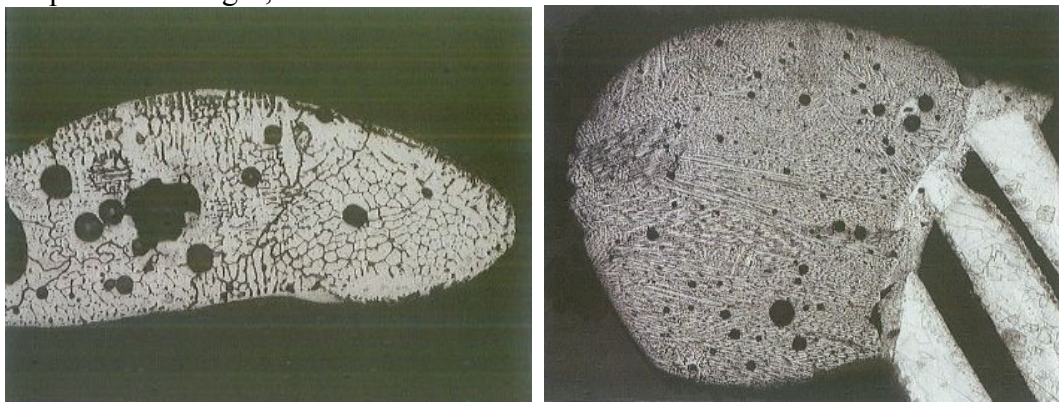
Copper wires short circuit melting scar was due to wires short-circuit itself lead to form metal melting scar, which formed before the fire, was the main cause of vehicle electrical fire. The short circuit melting scar before fire metallographic microstructure presented small columnar crystal or cellular crystal, eutecticum ($\text{Cu} + \text{Cu}_2\text{O}$) around the hole eutectic was less, the holes inside the organization was small and less and hole shape was circular or elliptic which relatively inerratic. There was obvious transition zone between melting scar and wire (figure 4). Due to short circuit occurred before fire, the melting scar formed fast. There was large temperature difference between wire and melting scar, the crystal had congealed before growing up, presented small closely packed cellular crystal or columnar crystal. The internal gas didn't had enough time to react and overflow, trapped within the organization, but melting scar in the process of formation had less combustion products and gas, so its holes were small and less.

Figure 4(a、 b) short circuit melting scar before fire metallographic microstructure of 100x

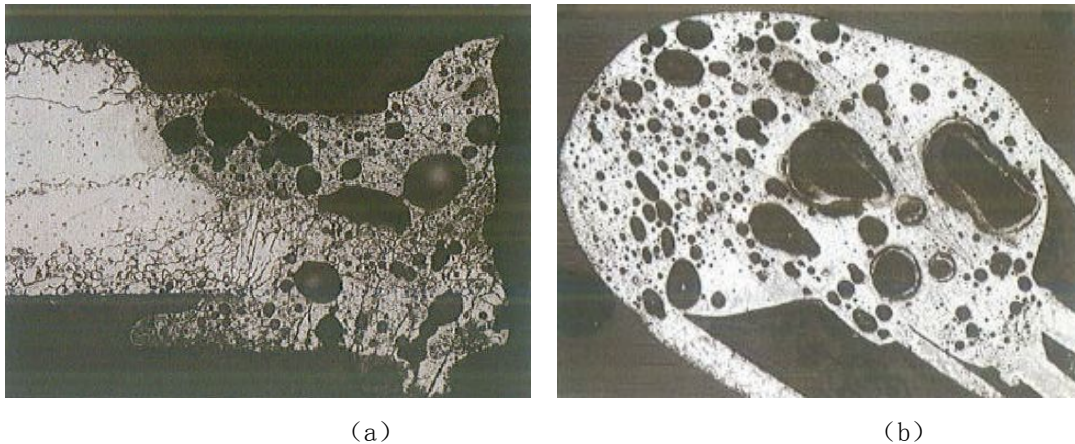
Copper wire of Short circuit melting scar in fire was wire insulation layer was burned by fire or melted by high temperature leads to the wire contact with the other wire to form short circuit, when the wire was under the condition of wire in the circuit conduction. Short circuit melting scar metallographic microstructure was composed of bulky columnar crystal or some big crystal boundary, the internal holes were large and more, eutecticum ($\text{Cu} + \text{Cu}_2\text{O}$) around the hole were more apparent, transition zone between wire and melting scar was not obvious. Due to short circuit melting scar was formed in fire which the fire temperature is high, the melting scar cooled down slower and cannot effectively form the transition zone, if the scene of the fire temperature was constant high temperature, the transition zone boundaries will become more blurred and disorder; The cooling rate of short circuit melting scar was slow, more gas can not overflow, plus the air in fire contained more dust, all kinds of combustion impurities, water vapor, therefore, these impurities will also enter the molten copper, so we can observe larger holes in this organization (figure 5).

Figure 5(a、 b) Short circuit melting scar in fire metallographic microstructure of 100x

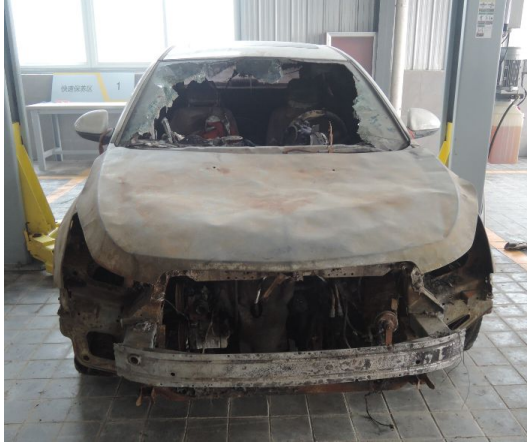
Figure 6 burned vehicle

A car drove into the community, after parking, suddenly engine compartment began to smoke. The front of the car body was damaged more seriously than the back of the body, showed a trend of obvious after former heavy light. Checked the car engine compartment, found that the front of the engine compartment was more serious than the back, the left side was more serious than the right side. The front of the car engine compartment damaged serious, aluminum alloy of front bumper right section ignited gone, front bumper left section had the smoke trace, preliminary analysis concluded was that the fire point of origin located in the front of the engine compartment, at the same time, found a melting scar in the battery cathode copper wires, need to be further identified the melting scar was formed before the fire or in the fire, which is of great significance to find the real cause of the fire. Therefore, extracted the melting scar, no. 1 (figure 8).

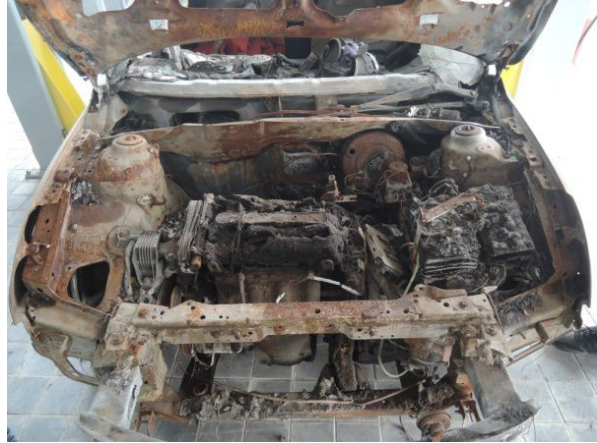
Figure 7 burned engine compartment

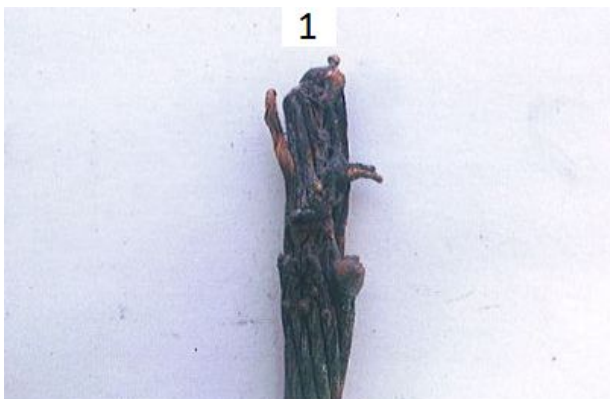
Figure 8 sample

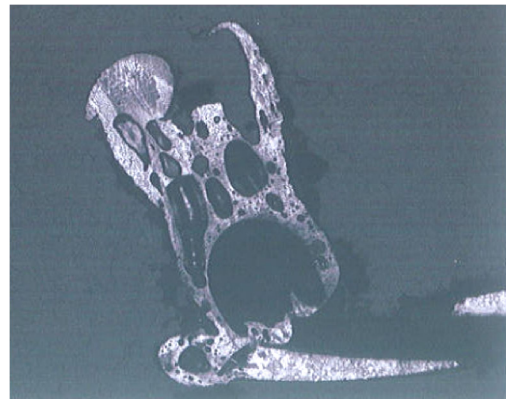
Figure 9 sample 1 metallographic microstructure

According to sample 1 of metallographic microstructure, we can see that sample 1 was short circuit melting scar in fire, so we can eliminate the vehicle fire cause of electrical wire fault, that provided scientific guidance to continue to find the real cause of the fire.
