Failure analysis of engine crankcast bolts treated by alodine anodic technology

Yanpeng Feng, Haijun Tang, Ping Shu

China Academy of Civil Aviation Science and Technology

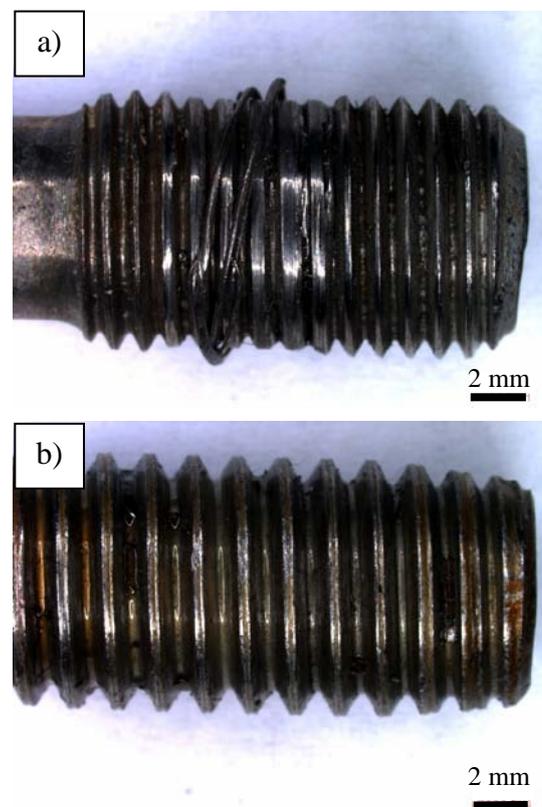
Observation of failure bolt revealed that the surface color of failure bolt and virgin one was obvious different. Color of failed bolt is shiny with bright metal color, while the virgin is grey brown color, and corrosion was absent in virgin one. On the head-end piece of the bolt, shearing-off of several threads was noticed, as shown in Fig.1.

Fig. 1 Treads of bolts. a) Bolt treated by alodine 1200S, b) virgin bolt

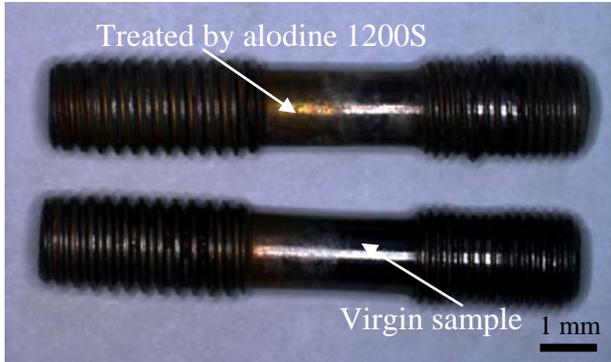
Macro photograph of failed and virgin bolts are shown in fig.2, both bolts are used, and some abrasion marks and deposition could be found in thread root position of both bolts. Except of the different color in threads parts, the rod of the bolts is different too. As mentioned above, the failed bolts were process by alodine treatment with the engine crankcase, so the bolts were exposed in alodine solution, absolutely. From macro view, metallic luster is found in the screw thread surface and rod for untreated bolt, which is mottled and discrete for the treated bolt.

Fig. 2 Optical photograph of virgin bolt and treated by alodine 1200S solution

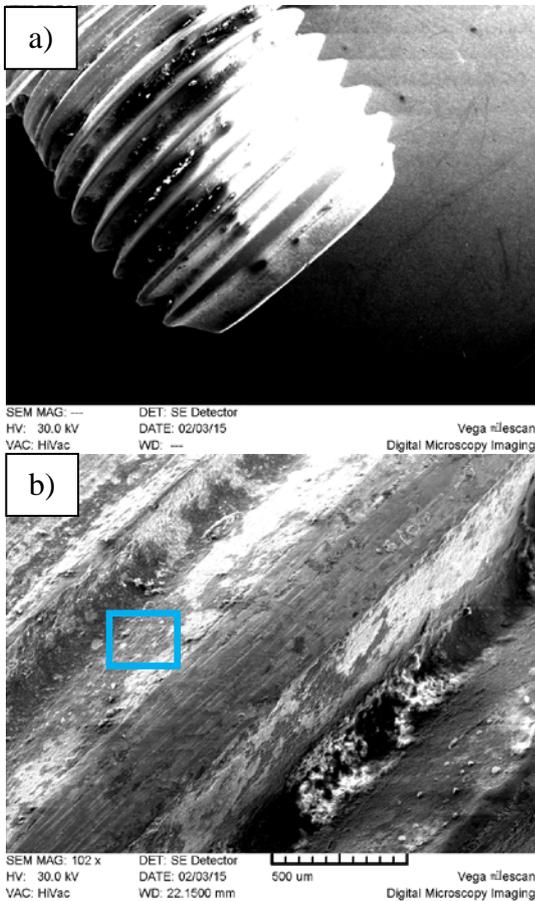
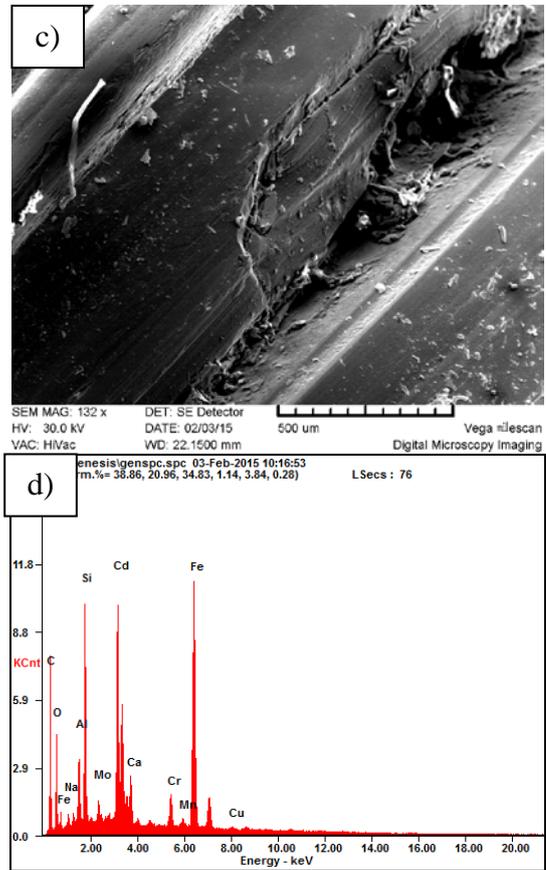
Fig. 3 Microstructure and energy dispersive spectrum (EDS) of failed bolt a) top of failed bolt; b) Surface of screw thread; c) root of screw thread; d) EDS of position in fig.3b.

Microstructure of treated bolt is shown in Fig.3. After the assembling process, many grinding products are formed and accumulated at root of threads, as shown in fig.3b. The energy dispersive spectrum (EDS) of the position in the profile of thread, where without any grinding marks, as the blue block in fig.3b is shown in fig.3d. The chemical elements including of Cd, Si, Fe, Mo and Cr are found. The element Cd may come from the coating materials, and Fe, Cr may come from matrix of bolt, and Mo, Si may come from lubricant materials. The shearing-off threads are shown in fig.3c, that were cut off during the assembling process after alodine treatment. But the dimensional matching between bolt and nut may no problem for it has been assembling once, and the force apply on bolt is control and monitor, and it's under the standard force. So the problem is that, why the bolt is so weaker?

Result of microstructures and EDS clarified that, the treated process corrode the Cd coating and lead to the loose and disconnected coating. During the assembling process, it cut off from surface of thread and accumulated in the root of thread. Deposition of deciduous coating materials may change the dimensional mater between bolt and but, and increasing the shearing force between bolt and nut.

This hydrogen can lead to delayed failure of high strength steel under load and it is the usual practice to bake such components for up to 24 h at 200 °C to remove the hydrogen.

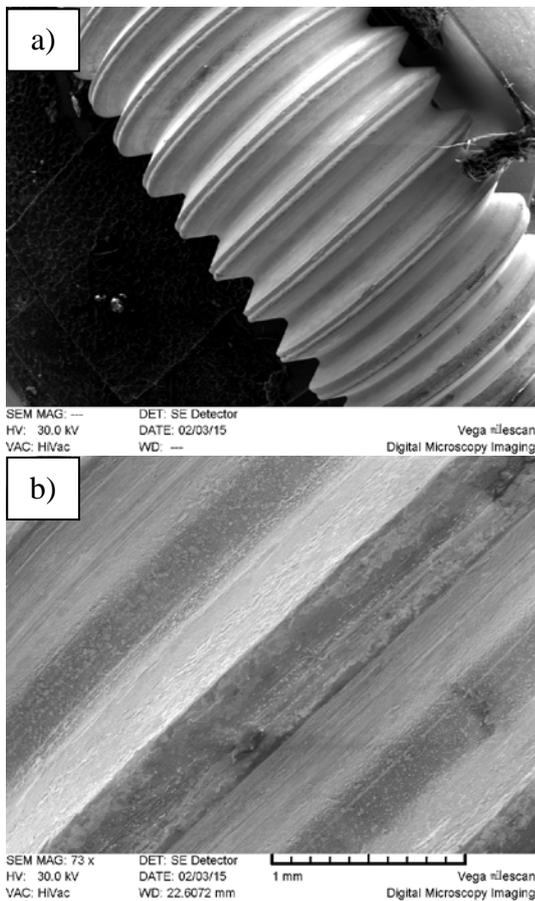
The surface of untreated bolt (virgin bolt) is shown in fig. 4, it's uniform, continuous and smooth. The surface is covered with uniform particulate matter (coating materials), that proved lubrication as mentioned by other articles. So why, the microstructure of this kind is not cutting or shearing during the assembling process? And the coating materials could proved perfect protect for the bolts.

Fig. 4 Microstructure of untreated bolt a) thread of untreated bolt; b) surface of thread

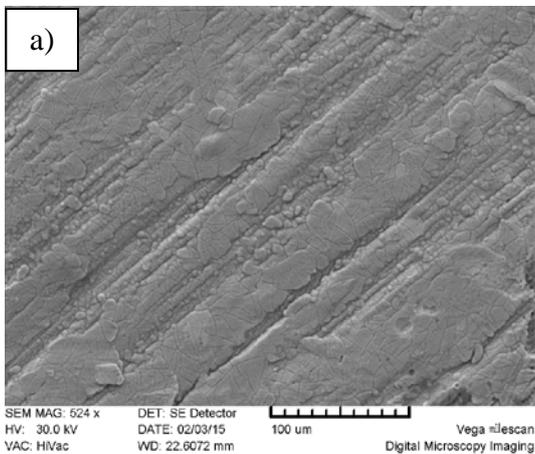
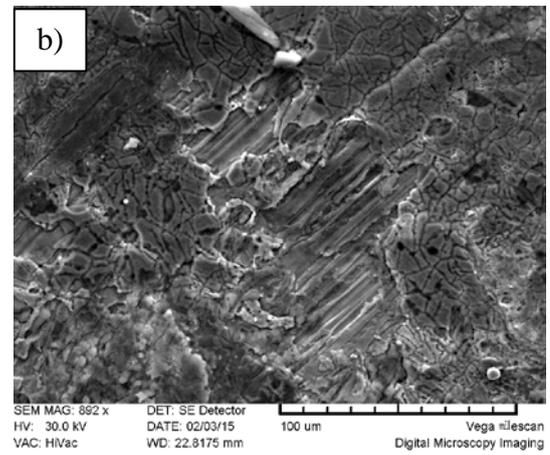
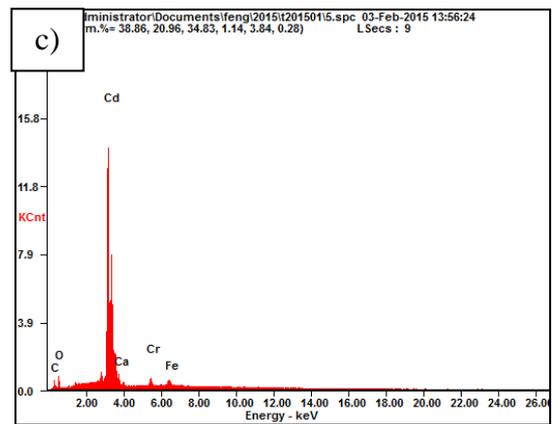
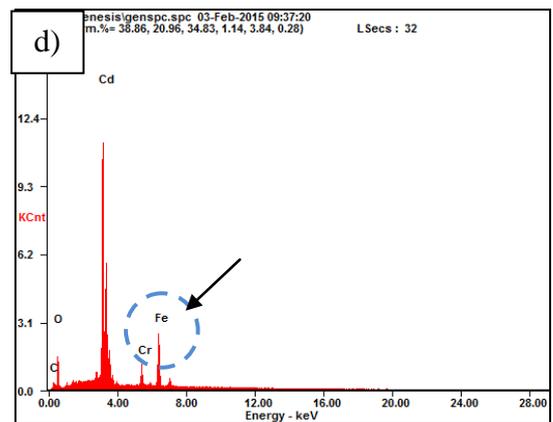
To clarify the above problems, microstructures and EDS of untreated and treated bolts are investigated and shown in fig.5. Surface of untreated thread is covered smooth coating with distribution of parallel mark that may be profile of matrix formatted during machining process. Surface of treated bolt is covered porous and loose coating and machining mark of matrix is exposed. EDS result shows that the main chemical element of untreated bolt surface is Cd, which is coating materials. But the chemical elements of treated bolt surface are Cd and Fe, Cr, that are matrix materials.

Fig. 5 Comparison of different microstructures and EDS between treated and untreated bolts a) surface of threads for untreated bolt, b) surface of threads for treated bolt, c) EDS of untreated threads, d) EDS of treated bolt.
