Semi Destructive Methods for Timber Structures Quality Assessment

Abstract— the content of this article is the assessment of the elements and truss structure state of the castle, which will soon be undergoing renovations. In addition to visual assessment was also used semi destructive drilling resistance measurement using resistograph to determine the state of wood mass inside the cross-sections of individual elements, which allows to determine the real state of the elements beneath the surface, to determine the extent of infestation of individual elements of wood-destroying insects and decay and to determine the optimal process of reconstruction of the truss structure.

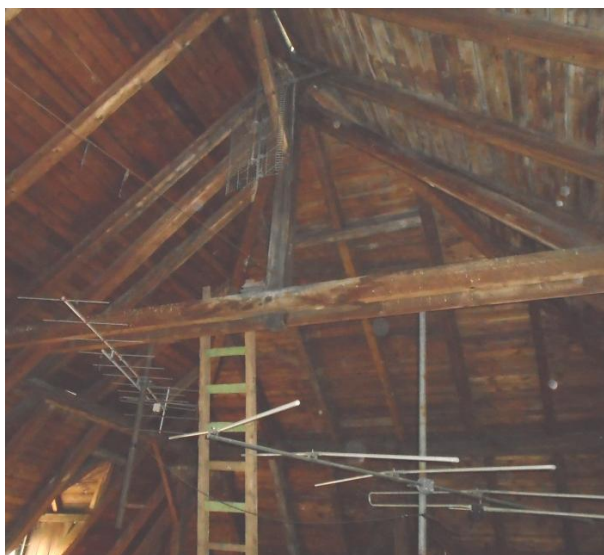
Figure 3. Castle– roof truss

The object of the exploration is the description of elements material quality of roof trusses over the object of castle (see Fig. 3) with a proposal for further progress of potential rehabilitations on the base of the gathered data.

Based on the results of the visual assessment and drilling resistance method was due to a large extent of the wood-destroying insects and decay infestation of the roof truss, and the condition of the roof structure recommended the total replacement truss structure.

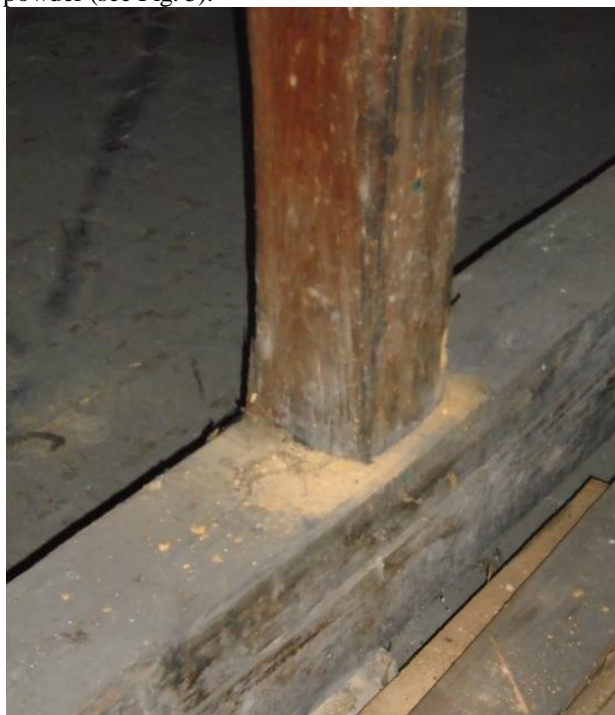
Most of the elements of the assessed truss structure in the castle (vertical, horizontal and oblique) appear to be infested (old-house borer), whether locally or over the entire length.

The wood response to tapping for most of elements is hollow. In the vicinity of the elements is visible wooden powder (see Fig. 5).

Figure 5. Infested timber element – wood destroying insect

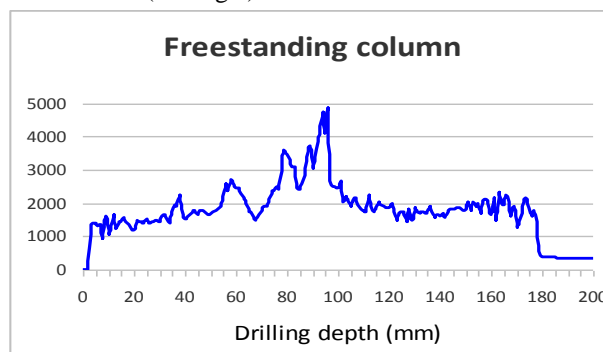
The first measurement was performed at the freestanding column, which is shown in Figure 5 - visibly infected with wood-destroying insects.

The center of the cross section shows greater resistance of the wood than its edge parts which are more affected by wood-destroying insects, which damages the timber progressively from the edges toward the middle of the cross-section (see Fig 6).

Figure 6. Drilling resistance – the freestanding column

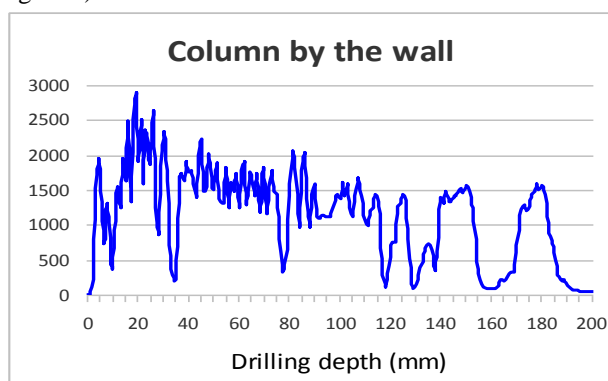
The second measurement was performed at the column standing by the wooden wall (see Figure 7). The result of the measurement shows significant decreases of wood practically the entire cross section of the column (see Figure 7).

Figure 7. Drilling resistance – column by the wall

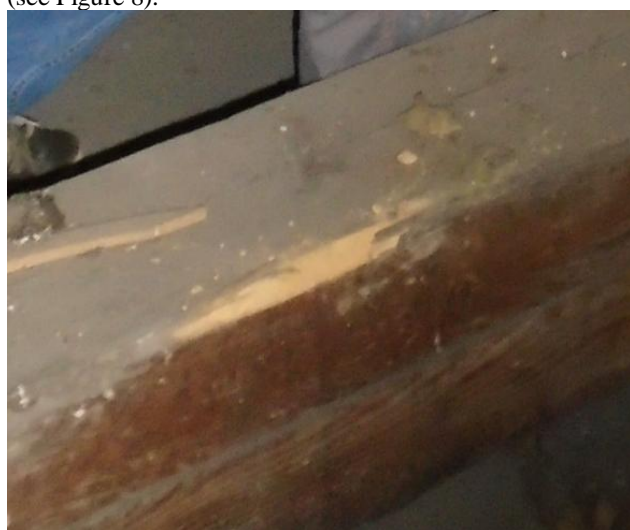
Another measurement was carried out on selected tie beam, which exhibited locally by wood-destroying insects (see Figure 8).

Figure 8. Tie beam – wood-destroying insect damage

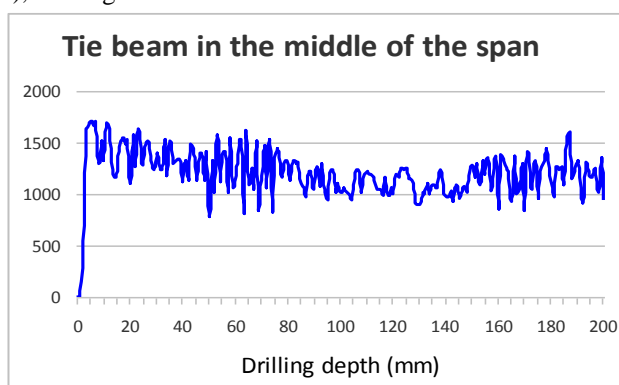
Measurement of the tie beam in the middle of its span does not show significant decreases in wood mass (Figure 9), although even this element is on its surface infected.

Figure 9. Drilling resistance – tie beam in the middle of the span

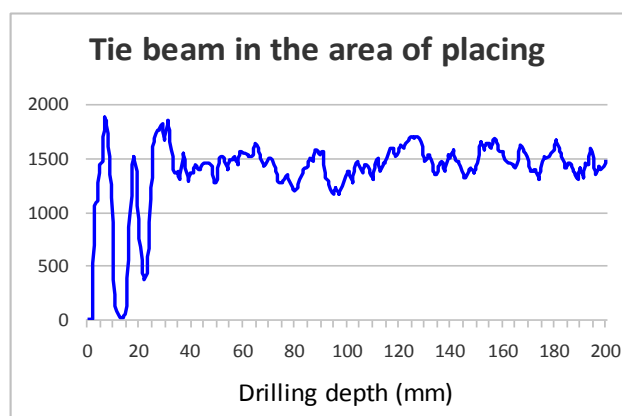
The results of drilling resistance measurements in the area of beam placing (see Figure 10) point to the damage wood mass with decay to the depth of 25 mm. This is

caused due to the increased moisture, which is caused by the lack of air circulation in this area.

Figure 10. Drilling resistance – tie beam in the area of placing

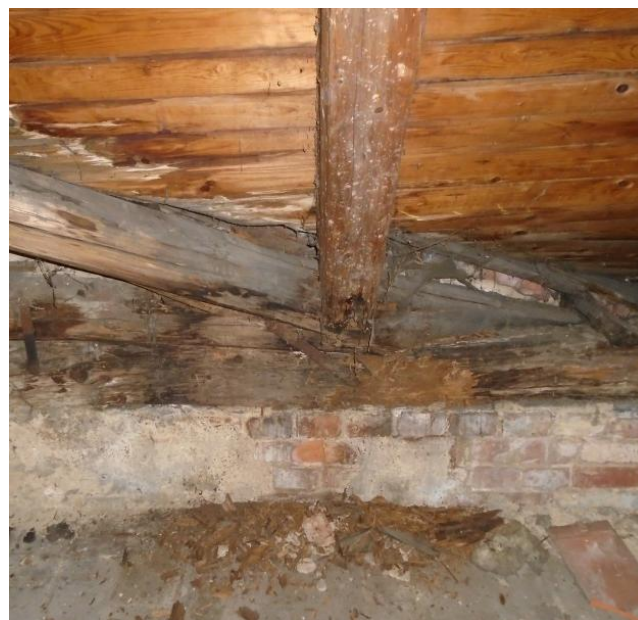
In the area of the roof truss placing on the wall plate over which is the damaged roof deck constructions was locally excessive rainwater leaking onto the roof elements.

As can be seen in Figures 11 and 12 it is the complete loss and damage of wood mass in this area. The wood loses in this place consistency (firmness) and free falls off.

Figure 11. Water leaking area – damage of wood caused by decay

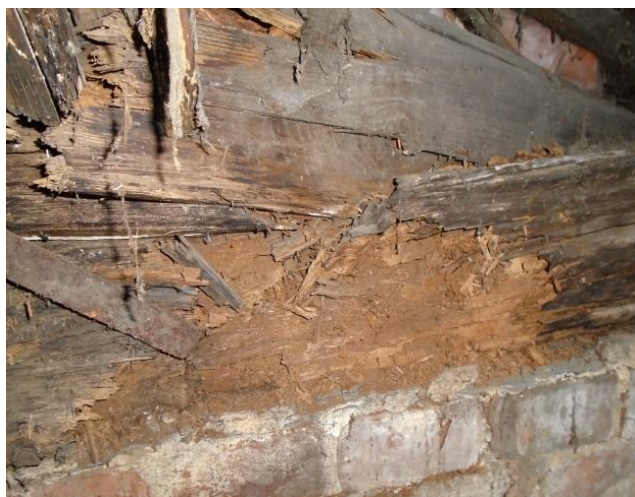
Figure 12. Water leaking area – damage of wood caused by decay – detail

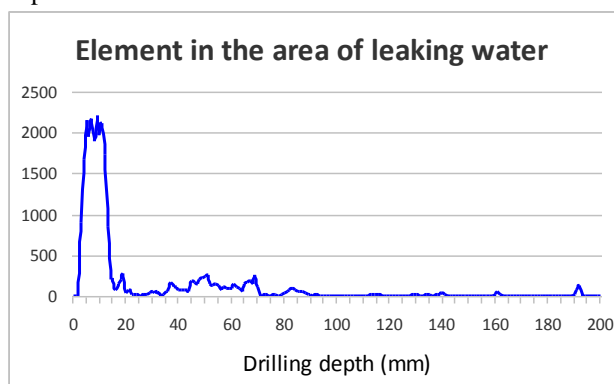
The results of the drilling resistance measurement of the damaged wall plate area has an almost zero resistance of timber (Figure 13) – it is the total destruction of the wood element, which confirms results of the visual inspection.

Figure 13. Drilling resistance – element in the area of water leaking
