## **Analysis of A 220kV Current Transformer Explosion Accident**

Jinzhou Power Supply Company, Liaoning Electric Power Company Limited, State Grid, China  
fushunpowersupply@163.com

A blast happened to the B-phase current transformer of the 220kV #1 transformer in a substation at 23:30 in one day in July 2015. The weather condition at that time was good, and there was no work there.

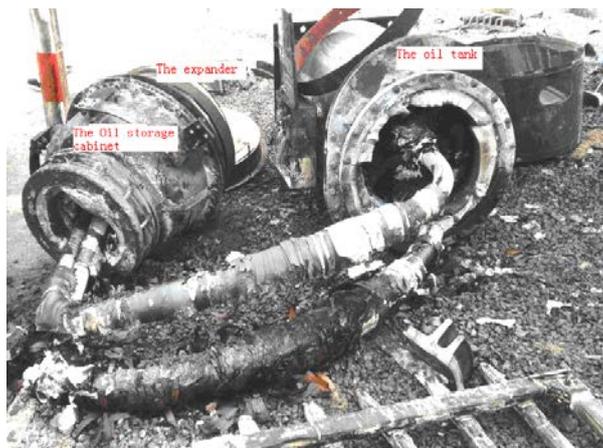
Fig.1 The accident scene

In the accident scene, it was found that the porcelain sleeve of the current transformer was blown to bits. The broken pieces showered around, and the farthest one is 100 meters away. Most parts of the current transformer were burnt only with the expander, the oil tank and the charred main capacitor left. Different degrees of damages were appeared in the Devices around. The condition is

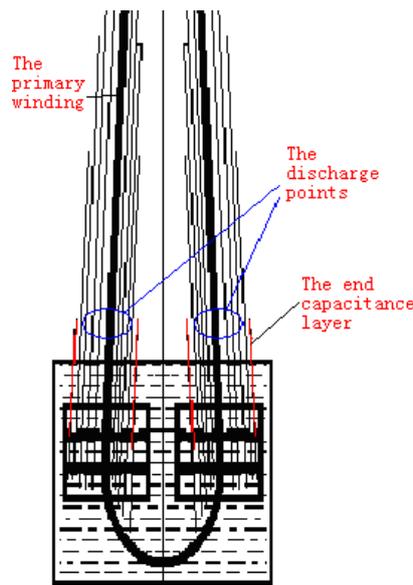
Fig.2 The internal structure diagram

As the porcelain sleeve was blown to bits and the charred main capacitor was burnt, only the oil tank was disintegrated. After the disintegration, two fault points located at the primary winding were found. The internal structure diagram is shown in Figure 2, and the specific circumstances of the various parts are as follows.

1) The oil tank: No obvious discharge point was found inside, and the bottom surface and the lateral side of the tank were slightly arched for the tank was subjected to a great impact.

2) The expander: there was no mark that the expander was damped. The four oil boxes in series were all over flown, and the whole part failed to fall off.

3) The secondary windings: after separated out from the oil tank, the secondary windings were found burnt into black. There was no fault point found.

5) The primary winding: the primary winding was a double winding constituted by two “U” type aluminum pipes. There were two fault points found. The first one was at P1 side 100mm away from the top edge of the oil tank, and the combustion length was 100mm. The other one suspected as the first discharge point was at P2 side 150mm away from the top edge of the oil tank, and the combustion length was 100mm.

(2) After the insulation strength reducing, the end capacitance layer where the electric field relatively concentrated became a weak part of the main insulation. Under the continuous flicker impact produced by impact loads such as forging, smelting and machining, discharge phenomena happened at the end capacitance layer, and then tremendous energy produced, leading to explosion and fire.

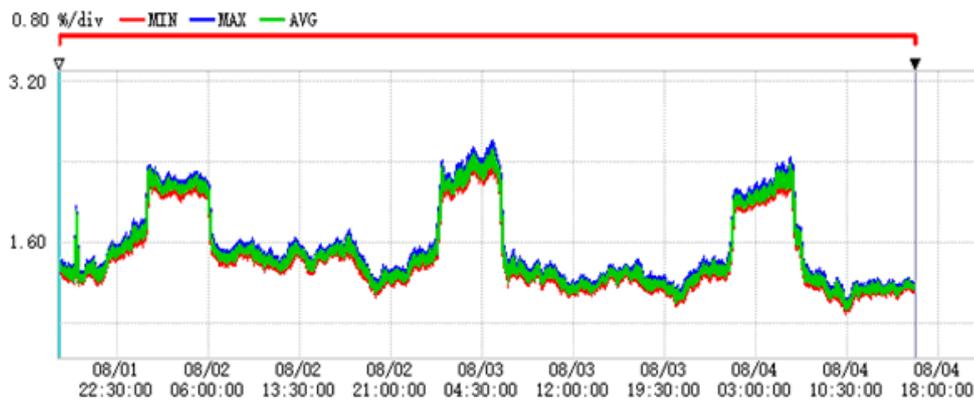
Fig.3 The harmonic voltage distortion rate measurement chart

It is found that the percentage of harmonic voltage and the flicker severity of this substation had exceeded the standard. It can be seen that the value of the 11th harmonic voltage and the 13th harmonic voltage were relatively high. And the time of the beyond-standard situation happened is approximately from 22:00 to 6:00 the next day, and the time of each day is almost the same. The harmonic voltage distortion rate measurement chart is shown in Figure 3, and the flicker measurement chart is shown in Figure 4.

It can be seen from Figure 3, the maximum harmonic voltage distortion rate had reached 2.63%, the 95% probability value was 2.35%, and these two values had exceeded the limits of GB/T 14549-1993 “Quality of electric energy supply Harmonics in public supply network”. At the same time, the beyond-standard situation had an obvious time period (from 22:00 to 6:00 the next day).

(1) Under the action of the high harmonic voltage for a long time, polarization loss of the paper/oil insulation increased, and dielectric loss also increased, then the temperature rose, causing the main insulation slowly deteriorated finally. During the process, chemical reactions such as thermal cracking and oxidative cracking would happen to the paper insulation at this high temperature, leading to further decline in its electrical performance and mechanical properties.

Carry out the survey of the harmonic load of 220kV substations, monitor the harmonic output point of the loads which may produce harmonics, and govern the loads whose harmonics and flicker exceed standards.

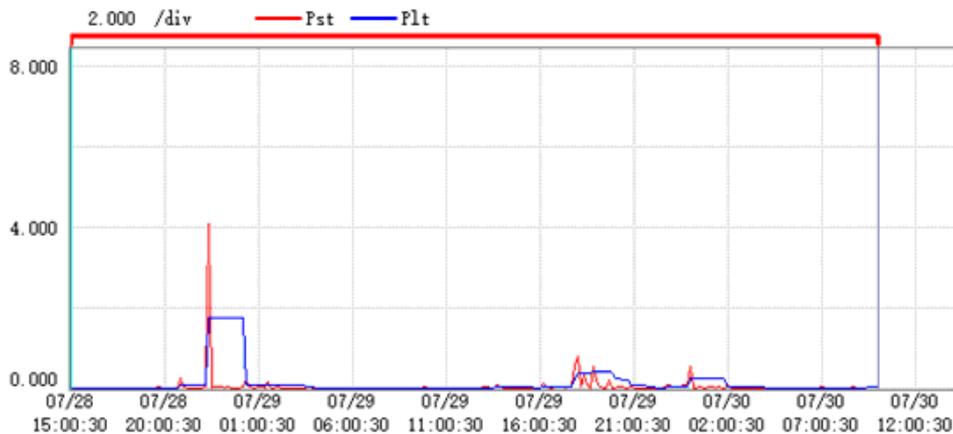
Fig.4 The flicker measurement chart

It can be seen from Figure 4, the maximum value of short time flicker had reached 4.09, the maximum value of long time flicker was 1.78, and these two values had exceeded the limits of GB/T 12326-2008 “Power quality – Voltage fluctuation and flicker”. At the same time, the beyond-standard situation had an obvious time period (from 22:00 to 6:00 the next day).
