## Failure Analysis of the Escalator Driving Chain in an Escalator Reversal Accident

Bo Li<sup>1, a</sup>, Xiao Liang<sup>1, b</sup>

<sup>1</sup>Shanghai Institute of Special Equipment Inspection and Technical Research, 399 North Nujiang Road, Shanghai 200333, PR China

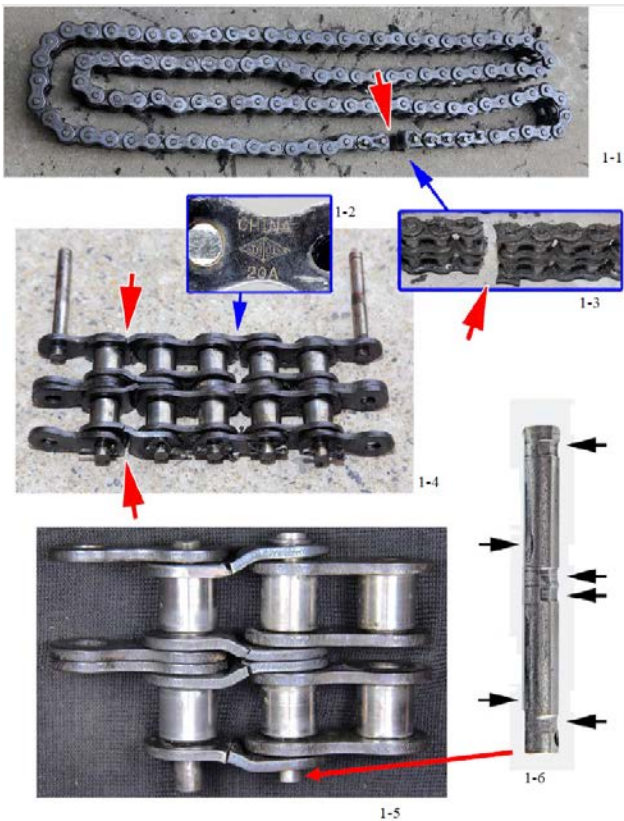
**Macro-structural Examination.** The fractured escalator drive chain belongs to the chain model of double row roller chain (Specification No.20A-2). The chain pitch is 31.75mm, with a long chain pin width of about 83.2mm. The breakage of the double drive chain occurred during its service process. The fracture position located at the transition section of the double row roller chain(Fig.1, and Fig.2). Moreover, the chain pin next to the transition chain plate was plastic deformed at severe locations where suffered partially forces from the drive chain of the escalator.

Fig.1 Macro-structure of the fractured chain

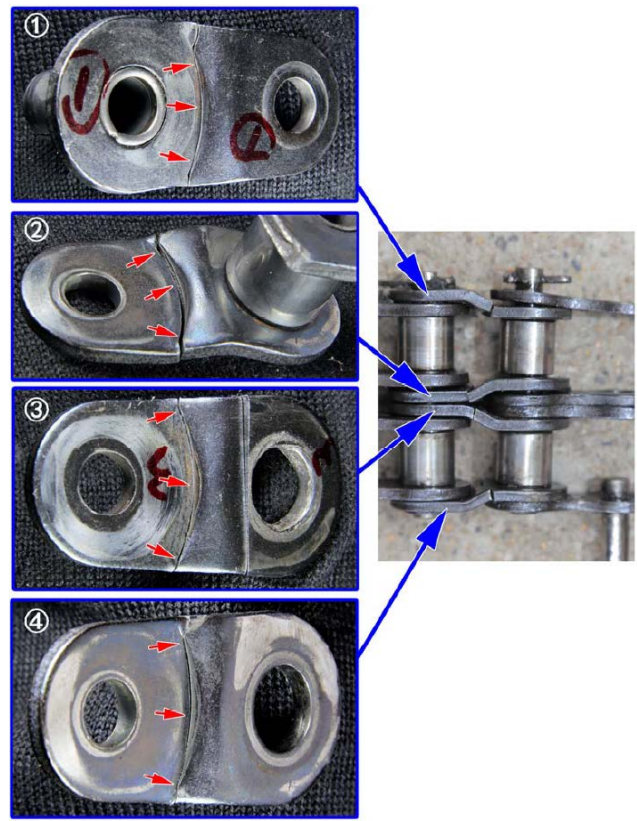
Fig.2 The fractured transition chain plates

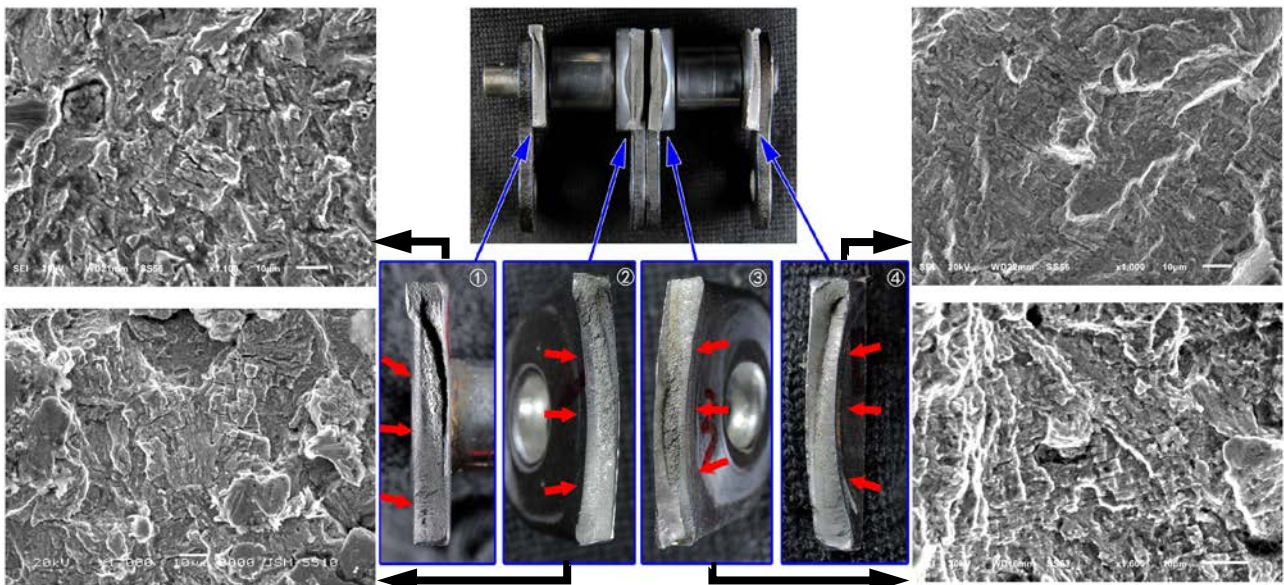
**Fracture Surface Observation.** The fracture surface morphology of the four fractured transition chain plates were observed in detail, as shown in Fig.3. The four fracture surface were all silver-grey in color. The crack patterns on the fracture surfaces extended along the cracking direction by the bending angle. The crack extensions were all initially from the chain plate surfaces into the inwards, as indicated by the red arrows in Fig.3. The SEI (Secondary Electron Imaging) of the fracture surfaces claimed that the typed fatigue striations were formed and presented on them, as shown in Fig.3. The parallel distribution of fatigue striations on the quasi-cleavage fracture surfaces implied the fatigue cracks were initiated and propagated before that the whole driving chain failure and the final accident occurred on the escalator.

Fig.3 Fracture surface morphology of the fractured chain plates

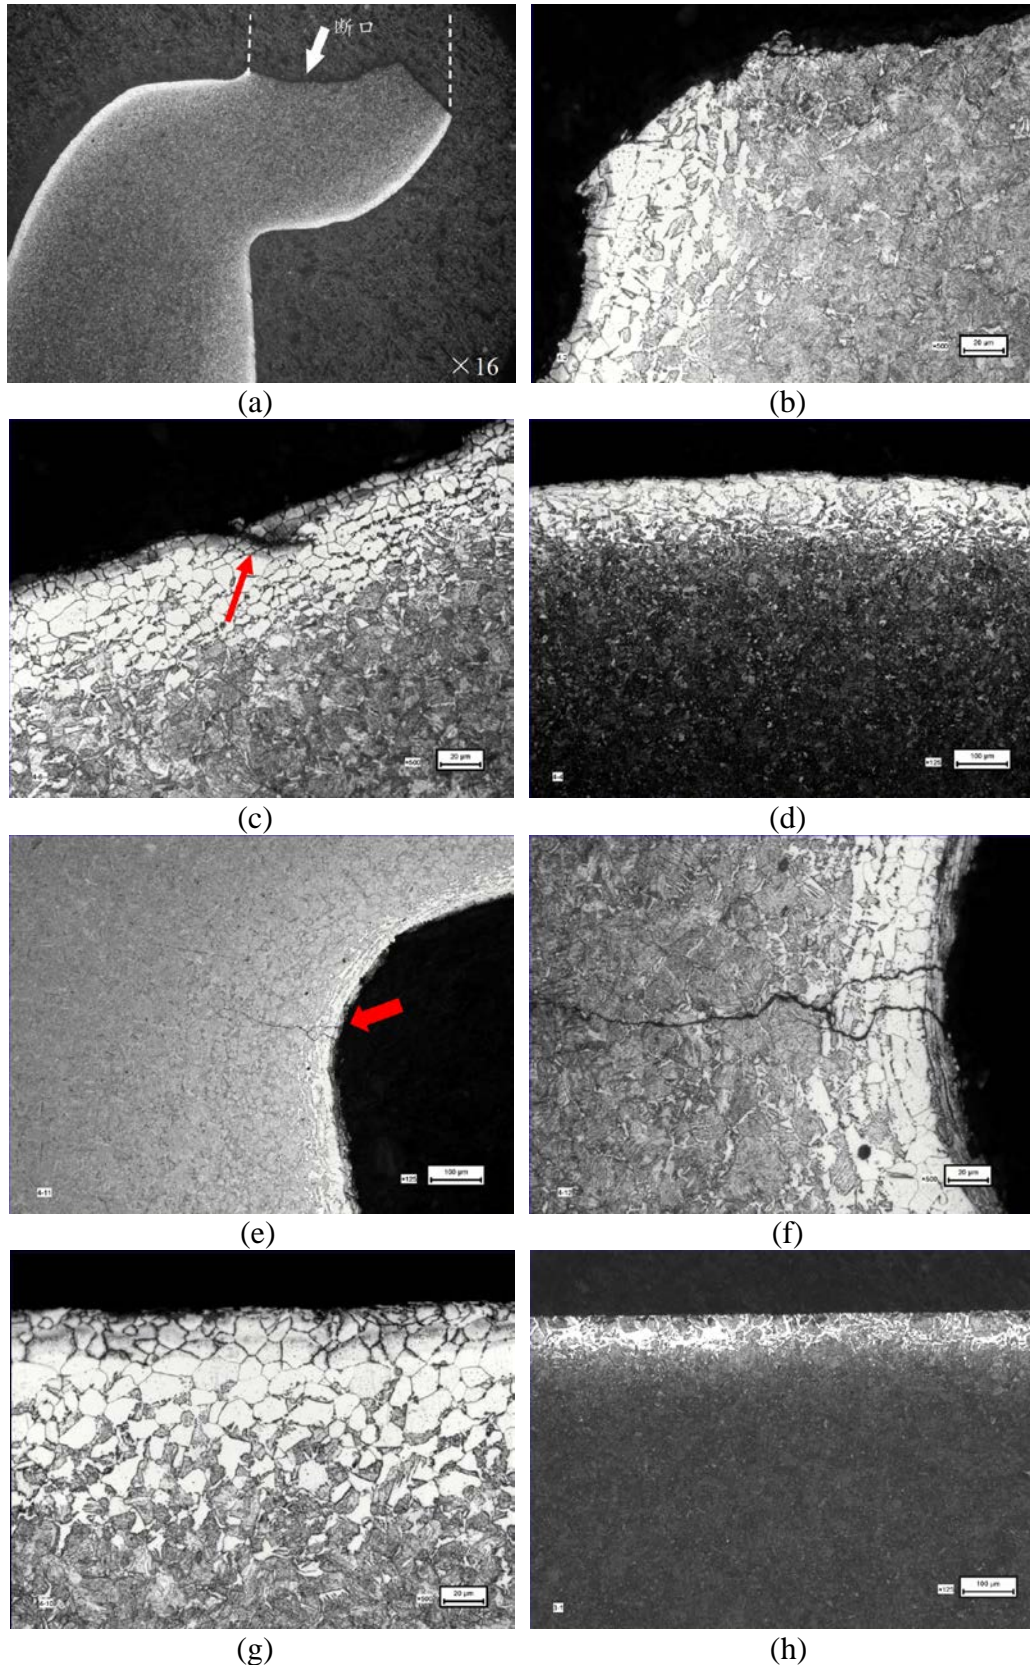
**Micro-structural Analysis.** The section micro-structure of the transitional chain plate, closing to the fracture position, was analyzed in detail and shown in Fig.4. The cross-section morphology of corresponding sample (the No.④ chain plate in Fig.2 and Fig.3) indicated that the decarburization phenomenon was existed on the outer surface. The micro-structure of the chain plate was Ferrite with a small amount of Sorbite. The micro cracking originated from the decarburization surface layer was given as Fig.4c. The depth of the decarburization surface layer was measured as about 90 $\mu$ m. And the micro cracks also existed within the decarburization surface layer of the bending area on the other side of the chain plate, as shown in Fig.4e and Fig.4f.

Fig.4 The micro-structures of the failed transitional chain plate with the decarburization surface layer and micro cracks.

**Hardness Measurement.** The results of Vickers hardness measurements on the cross section of the related samples are shown in Table 1. The Vickers hardness values of the surface layer of the samples are generally higher than those of the inner part of the samples. It indicates that the decarburization surface layer induces the material softening of the chain plate surface.

According to the metallographic and micro-structure scanning electron microscope analysis, it is claimed that no abnormal inclusion exists within the driving chain plates. Therefore, the micro inclusion is not the main factor inducing the fracture of the chain. The metallographic observation and hardness measurement results showed that the drive chain plate has the varying degree of surface decarburization defects. The surface decarburized layer can be inferred that the anti-fatigue ability of the chain plates is deviated. The cause of decarbonization phenomenon is directly related to the unreasonable heat treatment process of the chain. Decarburization (or decarbonization) is the process opposite to carburization, namely the reduction of carbon content. The term is typically used in metallurgy, describing the reduction of the carbon content in metals (usually steel). Decarburization is an important process during the heat treatment of steels. It can be divided into three separated events: dissolution of carbides, diffusion of carbon through the iron matrix, and surface reactions. Decarburization occurs when the metal is heated to temperatures of 700 °C or above when carbon in the metal reacts with gases containing oxygen or hydrogen. Decarburization can be either advantageous or detrimental, depending on the application for which the metal will be used. It is thus both something that can be done intentionally as a step in a manufacturing process, or something that happens as a side effect of a process (such as rolling) and must be either prevented or later reversed (such as via a carburization step). The decarburization mechanism can be described as three distinct events: the reaction at the steel surface, the interstitial diffusion of carbon atoms and the dissolution of carbides within the steel. The transition chain of the sample drive chain is fatigue fracture. The fatigue fracture of the multiple sources starting with the stress concentrations. Therefore, it is concluded that the surface decarburization will reduce the surface fatigue strength of chain plate, on the basis of the observation of the fracture surface analysis. At the same time, it is found that the cracking phenomenon can be inferred from the corner of the transition chain plate. The bending angle of the transition chain plate has obvious stress concentration effect in the operation.
