## Effects of Laser Cladding on Thermal Tensile Property and Fracture of Gas Turbine Engine Blade Material GH864

**Keywords:** Laser cladding, Gas turbine engine, Reheat crack, Blade, GH864 superalloy

**Abstract.** The consecutive layer of a nickel alloy was deposited onto a GH864 nickel-based superalloy gas turbine engine blade using laser cladding. To ensure the performance of blade, the gas turbine with laser cladding repaired blades worked two weeks and a detailed measurement and investigation were performed on chemical composition, mechanical performance, microstructure, macro-fractography and micro-fractography. The results indicate that the cracks at the inlet edge part of blade were caused by reheat crack. An inappropriate technology of laser cladding can result in the formation of incomplete fusion interface between the laser clad coating and substrate, or reheat cracking along the coarse grain boundary in the heat treatment zone. Tensile specimens were tested at both room temperature and elevated temperature. The results correlate to the conclusion that the reheat crack is the main reason for the performance degradation of the restored blade.

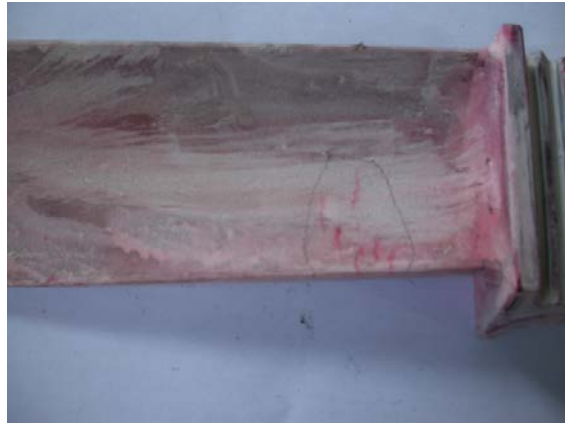
The blade restored by laser cladding, which was worked two weeks, has been checked by penetrant testing (Fig. 3). It can be seen that cracks were appeared at the inlet edge of the blade using penetrant testing. It means that cracks were appeared during operation time, the material property and the operation condition resulted in this case of cracks.

Fig. 3. Blade crack position.

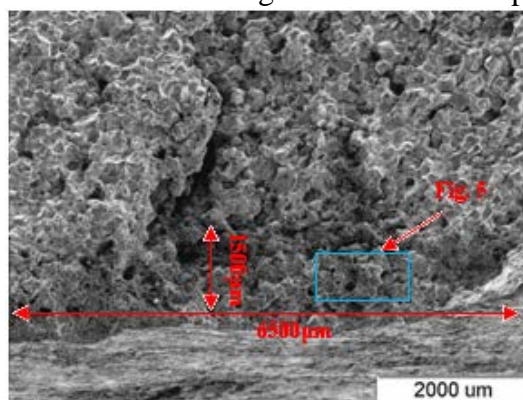
It is observed that the crack originated from the inlet edge of the blade basin. The SEM image in the figure 4 reveal the microstructure at the crack origin. The material at the top of the picture is substrate, which shows intergranular fracture characteristics. The material at the bottom of the picture is laser clad coating, it is clearly observed that there is a oxidation at the region between the substrate and laser clad coating, the crack is initiated at the oxidation zone. According to the measurement, it can be seen that the length of oxidation zone is exceeding 6.5mm and the depth is 1.5mm.

Fig. 4. SEM image of the crack origin.

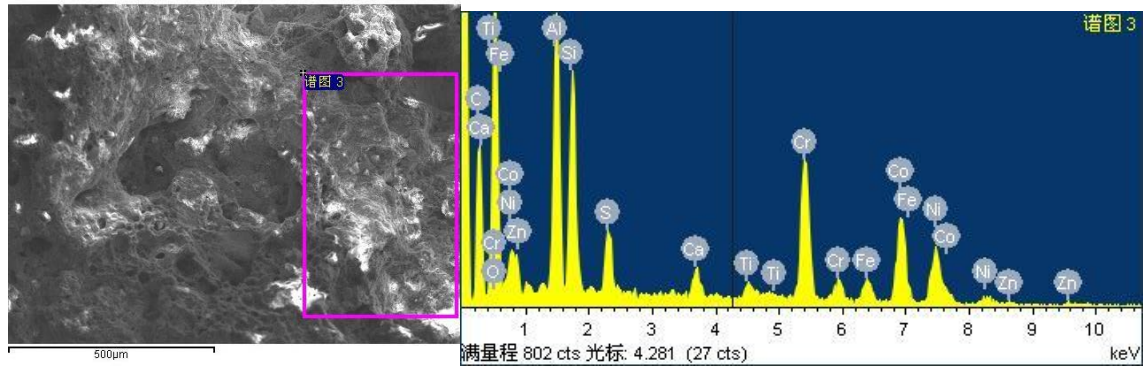
The local amplification of the oxidation was carried out, it is shown in figure 5. It can be seen that the oxidation region oxidized seriously, formed many holes. The EDS scanning conducted in the oxidation region showed that the oxidations were substrate with high O content. The gas turbine blade was working in the gas environment without oxygen, so that the oxide layer is not formed in the working time. It is observed that the oxidation zone is existed at the junction of substrate and laser clad coating, which distributed uniformity and unchanged in the thickness direction. It is indicated that the oxidation zone is the reheat crack formed during laser cladding.

Fig. 5. SEM image of the oxide at crack origin and EDS of the oxide.

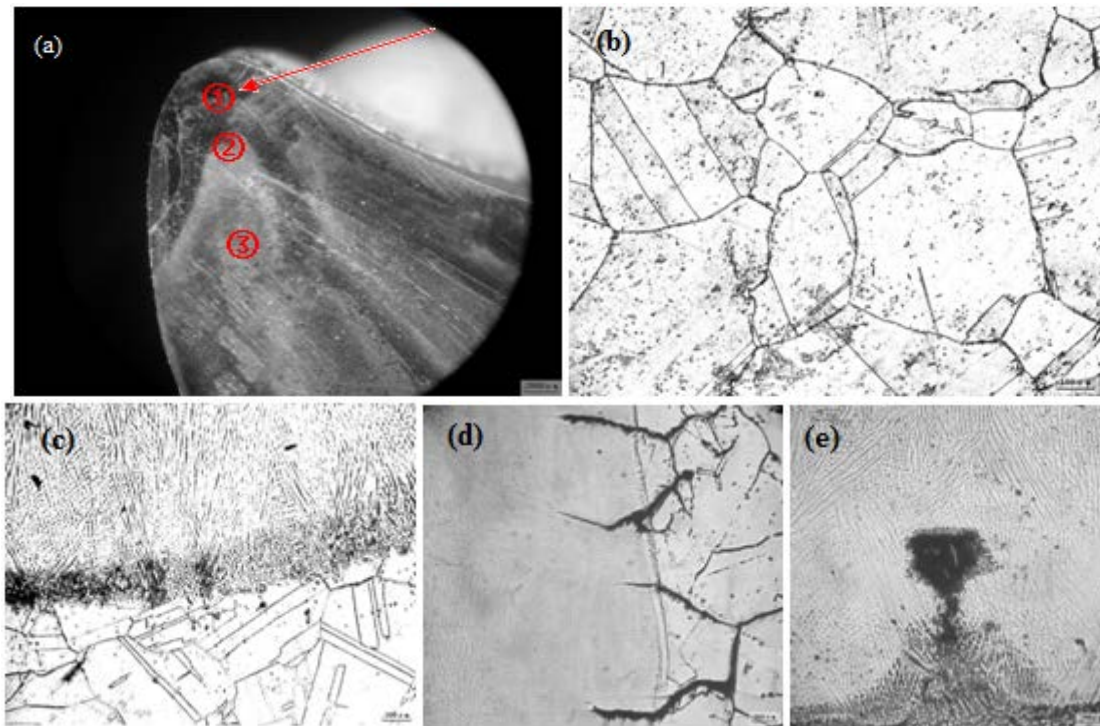
Figure 6a, b and c show the optical micrographs examined at of cladding thin wall in the cross-section, respectively. It can be seen clearly that there are three microstructure at the cladding thin wall, laser clad coating marked one, transition layer marked two and substrate marked three. The microstructure of base material consist of austenite, twin crystal and the strengthening phase distributed uniform. According to the observation of laser clad coating, it can be seen that the dendrite of laser clad coating is uniform and dense, the transition layer, which is in the middle of laser clad coating and substrate, connected naturally, no obvious stratification or layer.(a

Fig. 6. Optical micrograph taken in the cross-section of the cladding thin wall at crack position; (a) cross-section; (b) substrate; (c) fusion interface; (d) reheat crack; (e) hole.

The microstructure of defects in the transition layer and the cladding laser is presented in Figure 6d and e, respectively. Micro-cracks were found in the optical micrographs. The images show hole with very larger scale. It can be seen that many intergranular cracks are distributed in the heat treatment zone of the substrate, some of which has been extended to the laser clad coating, formed penetrated crack.

The widest points of the intergranular cracks are at the middle of the cracks, which are at the surface of substrate near the laser clad coating, both ends of the crack is fine. The boundary of crack touched with laser clad coating and substrate is clear, and there is no deposited filler filling phenomenon at the junction of crack and laser clad coating, this indicated that there is no

The formation of the crack can be described as following: during laser cladding, the grain boundary strength of grains at the substrate heat treatment zone is decreased with the temperature increasing. The surface temperature of the substrate is higher than the core temperature, so that the stress state of the substrate surface is tensile stress, it is easy to form crack at grain boundary. Similarly, the temperature of laser cladding coating is much higher, it is also tensile stress state during cooling and solidification, the crack can be extended from substrate to laser clad coating. Therefore, the substrate intergranular crack is the reheat crack forming during laser cladding.

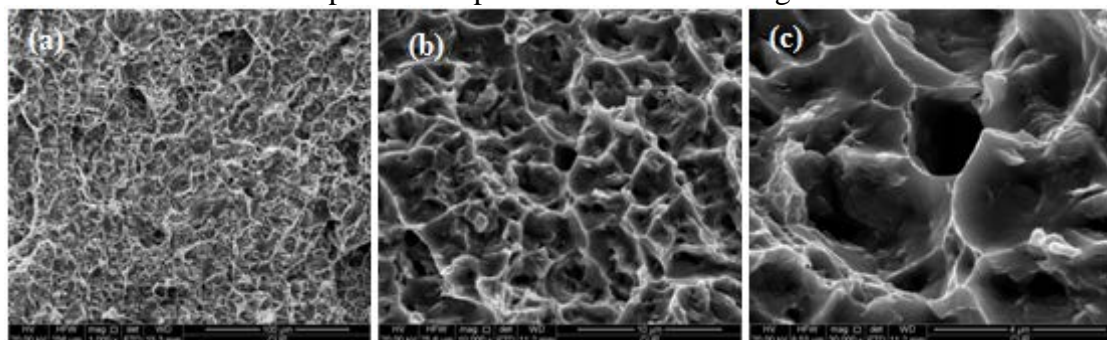
The fractographs of ambient temperature specimens are displayed in Fig.8. Typical fracture morphology of the substrate specimens exhibits a large amount of shear dimples, which indicates good ductility. Fracture surface of the specimens subjected to laser clad coating is mainly covered by dimples, but the dimples of the substrate sample are deeper and larger than that of the coating one.

Fig. 8. Fractographs of ambient temperature specimens; (a) GH864; (b)(c) coating.

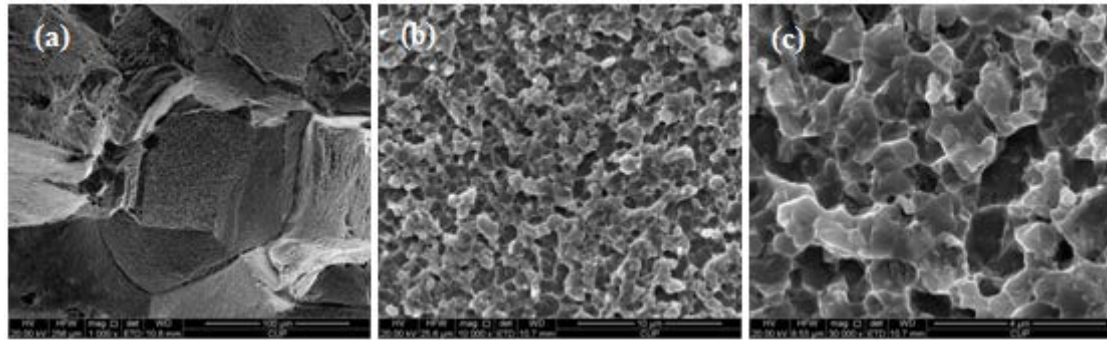
When the tests were carried out at elevated temperature, all specimens have remarkable necking. The fracture surfaces of substrate specimens mainly contain grains, which displays a obvious brittle fracture mode. On the contrary, fracture surface of coating specimens displays a complex fracture mode with fractured ductile dimples enveloped in the brittle cleavage matrix.

Fig. 9. Fractographs of specimens at 700°C; (a) GH864; (b)(c) coating.

It is concluded that thermal expansion behavior of laser clad coating is quite different from substrate. In addition, cracks often initiate at grain boundaries of substrate due to stress concentration resulting from reheat crack. On the other hand, penetrated reheat crack, not only weakens the strengthening effect of coating, but also provides the path for crack propagation, which leads to performance degradation of GH864 alloy.
