A Harness Crimping quality Issue Analysis

Abstract: Harness is the very important component of vehicles, there are many technologies about the quality control of harness cable crimping in the terminal. This thesis proposes a crimping quality issue happened in the instrument panel (IP) harness, using FTA and 5Whys to analyze the root cause and make the effective action plans.

Problem Description

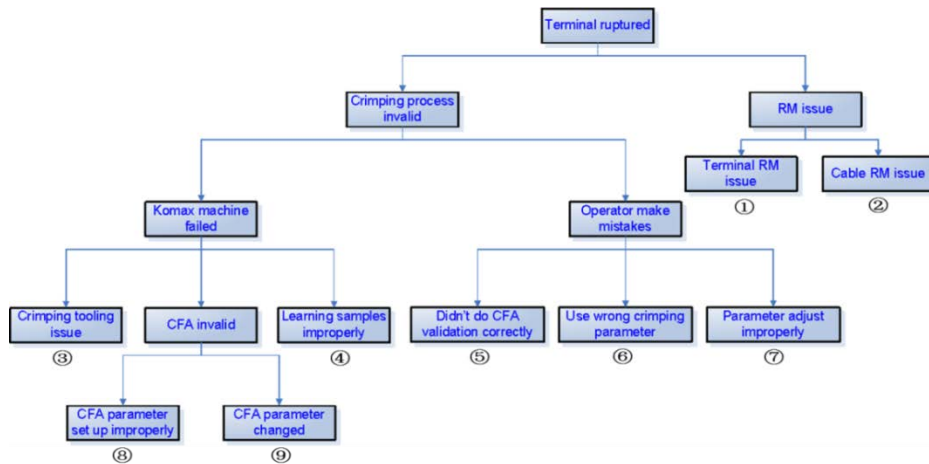
Photo1: FTA analysis

We use FTA(Failure Tree Analysis) tool to do the root cause analysis, as photo 1.

①+②: For the raw material issue, Check the appearance and dimension of the same lot terminal 15364267 and cable M4721005, the result are OK.

③: Check the defect parts, there were trace in insulation cut by crimping tooling, but the insulation didn't cut off, check the crimping tooling and found it wasn't obvious attrite.

The Komax machine operator feedback No.8 crimping tooling can't cut off insulation of the cable whose cable size is 0.35mm² matching terminal 15364267, we test short sample 100pcs and found 1pc defect sample, maybe the crimping tooling can't cut off the insulation easily.

- ④: Checked the first sample reserved by quality inspectors, the learning sample was OK.
- ⑤: Lookup night shift Komax No.8 machine daily check sheet, the operator does the CFA validation every day, and the result was OK on Aug.11.

⑥: Check the first sample crimping parameter in E-Cutting system was correct. And measure the defect sample CCH (Core Crimping Height) and ICH (Insulation Crimping Height), the result was OK.

⑦: Checked the first sample reserved by quality inspectors, the appearance was OK.

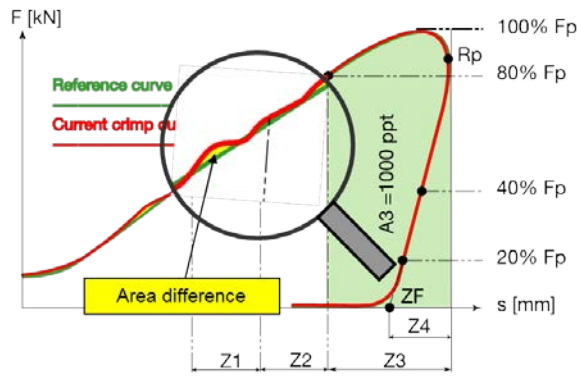
Photo 2: Force-Time Curve

For the good or bad separation the actual crimp curve will be compared with the reference curve and the area difference will be calculated. If the area difference is smaller than the error limit, the actual crimp will be recognized as a good crimp. But if the area difference is bigger than the error limit, the actual crimp will be recognized as a bad crimp (see photo 2).

Based on the force-time curve, we can set up the error-proofing parameter of CFA(see chart 1), the machine stop and alarm rules is that, $|RS1| \geq BL1$ or $RU1 \geq BL1$, $|RS2| \geq BL2$ or $RU2 \geq BL2$, $|RS3| \geq BL3$ or $RU3 \geq BL3$, and $|RSO| \geq BLO$ or $RUO \geq BLO$.

After we known the alarm rules of CFA, we re-checked the defect KB(KB ID:L9805252,Terminal ID:15364267,Cable Size:0.35mm²), when we didn't shell the insulation and do CFA validation, it can alarm normally at the Komax machine die station 1# but abnormally at die station 2#, Why?

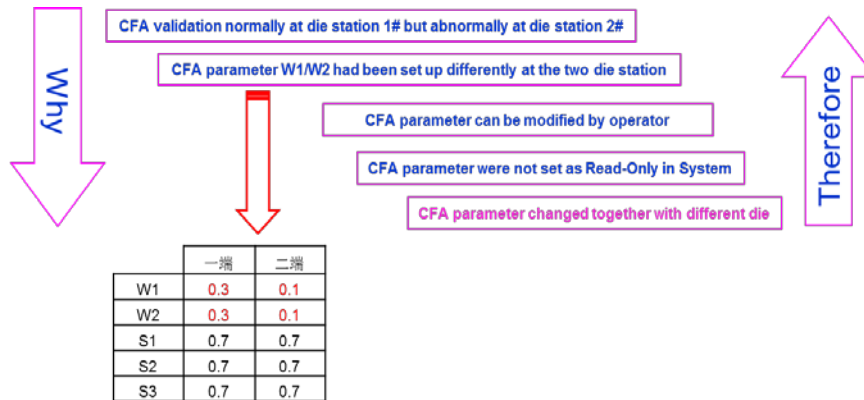
Photo 3: 5 Whys for CFA validation

So, CFA parameter for 15364267 terminal +0.35mm² cable set up improperly and CFA parameters changed together with different dies result in this crimping issue. Furthermore, Komax No.8 machine operator inspection loss will lead to escape.

System Reason: CFA parameter set up improperly and CFA parameter changed together with different die.

Reason	Action Plan
<p>Manufacturing Reason: The crimping tooling can't cut off the insulation easily.</p>	<p>Replaced the crimping tooling for Komax No.8 machine immediately.</p>
	<p>Check the crimping tooling status of other Komax machines and replace un-useful ones one by one as soon as possible.</p>
	<p>Strictly implement the maintenance work instruction, confirm the crimping tooling status in the preventive or protective maintenance for all Komax machines.</p>
<p>Escape Reason: K8 operator inspection loss and nobody double check for it.</p>	<p>Training Komax machine operators do the crimping appearance inspection carefully.</p>
	<p>Change Komax No.8 machine day shift and night shift inspection status from self-inspection to quality inspector inspection for a period time.</p>
<p>System Reason: CFA parameter for 15364267 terminal +0.35mm² cable set up improperly and CFA parameter changed together with different die.</p>	<p>For 15364267 terminal +0.35mm² cable, change CFA parameter W1/W2 to 0.3/0.3 at die station 2# for Komax No.8 machine, and set them as read-only.</p>

<p>Check all die CFA parameter, for 0.35mm² cable, adjust CFA parameter W1/W2, in order to alarm sensitive, and set them as read-only.</p>
	<p>For all Komax machines, choose the terminal matching the lowest cross section area cable, and adjust the die CFA parameter W1/W2, in order to alarm sensitively, and set them as read-only.</p>
	<p>Ask operators alarm immediately whenever they find CFA abnormally.</p>
	<p>Cross function team confirm Komax machine alarm normally whether or not randomly.</p>
