Survey of a venlo greenhouse by heavy snow hazard

Abstract. During the spring festival in 2013, a venlo greenhouse was collapsed due to the heavy snow hazard occurred in the south of Jiangsu, China. The general process of inspection and identification of lightweight steel structure greenhouse was introduced according to investigation and analysis of collapse of the greenhouse. At last, the current problem of venlo greenhouse design and construction in our country is discussed, and a good reference of reasonable design and construction is provided for this type structure.

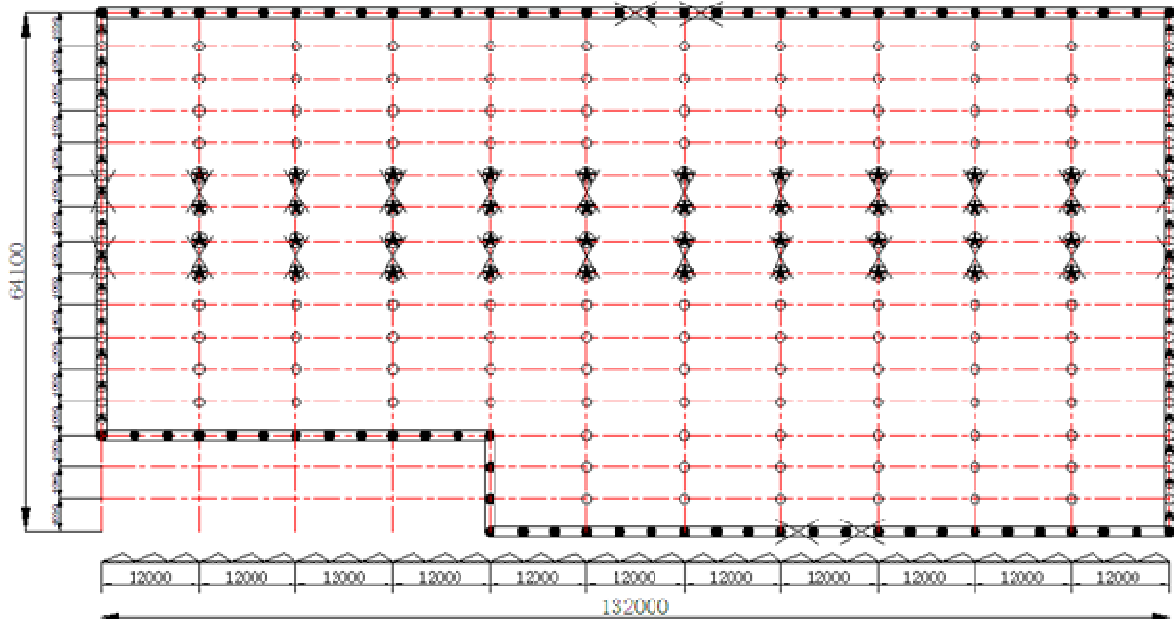
Figure1. layout of a venlo style greenhouse

aluminum alloy. The size of its plane axis is 132m×64.1m and the column axis 12m×4m folding back southwest. The layout of a total construction area of 800m² is presented as the chart, which is classified into A, B, C, D based on different size. Trusses, columns all employ Q235 steel with rectangle-shaped section bars and the roof, gutter, purlin 6063A-T5 aluminum alloy material with special section. The roof is equipped with solar panels and glass for the sake of power generation and lighting. NEN3859 and NPR3860 greenhouse standards of Dutch are taken as reference when designing the bearing capacity of the main structure. The main parameters: fundamental wind pressure of 0.44KN/ m², reference snow pressure of 0.25 KN/ m², no less than twenty years of service life. A sudden blizzard rendered the greenhouse into collapse during Spring Festival in 2013.

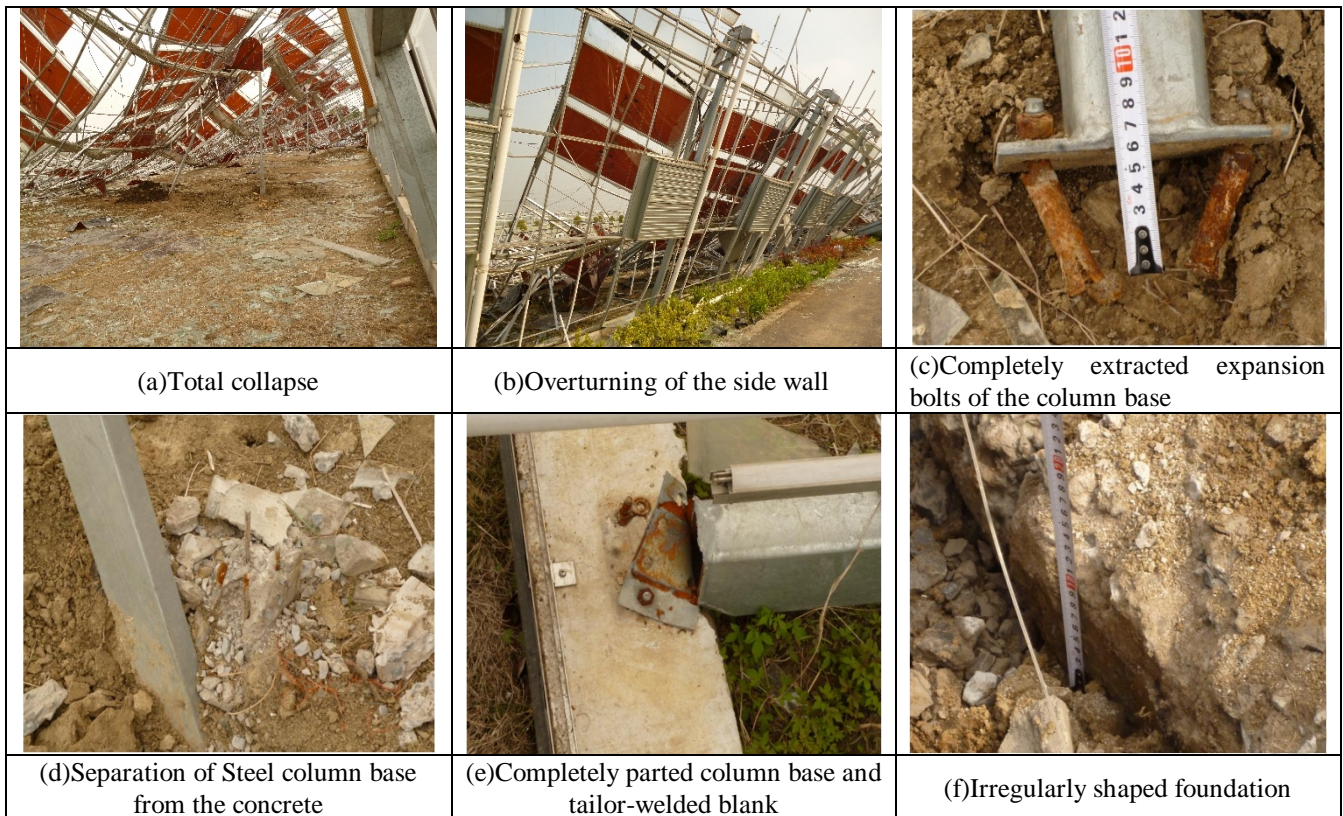
Figure2. damage forms of the site-inspection

Judging from in-situ observation, the damage forms of the structure are mainly characterized with disabled stele base, out-of-plane stability of the upper and lower chord, yield failure of abdominal rod, inward collapse from a certain side with the side and middle spans falling successively to the other side as the consequences above features. And finally only an array of side span columns left behind as shown in Figure2 a, b.

Damage forms of the components: Two expansion bolts, which are connected with steel column base, are completely pulled out and broken (Figure2 c); stele base is separate from concrete column and steels inside the concrete column are exposed after the foundation pillars crushing down due to the forces of stress (Figure2 d); column base and tailor-welded blanks are split at the welded side column bases which are jointed by two expansion bolts (Figure2 e); The thickness of the concrete foundation arranges from 120mm to 180mm and it is shaped irregularly(Figure2 f).

- 1) The actual situation in China must be taken into consideration when introducing excellent foreign experiences. Overload claims the principal responsibility for this collapse by blindly coping the standard snow load of greenhouse in Dutch which is smaller than China's.
- 2) Design must be strictly abided by during construction. Amount of expansion bolts in the column base are obviously cut down--- originally-designed six column bolts and foundation anchor are reduced to one or two in practice when building the greenhouse, which easily results in instability of pillars in large load.
